“Full” Reserve Study

HMC Water System

Herron Island, WA

Report #: 26621-0
For Period Beginning: October 1, 2014
Expires: September 30, 2015

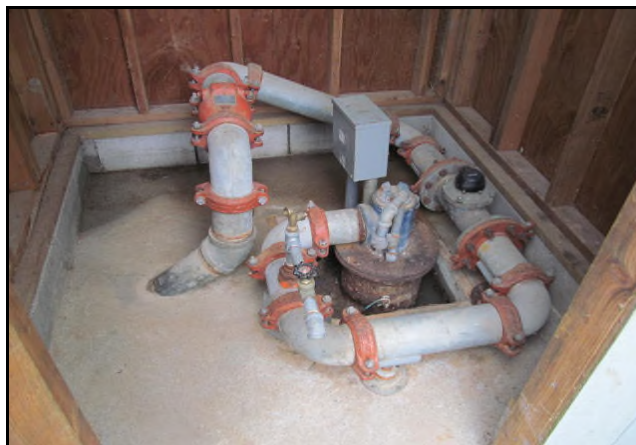
Comp # : 900 Wells - Replace Quantity: (2) active

Evaluation : There are two wells on the property; both are active and located within 65' of each other. Well #1 was reportedly drilled in in either 1955 or 1959 and Well #2 in perhaps 1982 or 1983. Current depth is ~200' for each with combined 370 GPM pumping output. Detailed information about background, depth, supply, etc... should be found within the comprehensive Water System Plan by Anchor Environmental, LLC (dated September 2009) and the subsequent 2011 Distribution System Replacement Project Report by Northwest Water Systems, Inc.. The WSP details current and future projected water needs. Information within that plan and our research did not indicate any predictable time frame for the need to drill a new well within the current water system planning period which ends in 2028 nor for the distant foreseeable future. Note that without any known deficiencies of aquifer, service life of wells can be very extended, often 100 years or more. Further, existing wells may have potential to be extended rather than selecting new wells/locations. As the community ages and your SWSMP is updated frequently, begin accruing reserve funds to add, modify or replace any wells when basis for future needs or useful life is confirmed to be less than 30 years and then update your long term budget accordingly.

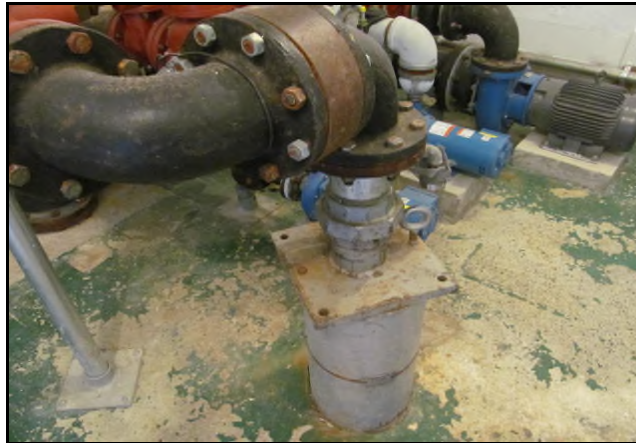
Comp # : 901 Well Pumps/Motors - Replace

Evaluation : Both well pumps/motors were replaced last in September 2012. Going forward, regular testing and inspection should be factored within the operating budget. Minor repairs/replacements (below \$2,000) of miscellaneous valves, piping, hardware, etc... should also be considered maintenance items. Installing contractor indicated replacement at the typical useful life projection of between 15-30 years for most applications, with longer end of this range for these systems.

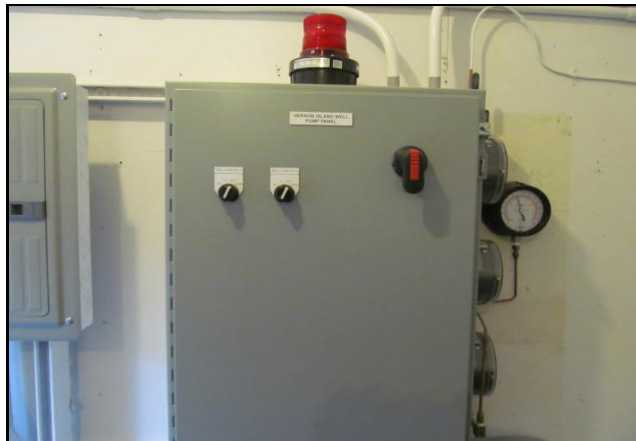
Comp # : 904 Well Controls - Replace

Evaluation : Well control panel was recently replaced. Assumption for eventual intervals of controller system replacement to ensure functionality and offset potential parts obsolescence.

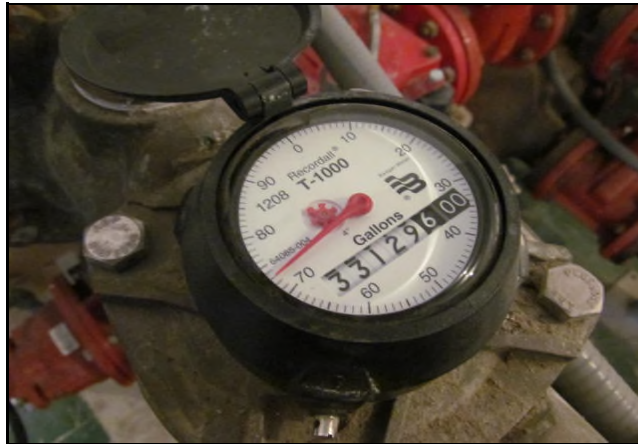
Source Flow Meters - Replace

Evaluation : Age and model appear to vary but no reported problems; both are assumed to be within allowable accuracy tolerances. Typical life is in the 10-20 year range. Roughly \$1,000-\$1,200 expense of individual replacements, when needed, do not merit reserve designation.

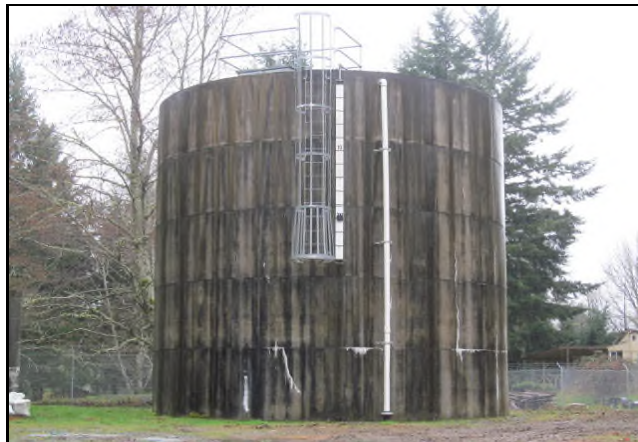
Comp # : 910 Storage Tank, Concrete - Replace Quantity: (1) 99,000 gallon
 Location : 421 West Madrona (Lots 7 and 8, Block 3, Division 5)
 Funded? : Yes

Evaluation : This above grade concrete tank was reportedly installed in 2005. It is our understanding that water storage capacity is 94,000 gallons for this 99,000 gallon reservoir. No significant cracking, damage or spalling but local efflorescence (mineral staining) was apparent. This is typically indicative of water seepage and we assume ongoing evaluation for stability and leak detection will occur. Interior of concrete tank is without any liner requiring renewal or replacement. Our research suggests planning for typical service life of between 60-80 years for concrete tanks. Continue to monitor closely and perhaps have engineer evaluate if cracking/spalling, or actual leaks become prevalent. Also, inspect access metal work and keep in good repair as ongoing maintenance. Note; some possibility of increased storage needs may exist for future years, as well as multitude of other design criteria - adjust in future reserve updates as conditions merit.

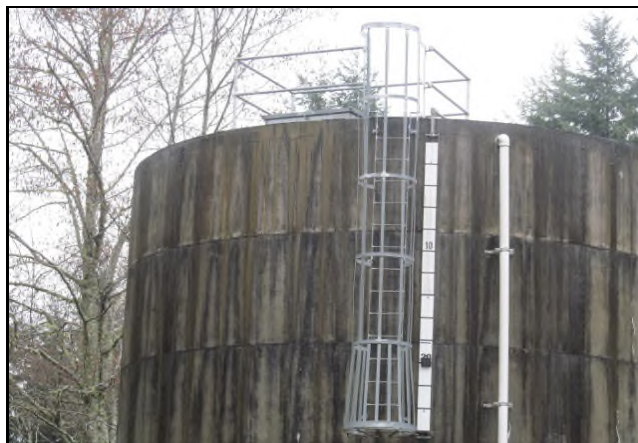
Evaluation : No image of interior available; exterior of tank represented below. Presently no type of interior tank liner exists with no anticipating of such applications for the foreseeable future. Note that if beginning such application of interior coatings, typical life expectancy is 10-15 years and cost would likely be in the \$10,000-\$15,000 range .

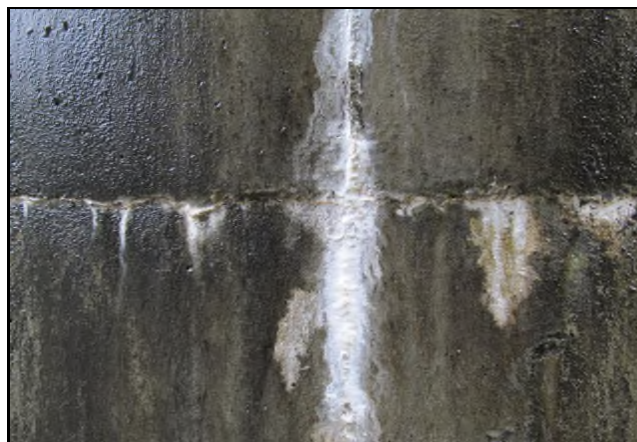
Evaluation : Exterior surface is without any protective coating (as typical for concrete reservoir). General grime, mildew and staining was illustrated; needs for cleaning were evident. Recent removal of surrounding trees has increased visible exposure to surrounding owners but day-lighting may help keep tank exterior cleaner in the future. In any event, no preliminary bids or timing for exterior cleaning project were expressed but we have factored an allowance for such to benefit aesthetics.

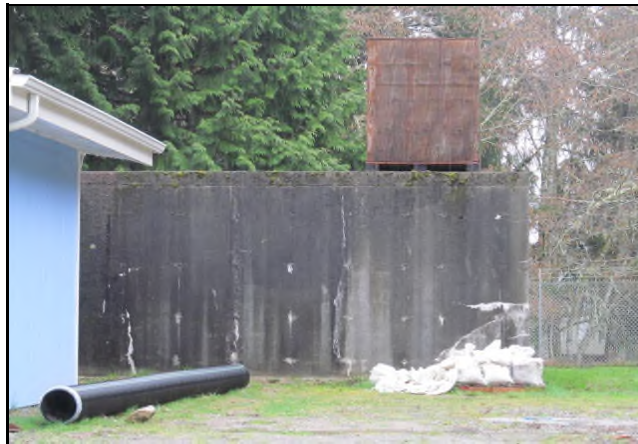
Evaluation : No plans for expense to demolish and remove this decommissioned concrete reservoir at present. Incorporate into future reserve study update as conditions warrant.
