Update "With-Site-Visit" Reserve Study

HMC Water System Lakebay, WA

Report #: 26621-6

Date Prepared: September 1, 2020

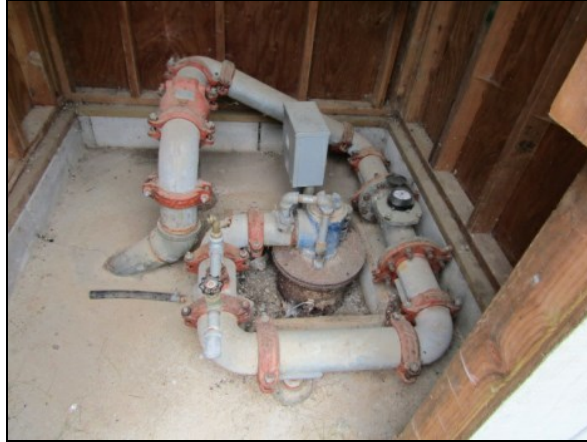
Comp #: 901 Well Pumps/Motors - Replace**Quantity: (2) 5 HP submersible, 4"**

History: Both active 5 HP submersible, 4" well pumps/motors were replaced last in September 2012.

Comments: Both active 5 HP submersible, 4" well pumps/motors were replaced last in September 2012. Previous research with installing contractor indicated replacement at the typical useful life projection of between 15-30 years for most applications, with longer end of this range for these systems. Going forward, regular testing and inspection should be factored within the operating budget. Minor repairs/replacements (below \$2,000) of miscellaneous valves, piping, hardware, etc... should also be considered maintenance items. The inactive well pump/motor is not currently factored for replacement intervals.

Useful Life:
30 yearsRemaining Life:
22 years

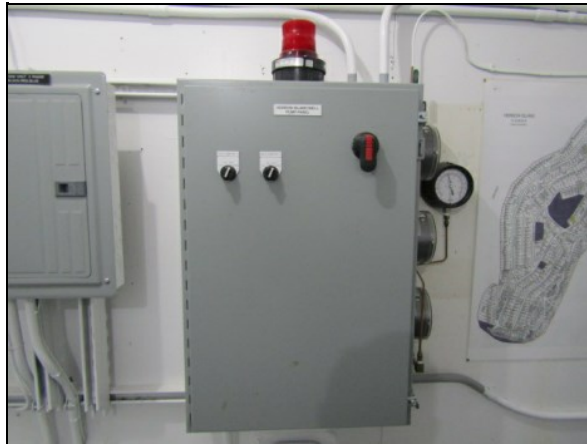
Comments: Well control panels without reported problems. Assumption for eventual intervals of well controller system replacement to ensure functionality and offset potential parts obsolescence.

Useful Life:
30 yearsRemaining Life:
22 years

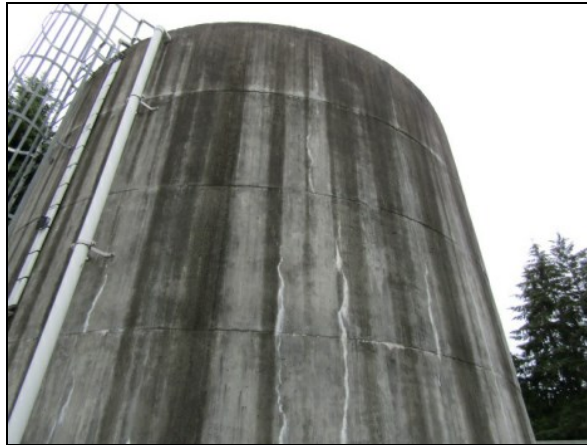
Comments: This above grade concrete tank was reportedly installed in 2005. It is our understanding that water storage capacity is 94,000 gallons for this 99,000 gallon reservoir. No significant cracking, damage or spalling was apparent during our limited scope visual inspection. As before, local efflorescence (mineral staining) was noted. This condition is reportedly consistent since initial 2005 construction and apparently not indicative of significant water loss. We assume ongoing evaluation for stability and leak detection will occur. Interior of concrete tank is without any liner requiring renewal or replacement. Our research suggests planning for typical service life of between 60-80 years for concrete tanks. Continue to monitor closely and perhaps have engineer evaluate if cracking/spalling, or actual leaks become prevalent. Also, inspect access metal work and keep in good repair as ongoing maintenance. Note; some possibility of increased storage needs may exist for future years, as well as multitude of other design criteria. Update your WSP or SWSMP and adjust in future reserve updates as conditions merit.

Useful Life:
80 yearsRemaining Life:
65 years

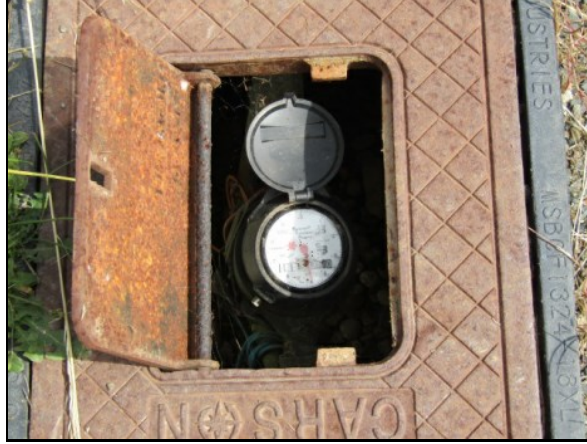
Anticipate some local replacement needs (due to spot additions and/or early failure) in between large scale projects; treat such as ongoing maintenance items.

Useful Life:
10 yearsRemaining Life:
2 years

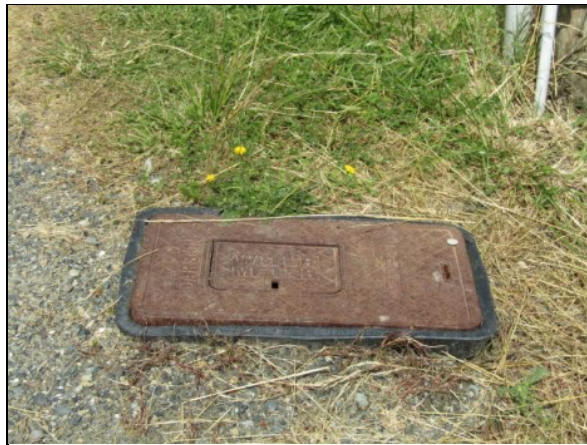
Comments: Note that associated water meter boxes, setters/shut-off valves are life limited as well. Unless more urgent needs arise, we recommend integrated replacement timed to coincide with every other meter replacement project.

Useful Life:
20 yearsRemaining Life:
12 years
