Herron Island Mainland Ferry Terminal

ROUTINE STRUCTURE INSPECTION – 2012

Inspection Date: March 16, 2012

RE: Ferry Terminal Observation
Project No.: A12108.00

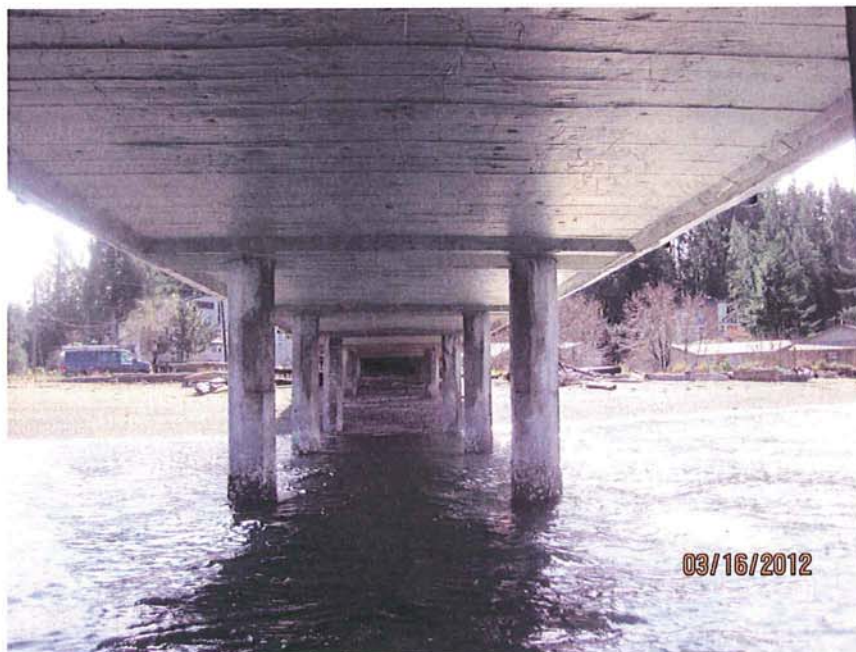
The reinforced concrete approach slabs are integral with the bent caps and piles:

Image 1: Reinforced concrete approach spans.

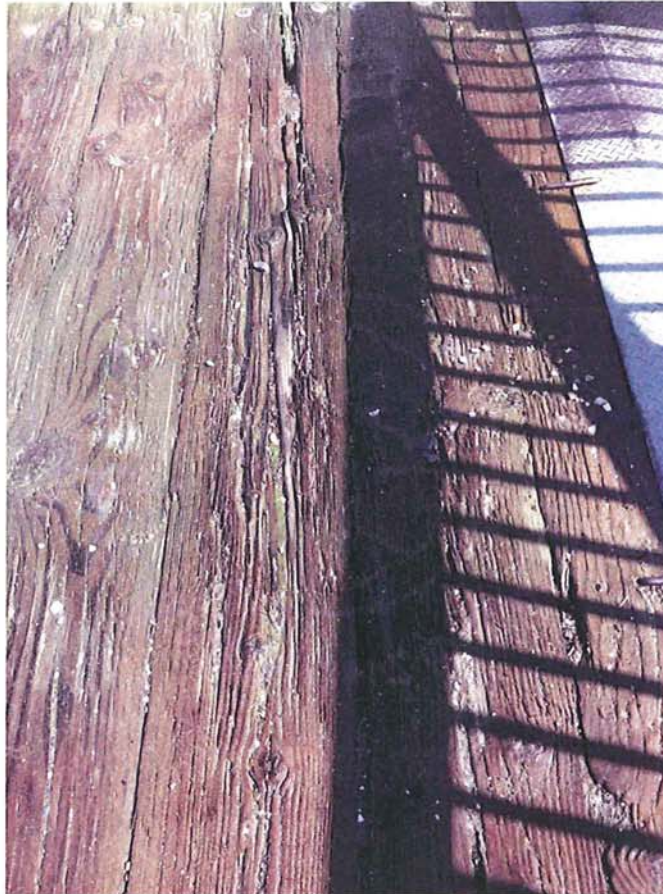
- Generally, the deck planks are becoming worn and are in the later stages of their service life. The surface of the planks is wearing and rutting in the traffic wheel lines and there are checks and splits in many of the planks. Counting from the mainland end, planks three and 26 are heavily split and decayed and should be replaced soon. Planks 17, 22, 24, 31, 33, 43, 46, 47, 50, 60, 67, 87, and 90 were found to have advanced splitting and wear and should be monitored for further deterioration. The deck attachment clips to the stringers are in good condition.

Image 2: Note splits in the timber deck near the top of the Image.

1. Blast clean and spot paint the steel girders in the lift spans.
2. Monitor lift spans paint systems, schedule complete paint system as necessary.
3. Monitor intersecting welds on floor beams and main girders during subsequent inspections.
4. Replace deck planks three and 26, monitor and replace remaining planks as necessary.
5. Periodically clean out the cavity on the top side of the reinforced concrete counter weights.

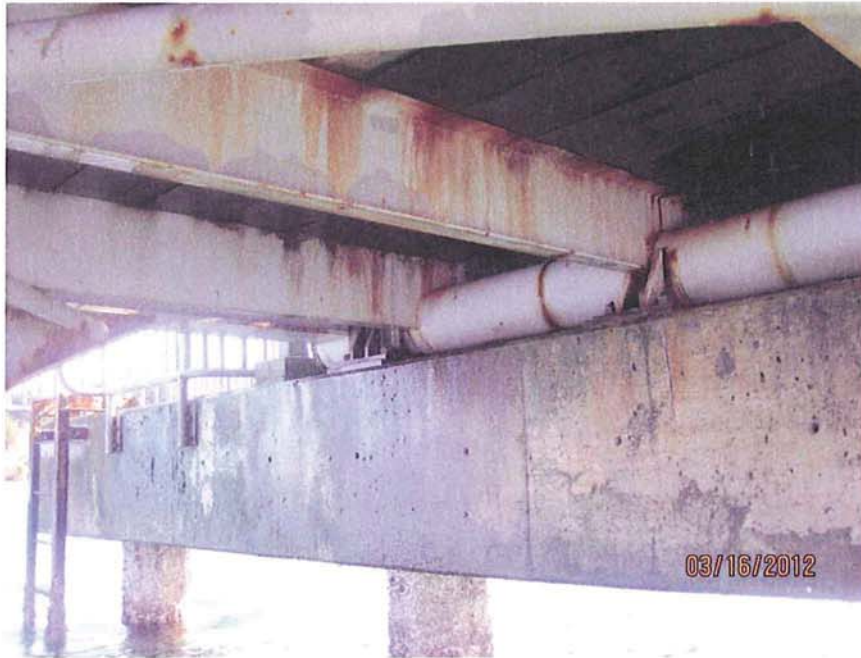
- The stringers are in fair condition. There are rust stains washing down from the interface between the stringers and the deck. Vehicle traffic is most likely causing the deck planks to wear against the tops of the stringers, causing the paint to wear. Several stringers have dark rust stains along their welded connections to the floor beams. No significant corrosion was observed in these joints or on the stringers. There are many local paint failures throughout the stringers, which promote surface corrosion.

Image 3: Note surface rusting on the steel stringer.

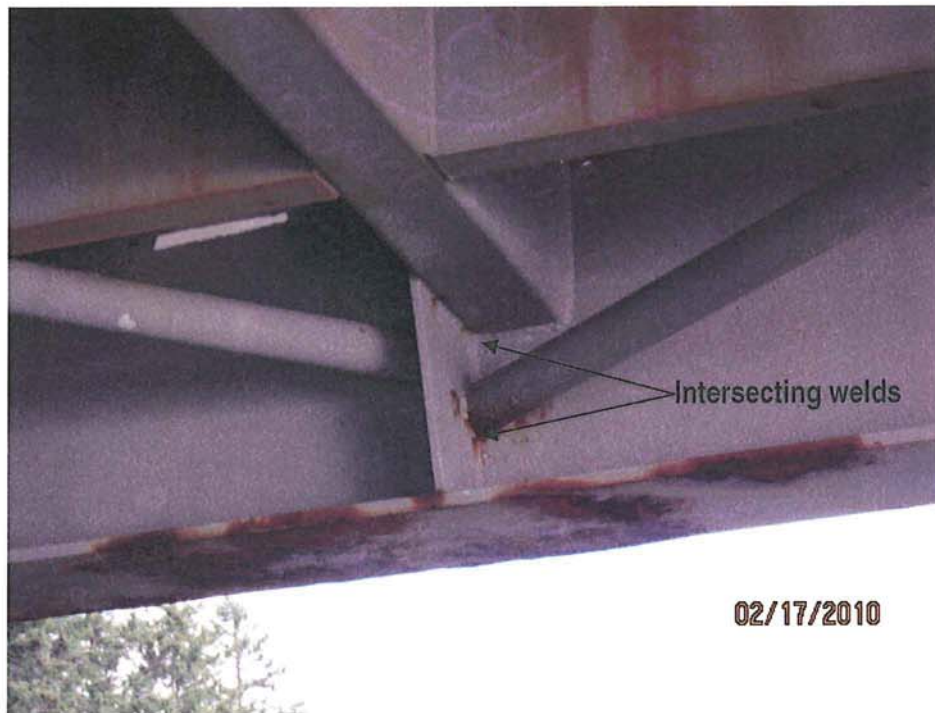
- The painted steel floor beams are in a similar condition as the stringers. The floor beam connection to the main girder is welded. The welds are such that they intersect the welds of adjacent lateral bracing gusset plates. When welds like these intersect, they cause a stress concentration. This area can be susceptible to cracking. No cracking was observed in these welds at the time of this inspection. However, this is a location that should be closely looked at during each inspection.

Image 4: Typical of the floor beam connection to the girder.

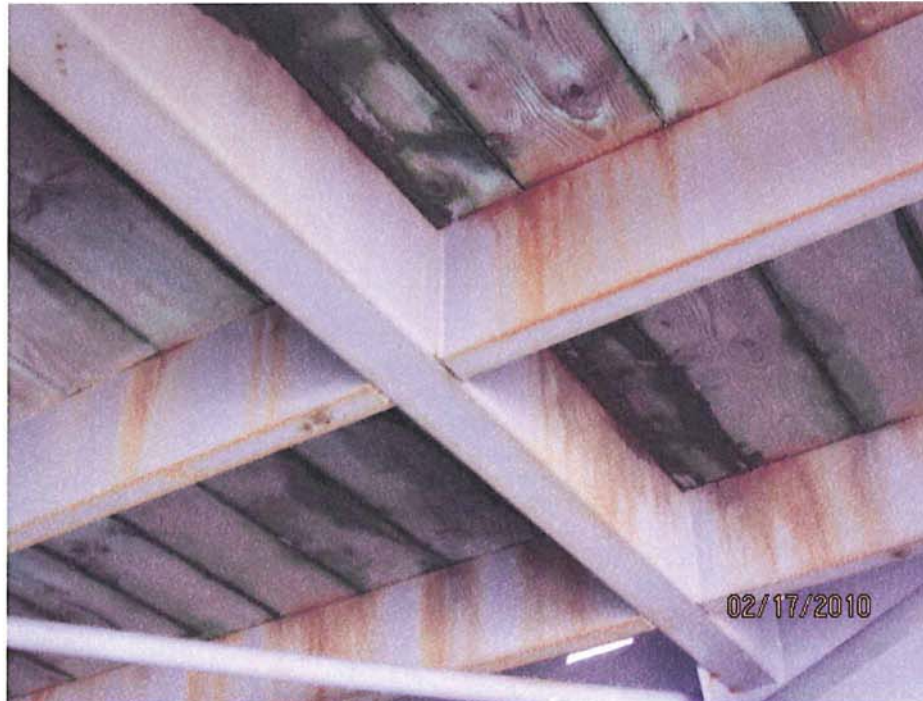
Image 5: Typical of rust staining washing down the stringers and floor beams.

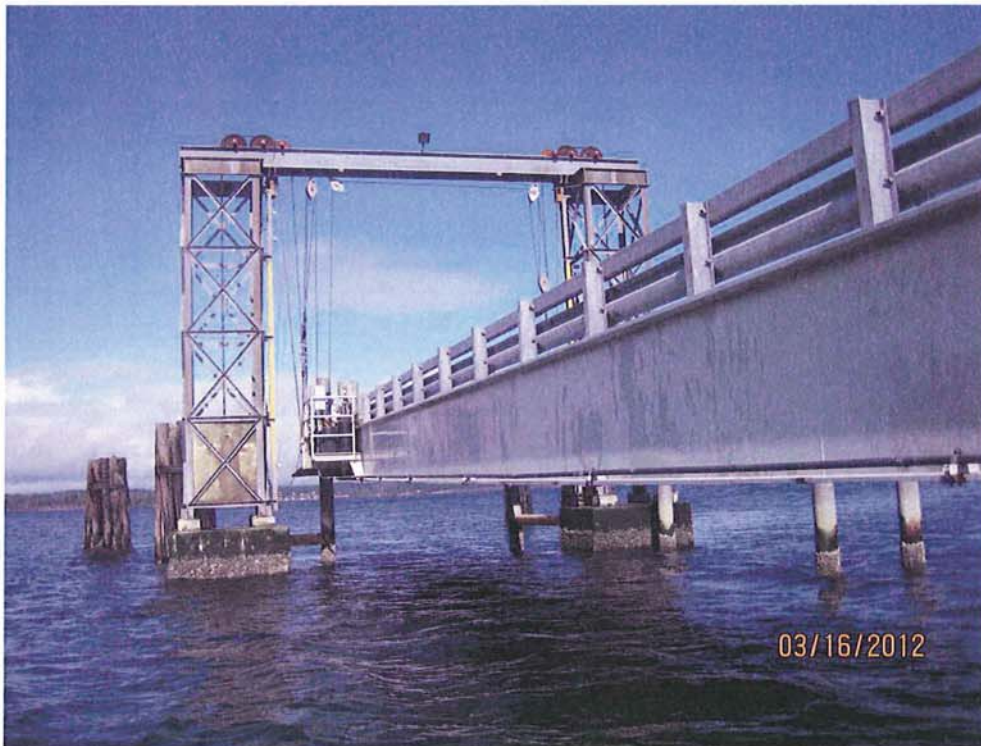
- The steel girders are in fair condition. There are two main girders in this span, which are considered fracture critical because they are steel and there is no load path redundancy. I.E., if one girder were to fail the entire span would fail. The steel girders appear to receive more salt spray than the stringers and floor beams, as a result there are several areas of blistering paint and surface corrosion. Most blistering is along the bottom flange of the girders. Several strengthening details have intersecting welds similar to those of the floor beams. No cracking in the girders or welds were observed at the time of this inspection. No deficiencies were noted in the lifting outriggers located near the end of the lift span.

Image 6: Typical condition of the exterior face of the steel girders.

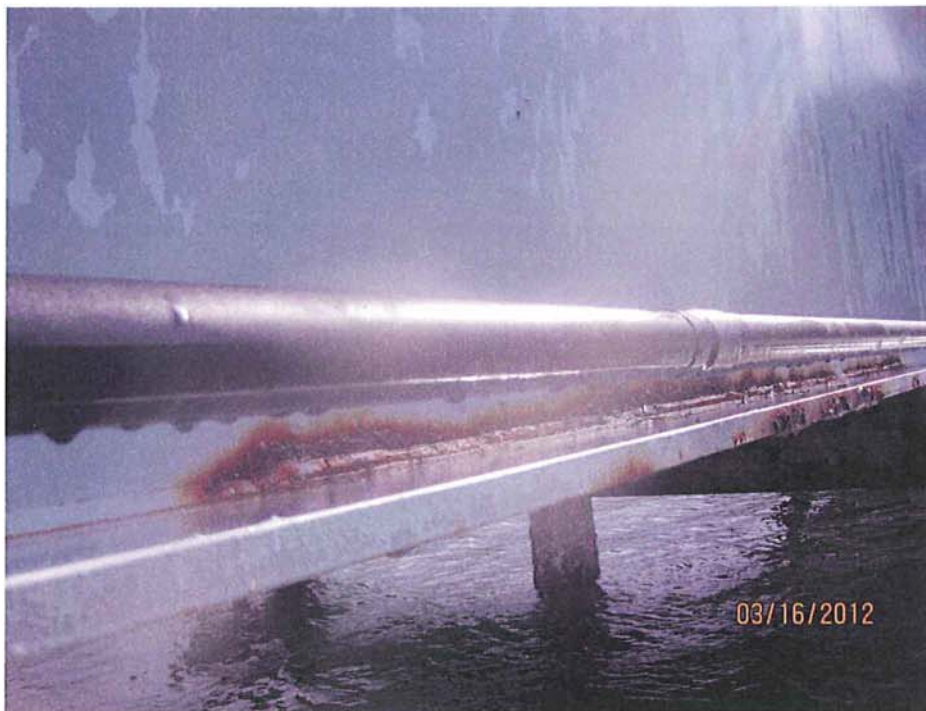
Image 7: Localized corrosion on the exterior face of a steel girder, along the bottom edge.

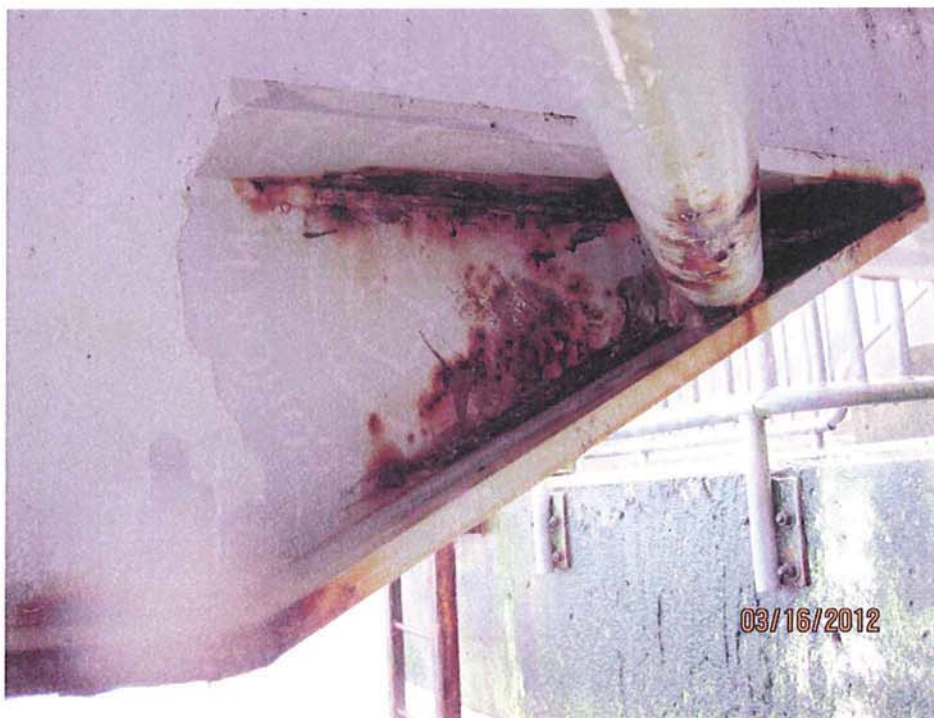
Image 8: Interior face of a steel girder: Typical of the corrosion around the connections of other members to the interior side of the girders.

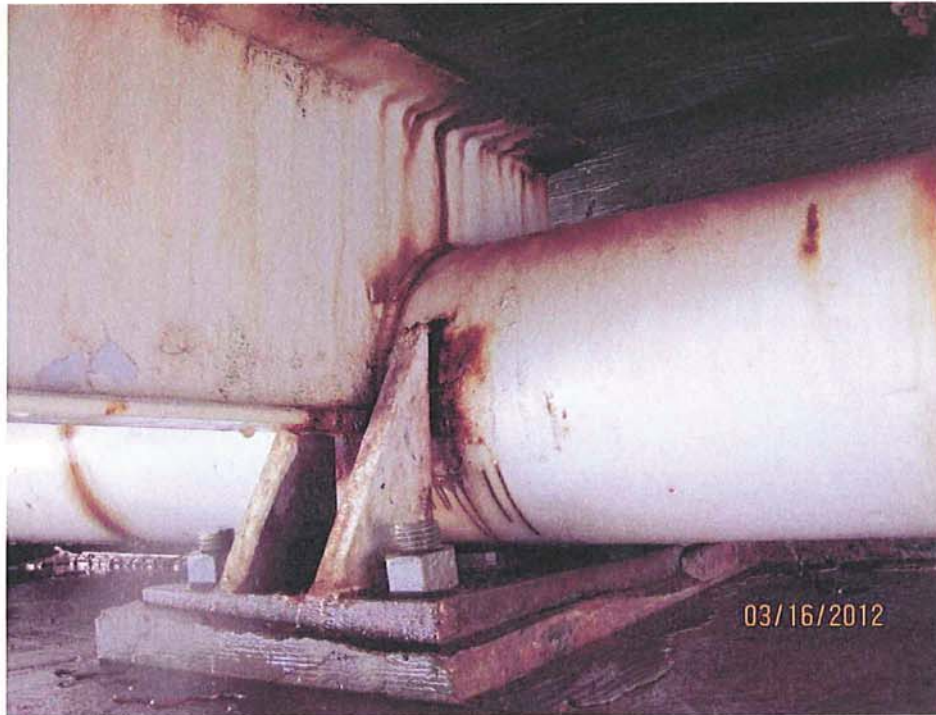
- The bearings are in fair condition. The movable painted steel bearing at bent 9 appears to be free and in good service condition. There is some paint deterioration and corrosion along the edges of the bearing.

Image 9: Typical of the corrosion around the girder bearing.

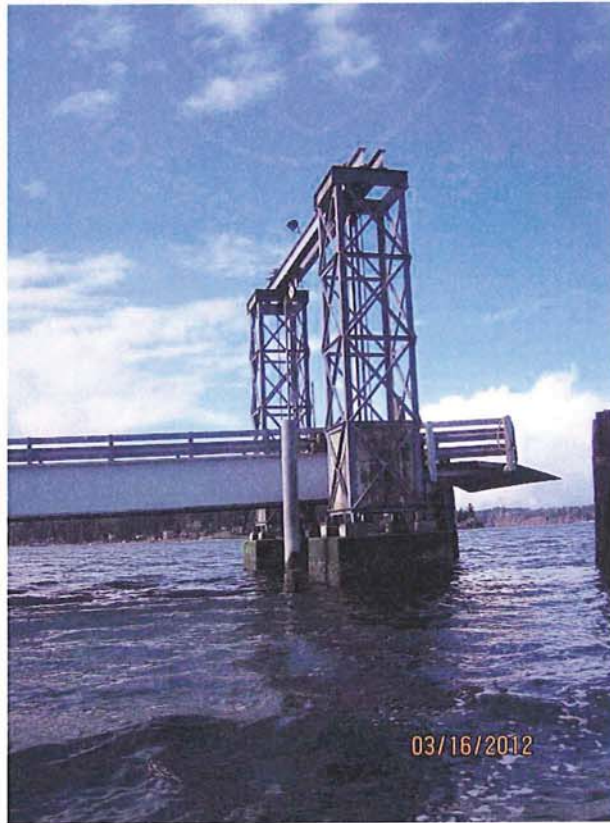
Image 10: Typical of the steel lifting towers.

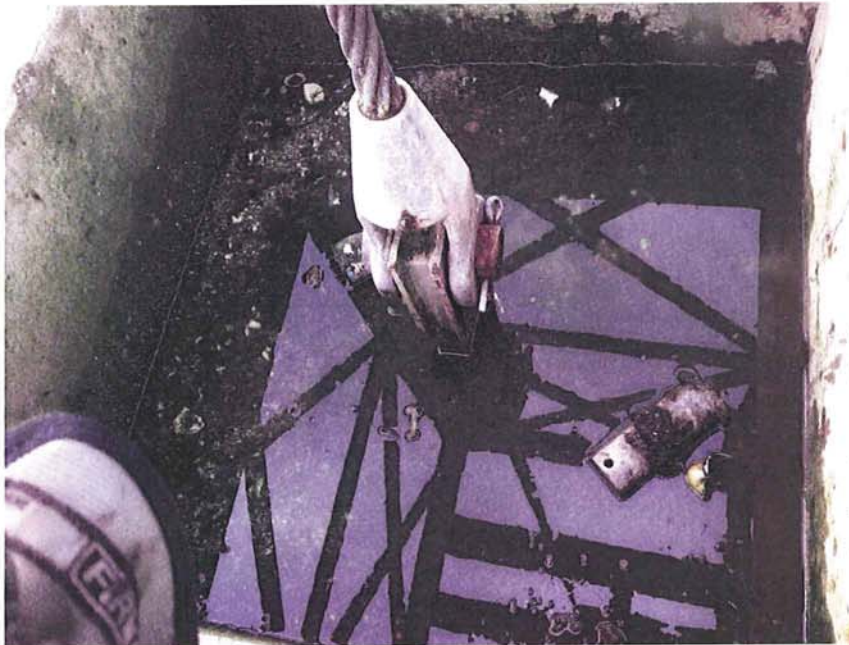
- Good condition, no deficiencies observed in the galvanized steel tower.
- Debris and muck is accumulating in the cavity on top of the reinforced concrete counterweight. The debris and muck should be cleaned out periodically.

Image 11: Typical of debris and muck build-up in the cavity on top of the counterweights.

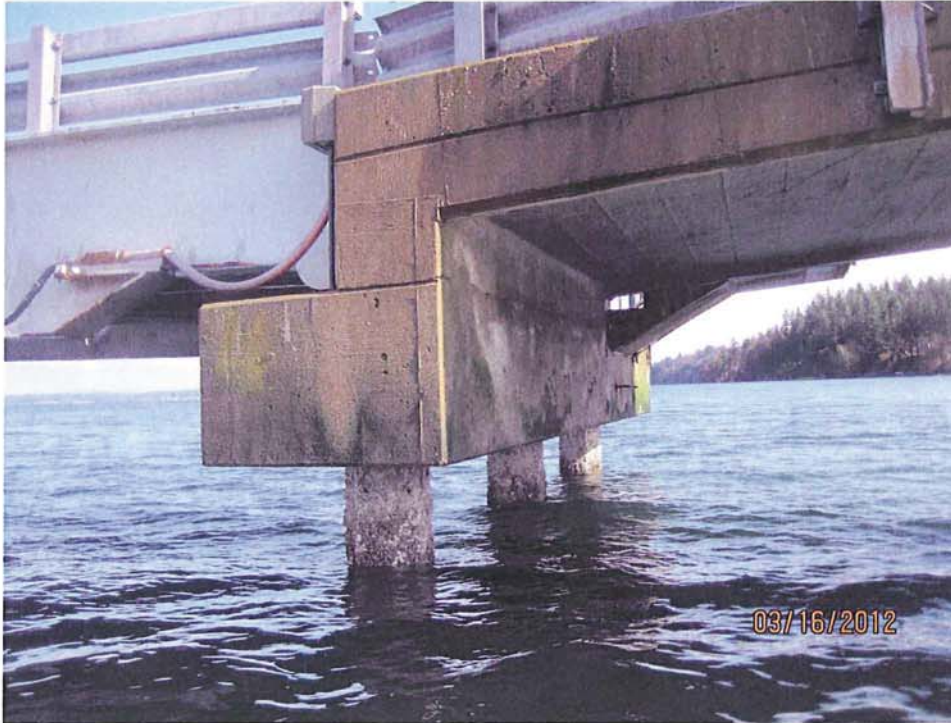
Image 12: Pier 10.

- Good condition, no deficiencies observed.

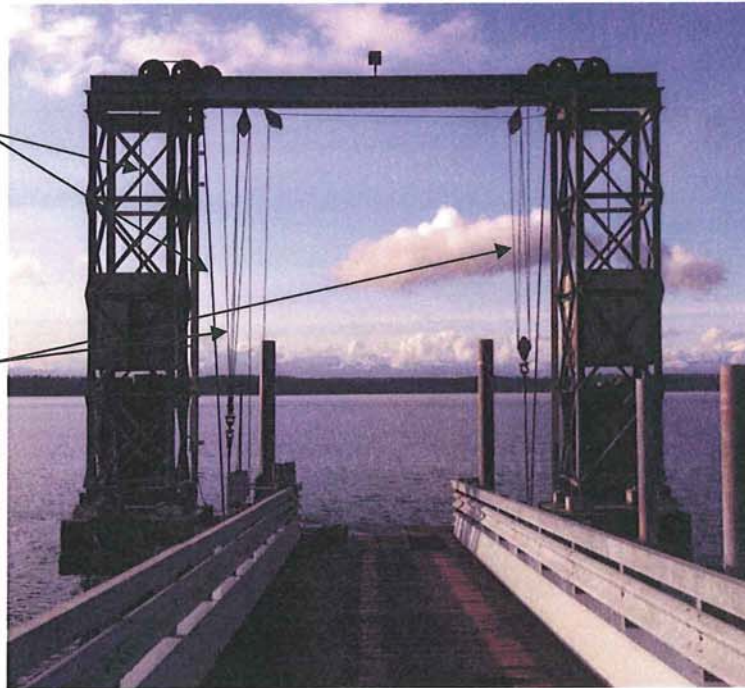
Image 13: Mechanical cable lifting system.

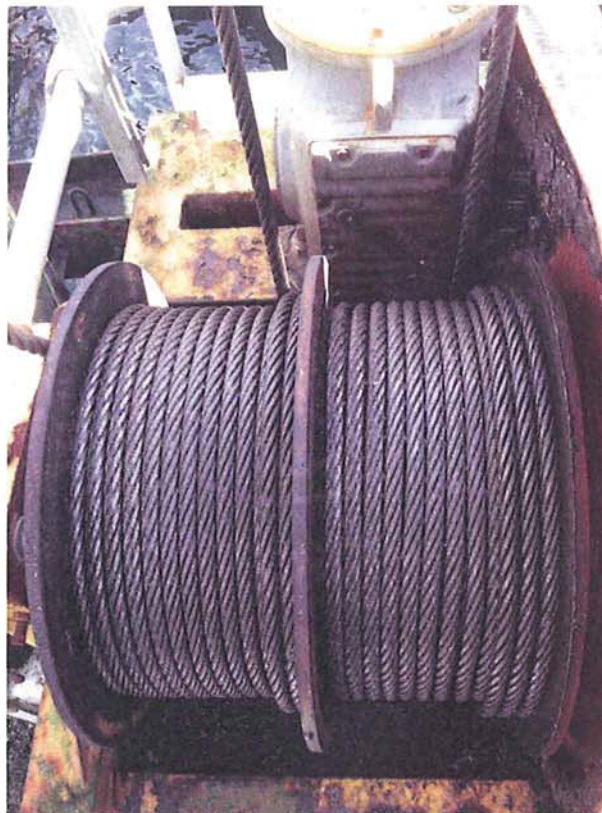
Image 14: Correctly spooled lifting cables. Note uniform and even wrap.

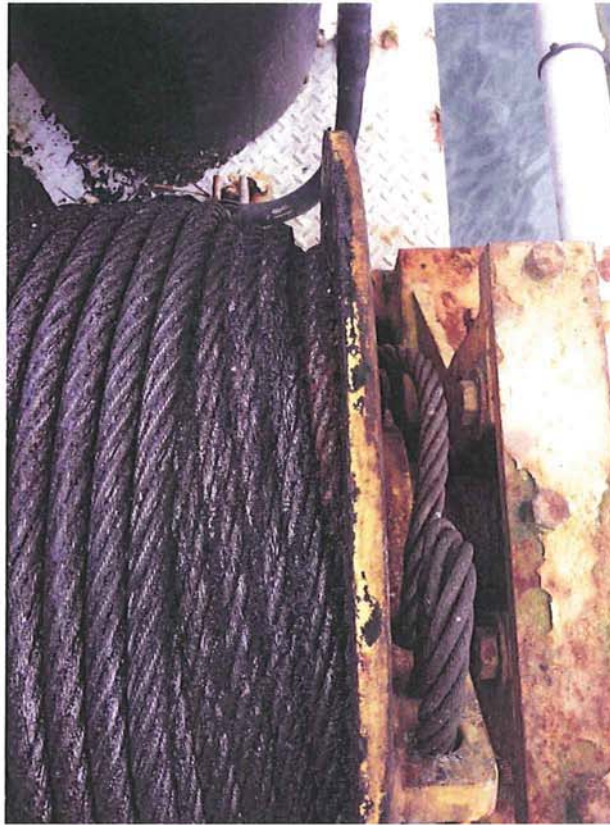
- The left side lifting cable is in good condition. The right side lifting cable is in poor condition. Both cables are well greased. The right side cable is not properly winding onto the winch spool. The cable is not winding in uniform and even layers, rather it is somewhat arbitrarily winding on to the spool. The tension in the cable is causing the cable to drag and twang into place, which is causing it to wear on itself. This wear has caused several of the strands within the cable to fray and sever. The cable should be replaced as soon as possible. Until the cable is replaced it should be re-spoiled correctly and monitored for further wear. If it becomes noticeable that more strands are breaking, the cable should be immediately removed from service. The left side lifting cable appears to be winding correctly.

Image 15: Incorrectly spooled lifting cable, note gaps and lack of uniformity.

6. Continue cable and grease maintenance schedule.
7. Replace the right side mainland terminal lifting cable as soon as possible.

8. Re-spool and monitor the existing right side mainland lifting cable until it can be replaced.
9. Consider replacing the existing clevis bolts without cotter pins, for longer ones with cotter pins.

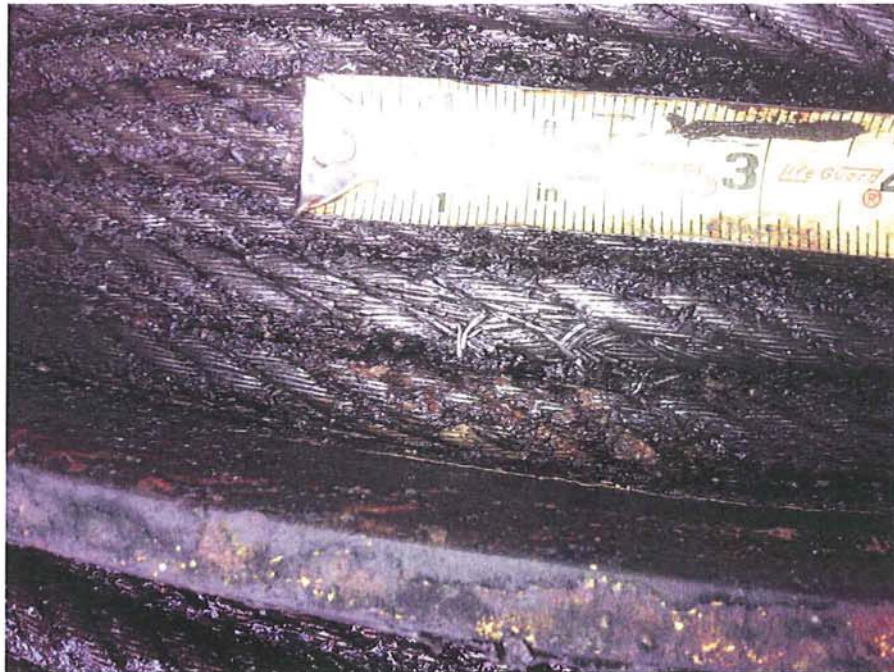
Image 16: Damaged and broken strands in the lifting cable.

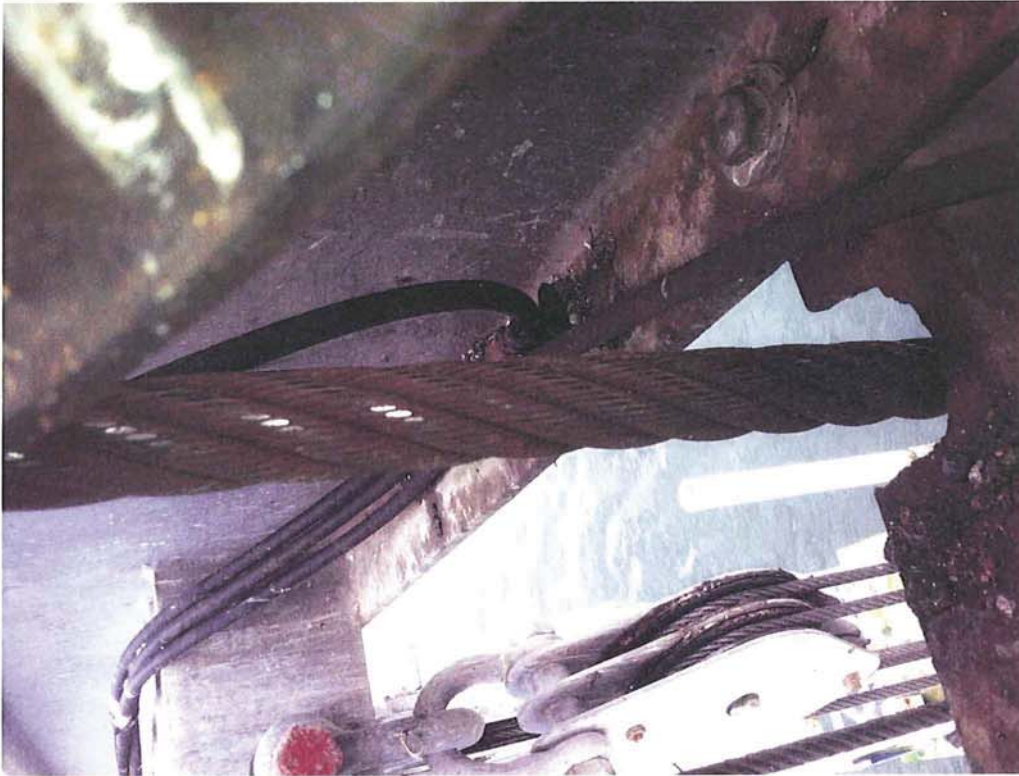
- The counterweight cables are well greased and in satisfactory condition. There is some minor wear in the strands along the bottom side of the cable that passes over the two larger 24 inch diameter sheaves on top of the lifting tower.

Image 17: Shiny flat spots in the counterweight cable near the upper sheaves.

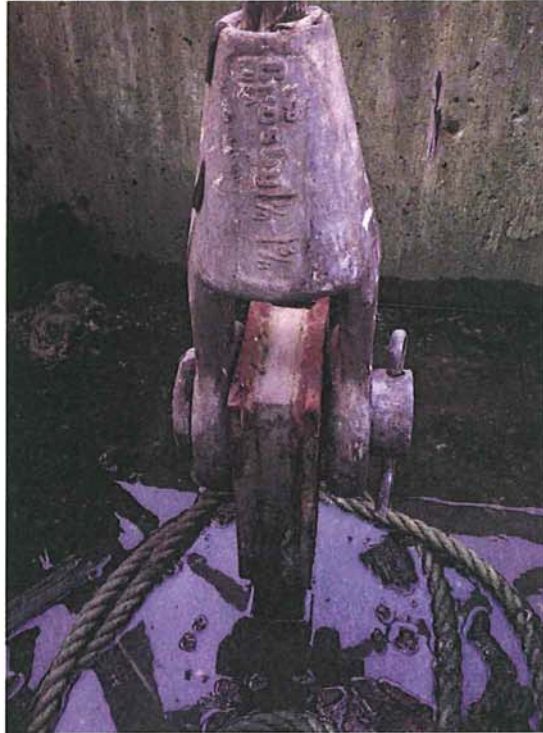
- The counterweight cable anchors are in good condition. Debris and muck is building up in the cavity on top of the counterweight. The debris is clogging the drain holes and causing standing water around the connection of the cable to the weight. The cable anchor plate paint is wearing thin and the plates have some surface corrosion.
- The lifting cable anchors are in good condition.

Image 18: Typical counter weight cable anchor. Also note the surface corrosion on the connection plate.

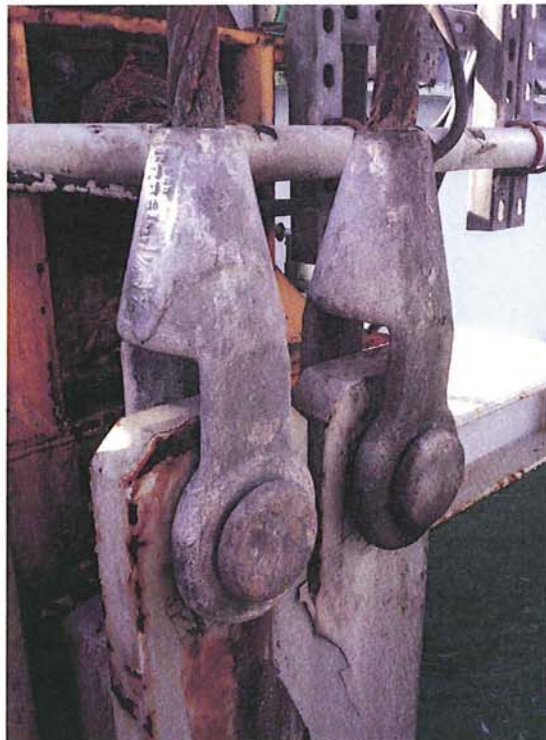
Image 19: Typical lifting cable anchor. Also note the surface corrosion on the outrigger connection plate.

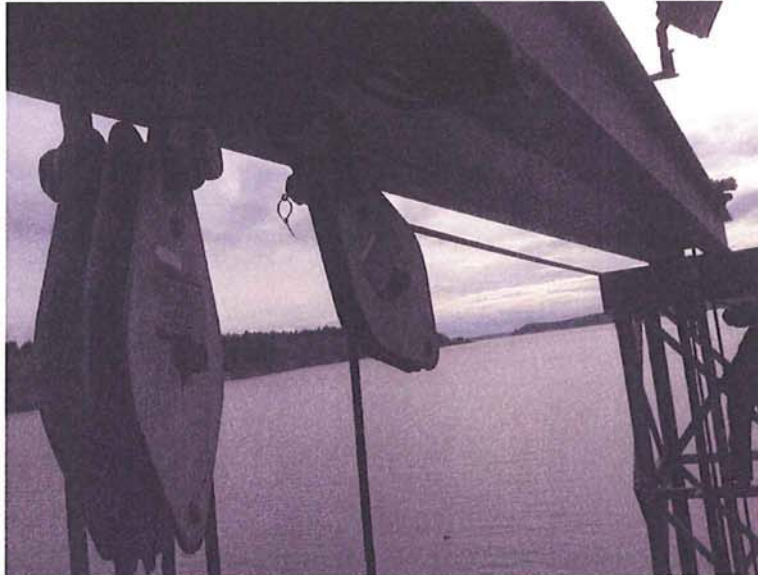
Image 19: Lifting pulleys.

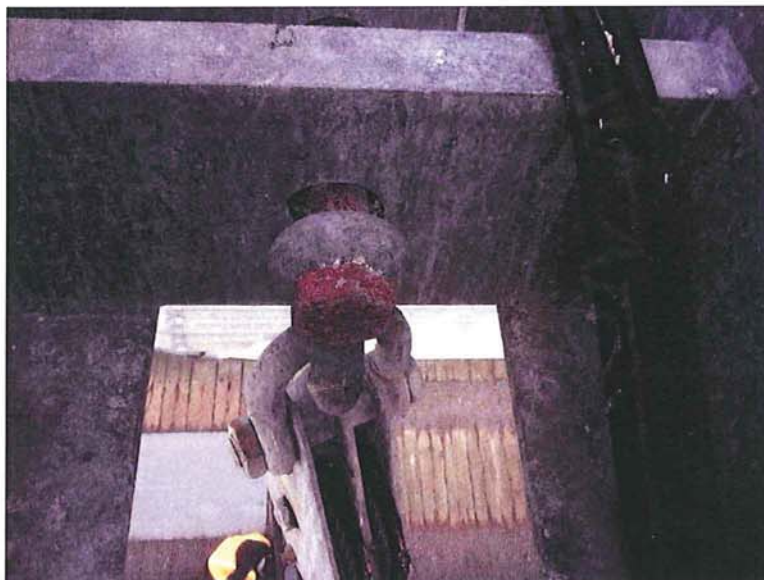
- The pulleys within the cable lifting system are in good condition.
- The clevis connections in the counterweight and lifting system are in good condition. There are several clevis connections without cotter pins. There is no indication that any of the bolts in the clevises are loose or that the lack of a cotter pin is a problem.

Image 20: Typical clevis connecting a lifting cable to a pulley. Note the lack of a cotter pin in the clevis bolt.

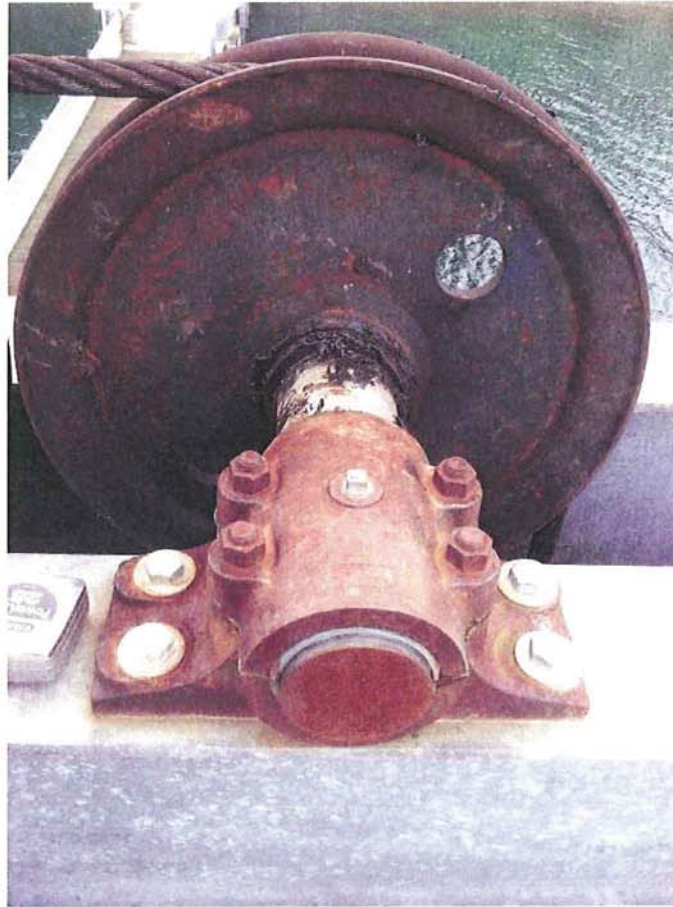
Image 21: Typical well-greased counterweight sheave.

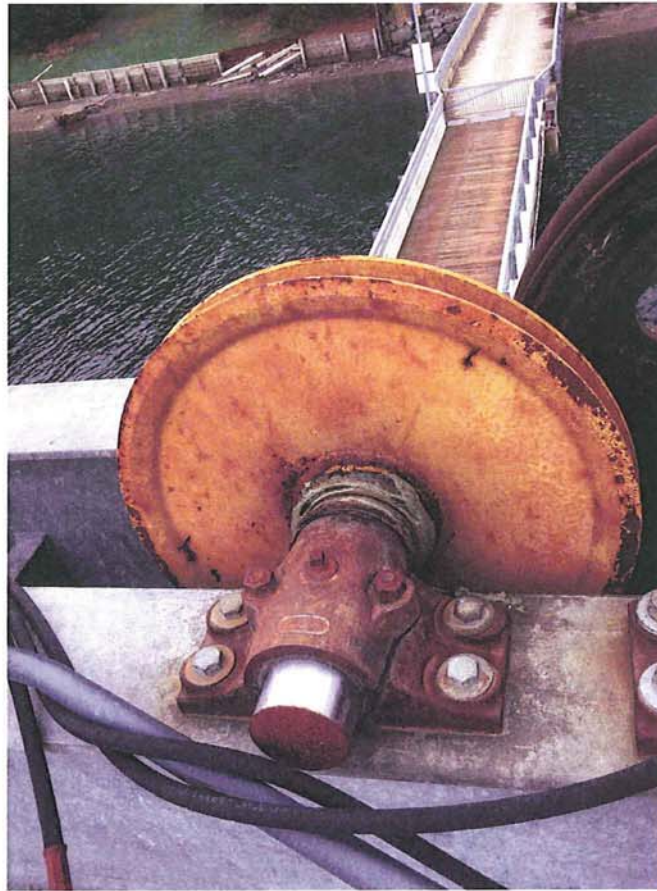
Image 22: Typical well-greased lifting cable sheave.
