Update "With-Site-Visit" Reserve Study

HMC Management Lakebay, WA

Report #: 24901-6
For Period Beginning: October 1, 2019
Expires: September 30, 2020

Date Prepared: April 18, 2019

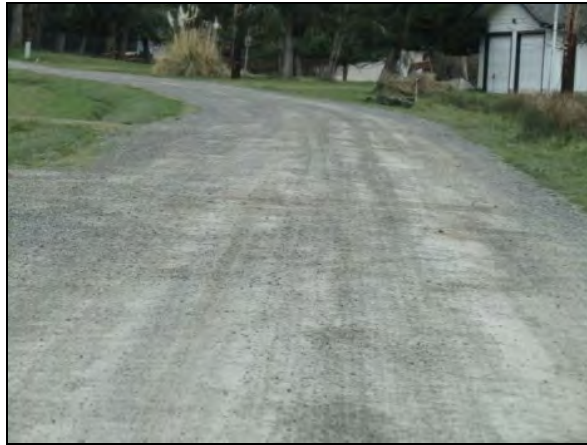
Comments: Majority of surfaces are without significant damage or instability but local repair needs were indicated. Gravel-topped access and parking areas have historically received annual maintenance from the operating budget. Barge delivery of gravel to facilitate such in FY 2018/2019 after our 3.21.2019 site inspection at reported expense of \$56,000. Previous event reportedly occurred in FY 2014/2015 at an expense of ~\$42,300. Reserve funding is factored for gravel delivery roughly every 5 years going forward. We assume provision for other signification expenses for surface grading, application of gravel, vegetation control, dust control, local road and drainage repairs will continue as annual maintenance items. Update in future reserve study updates as conditions merit.

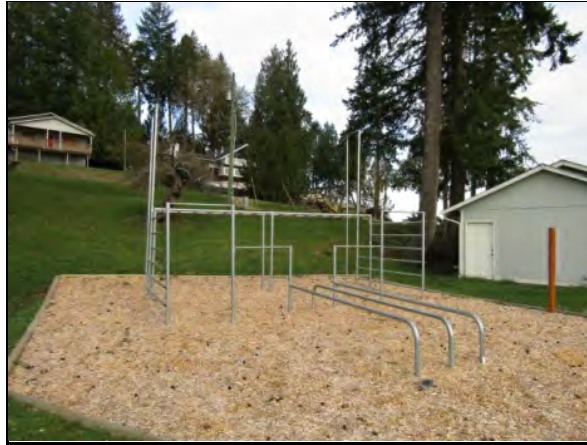
Comments: New play area with climbing toy added in FY 2017/2018 at reported expense of \$6,000. Anticipate similar future projects at interval below. Replenish material in fall zones and replace wood borders as operating budget items at this location.

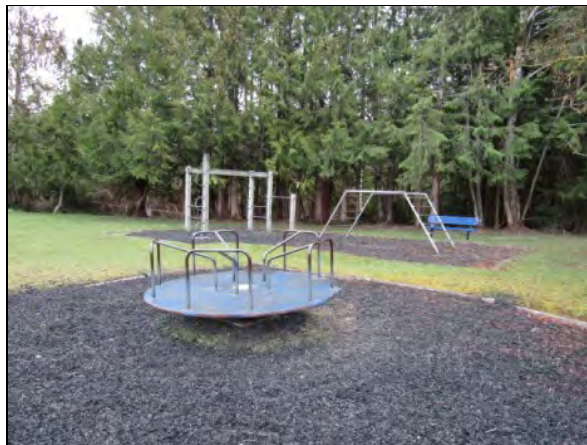
Comments: As before, majority of the larger play equipment here with general deterioration, minor corrosion and outdated appearance. In FY 2014/2015, two previous swings were vandalized and then only one new replacement was installed at \$2,000 material expense and volunteer labor. Present schedule includes (1) metal slide, (1) swing set, (1) roundabout, (1) metal climbing toy and (1) wood/metal monkey bars at Goodpastor Park. Wide range of equipment/expense are possible; some communities expend \$20,000-\$50,000 or more for integrated replacements in locations like these. Research for this update informed us that you have no current plans for such type of all-at-once projects but will replace existing rubber chip material in fall zones, transition to wood material in FY 2018/2019 at reported expense of \$8,000. General funding allowance for partial replacements going forward factored below with input from Management. Update in future reserve study updates as desires, conditions merit.

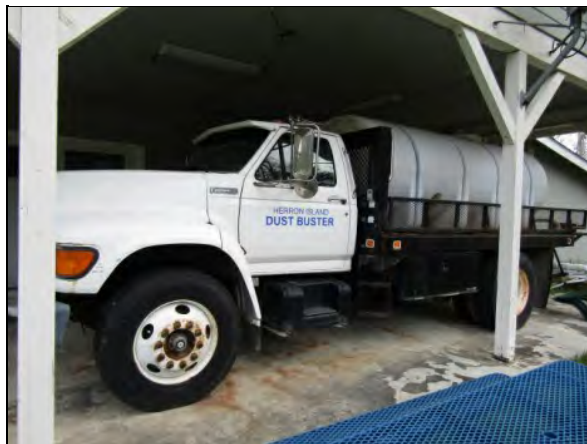
Comments: Recently replaced but older vehicle provides method of dust control for roadways. Current truck is 1997 Ford F800 but only 43,477 showing on odometer on 3.21.2019. This vehicle was reportedly purchased (used) in FY 2017/2018 at expense of \$18,000; prudent planning suggests intervals of replacement will continue to be needed going forward. Note; water tank appears to be in fair condition at this time and should be replaced as needed from operating funds.

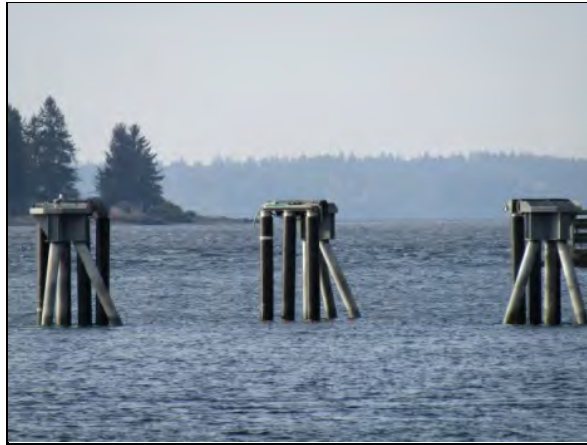
Comments: New steel dolphins replaced previous wood clusters in FY 2017/2018; final project completion at total expense of \$1,200,000. Some reserves monies were utilized but vast majority of project cost financed with long term USDA debt/loan. No future impact upon HMC maintenance reserves is factored since collections and payments will reportedly be handled in a separate account for this debt obligation (similar to separate Water System indebtedness). The reader should note that one of the key concepts of adequate reserve funding is to collect appropriate contributions from membership to offset deterioration as it occurs (in this particular instance, over many years) and therefore fairly distribute the burden of expense between current and future owners. That is, members pay only their fair share as individual reserve components are "used up" during their individual ownership period. Additionally, note that HMC reserve monies accrued for future projects should continue to earn interest and grow as opposed to paying out interest and loan fees.
