Home Inspection Report

4456 Gina Street
Fremont, CA 94538

Date of Inspection: 08/07/2023

Inspection No. 261489-1644

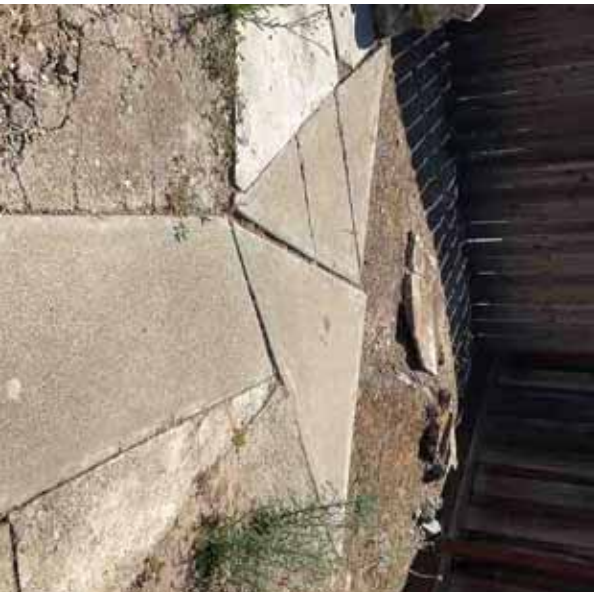
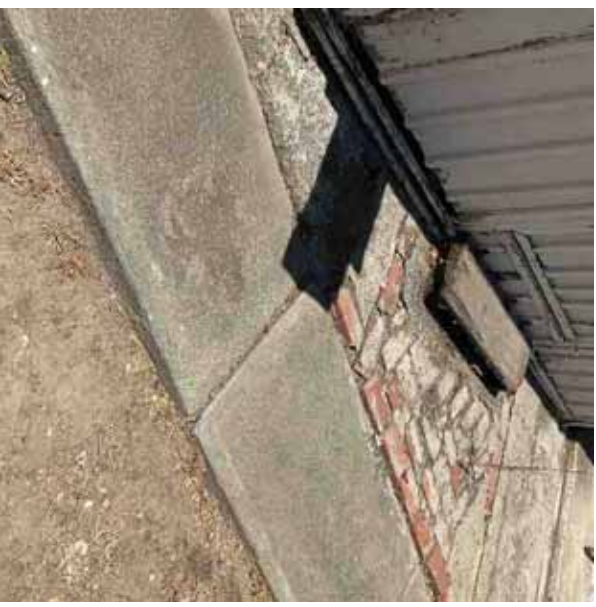
2.3.2 The walkway is damaged. Repair to prevent further deterioration and trip hazards. (Exterior Back)

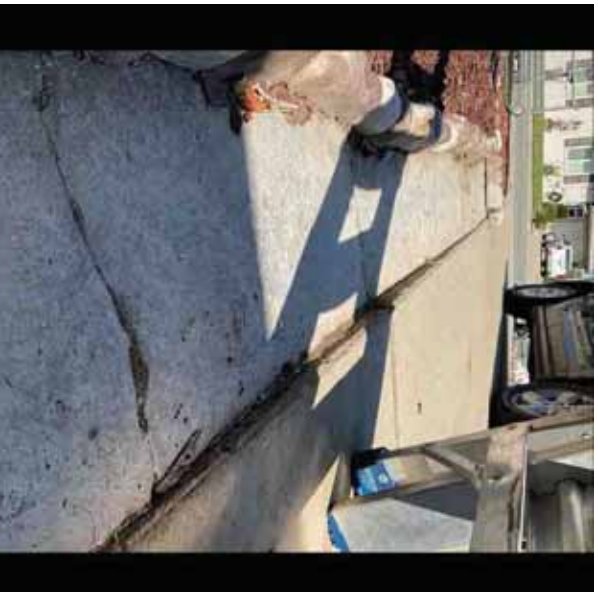
2.4.2 The driveway is damaged. Repair to prevent further deterioration and trip hazards. (Exterior Front)

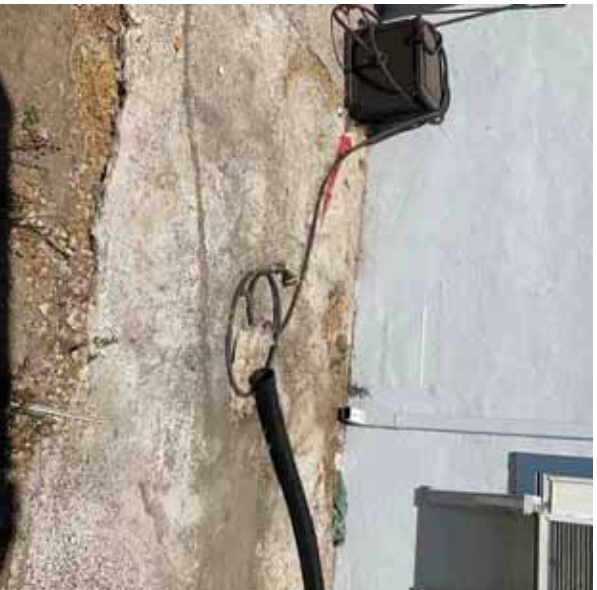
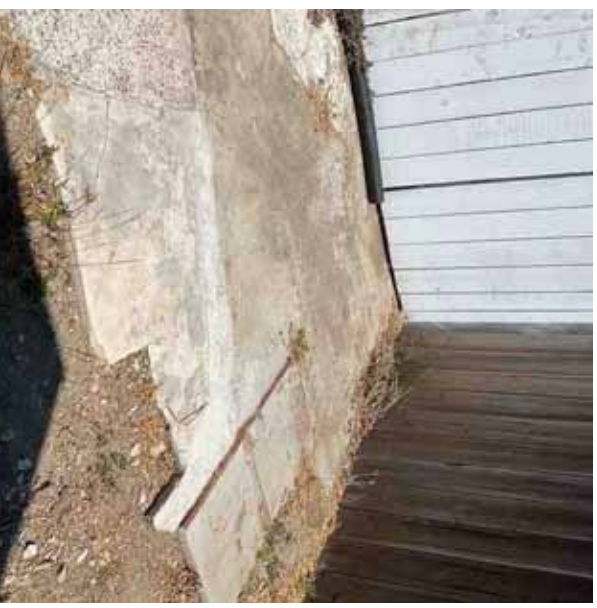
2.5.3 The patio is damaged. Repair to prevent further deterioration and trip hazards. (Exterior Back)

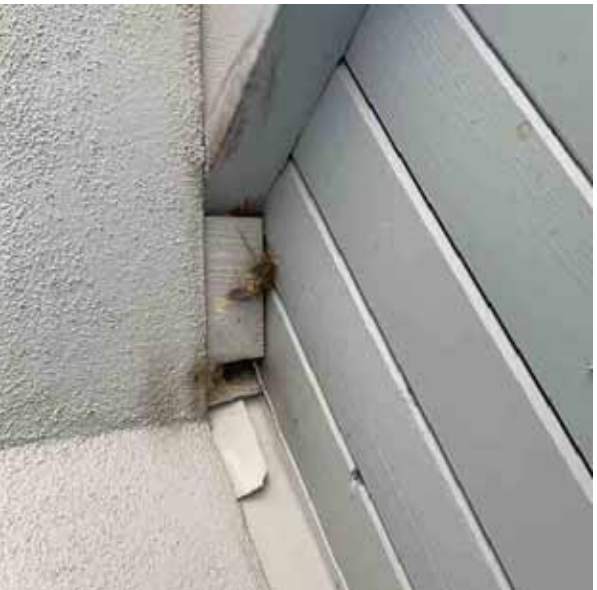
3.1.2 Remove the bird nest to avoid pest related damages and deterioration. **(Exterior Front)**

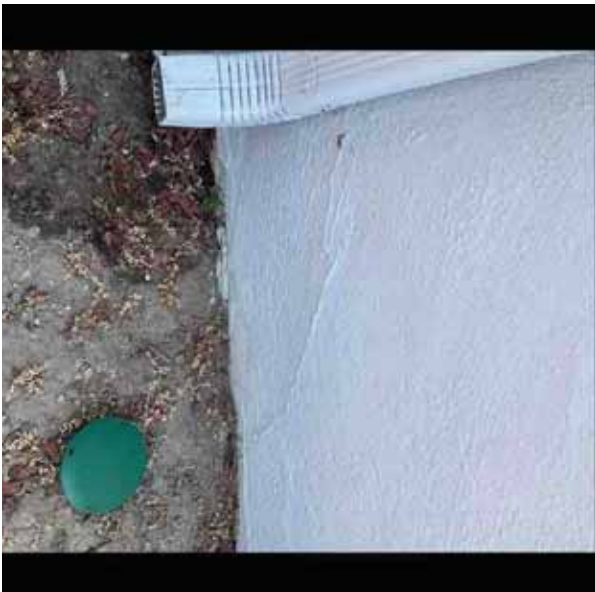
3.3.3 Repair / caulk and paint all cracks / damage in stucco and monitor to reduce water entry and potential deterioration. Pictures are a representative sample. **(Exterior Right)**

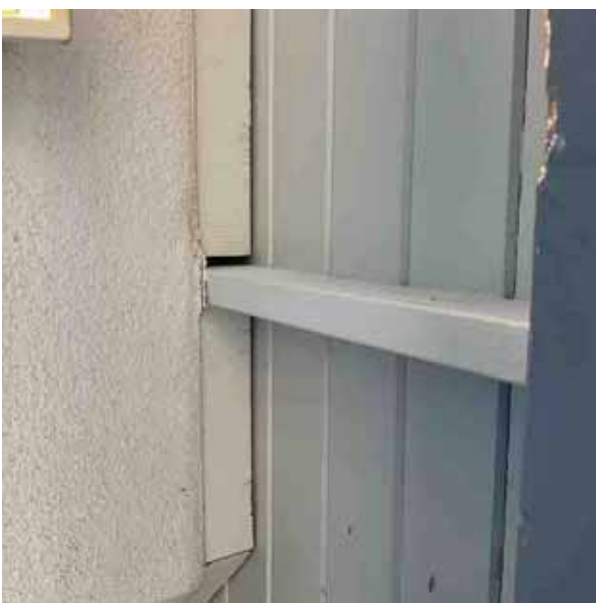
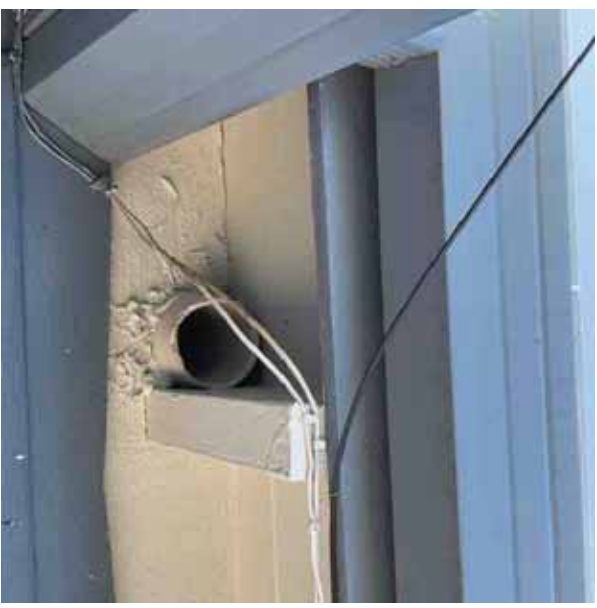
3.3.4 Wall penetrations/voids should be sealed to avoid potential water/pest intrusion. **(Exterior Front)**

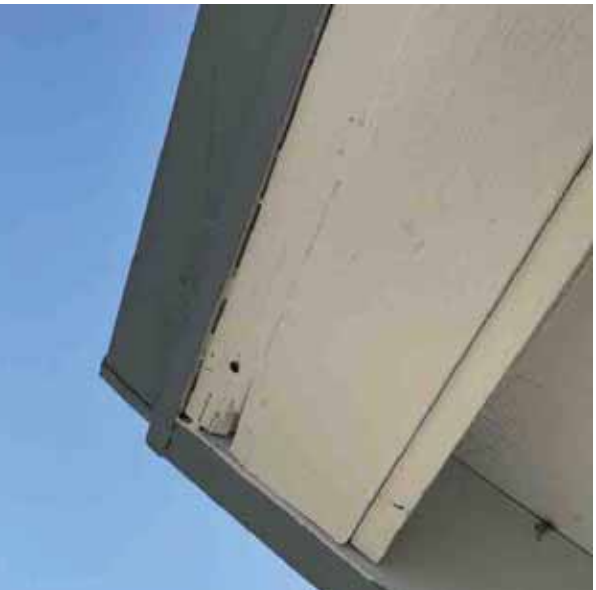
3.4.2 Wood rot, termite damage and/or deterioration are present. Further evaluation required to determine extent of the deterioration. Repair or replace as required to prevent continued deterioration. Reference the WDO (Wood Destroying Organism) Report for further assessment and next course of action. **(Exterior Back)**

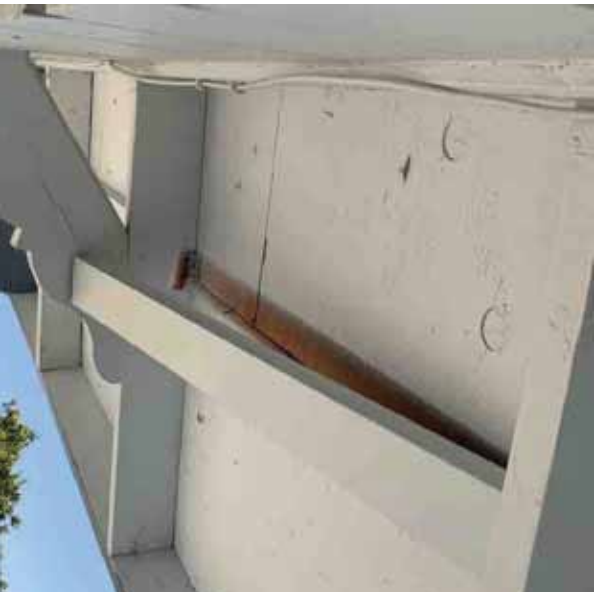
3.5.2 The trim has loose sections. Repair / replace as necessary to possible water penetration and related damages, further deterioration and to restore integrity. **(Exterior Back)**

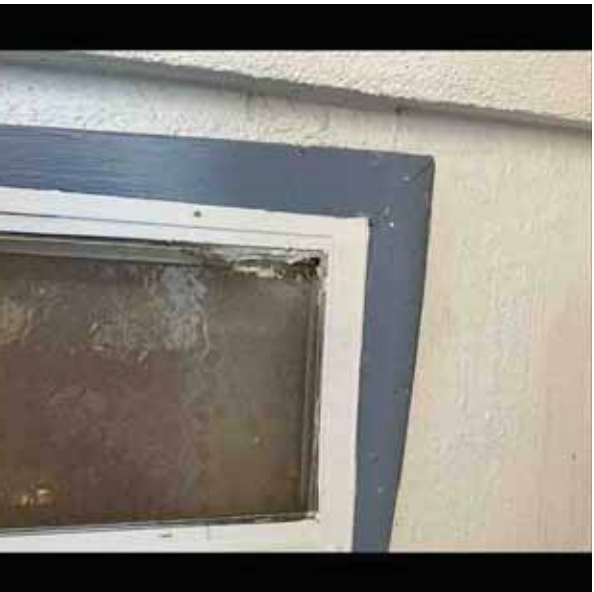
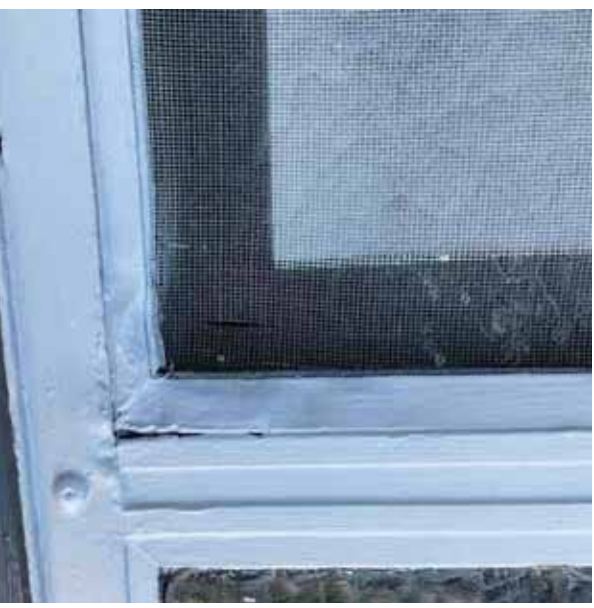
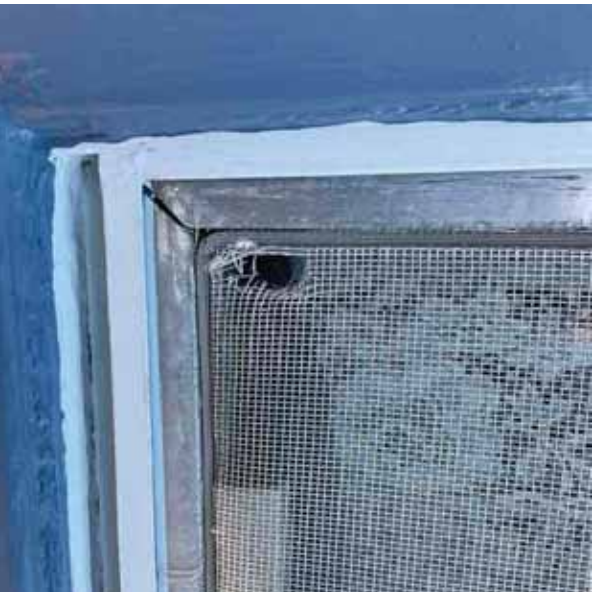
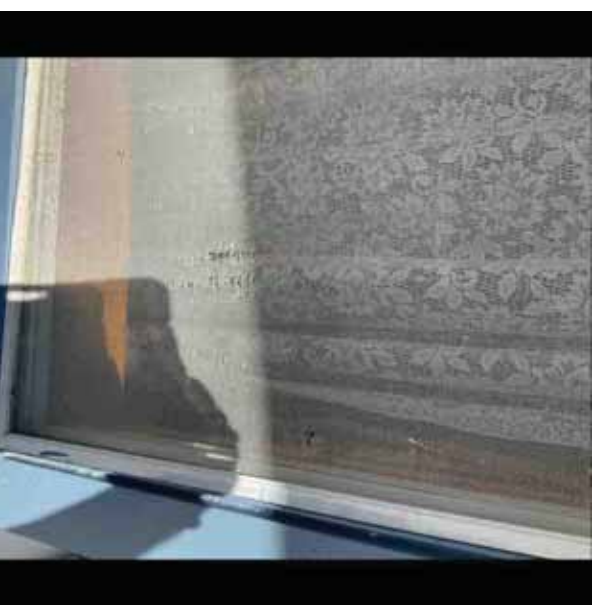
3.6.2 Window screen(s) / frame(s) are torn, damaged or missing. Repair / Replace as needed intended for functionality and to avoid pest entry. **(Various locations)**

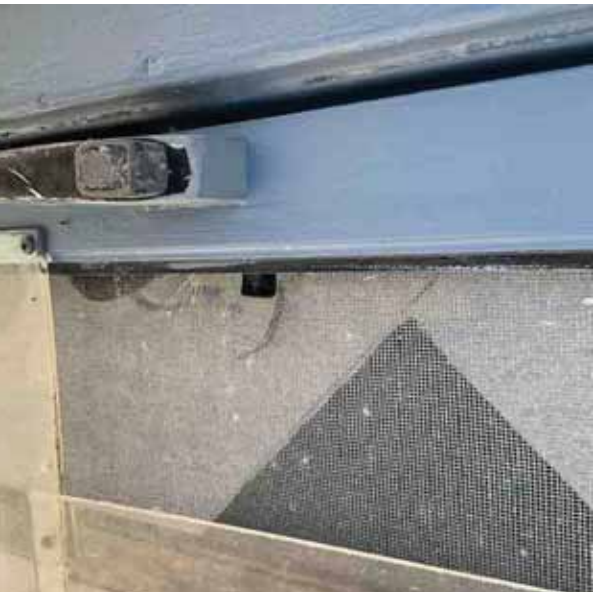
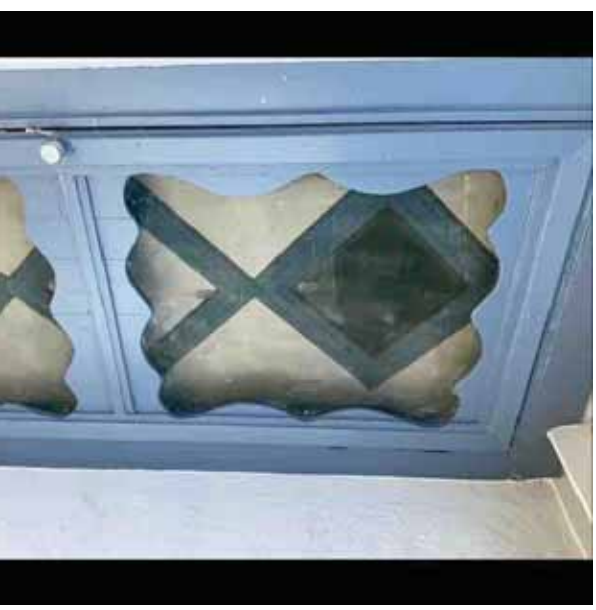
3.7.2 The screen door is missing/damaged. Install/Repair the screen door to prevent animal and insect entry.
(Exterior Back)

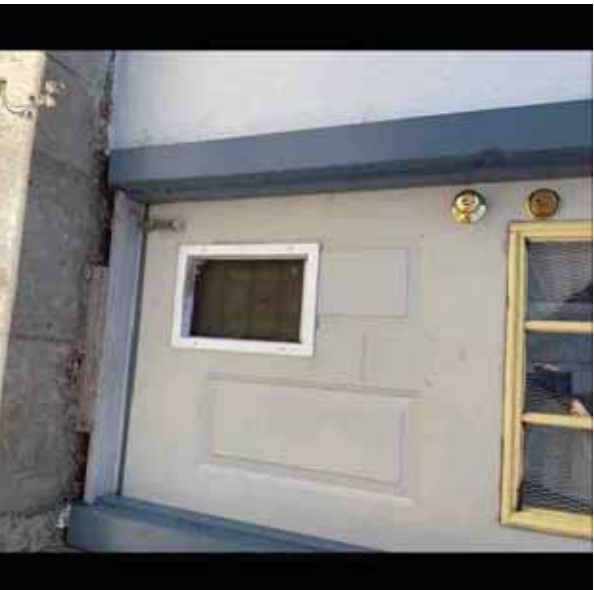
3.7.3 A pet door has been installed into the exterior door. Pet door installation can compromise the door and allow for water / pest intrusion, repairs required to prevent intrusion and related damages. **(Exterior Left)**

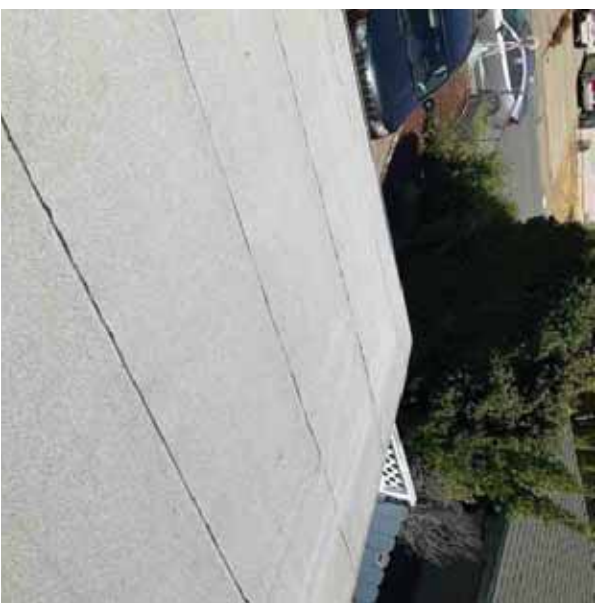
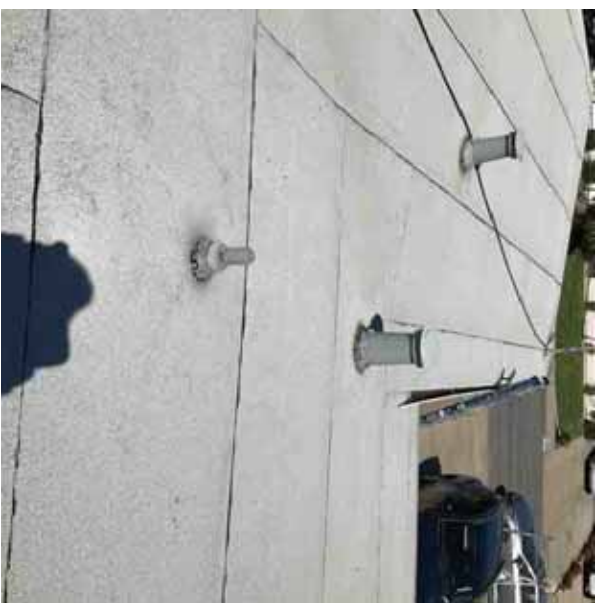
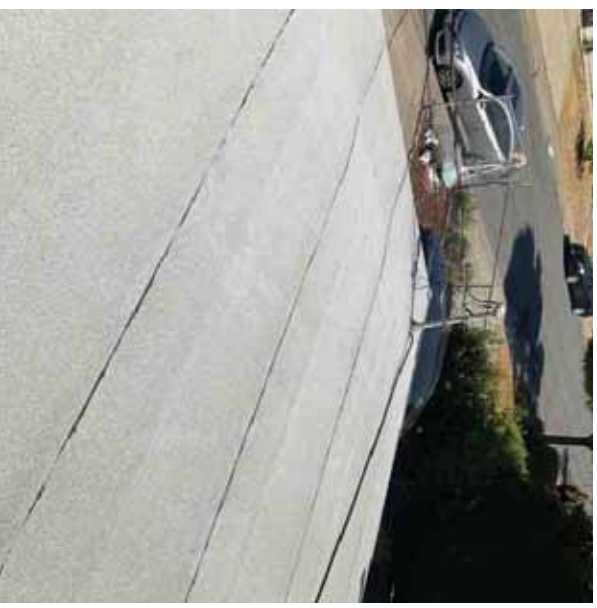
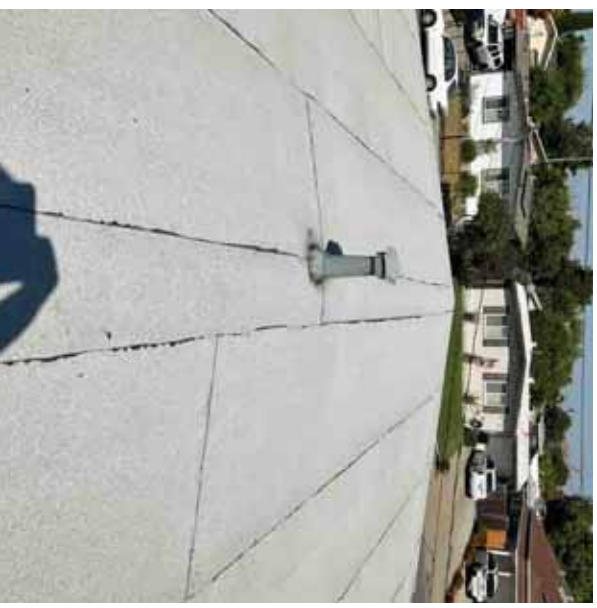
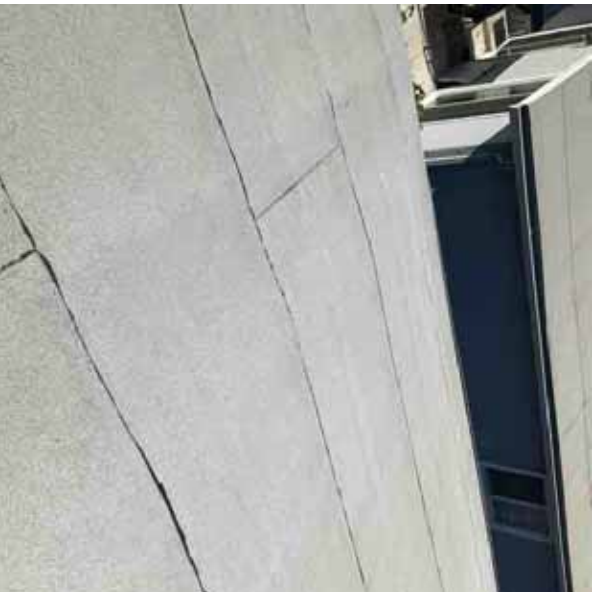
4.3.2 The roofing material has been recently installed, inquire to installation date and any if a transferable builder warranty is available. The company that installed the system has performed a roof inspection prior to listing and has performed recent maintenance. Inquire as to specifics for your information.

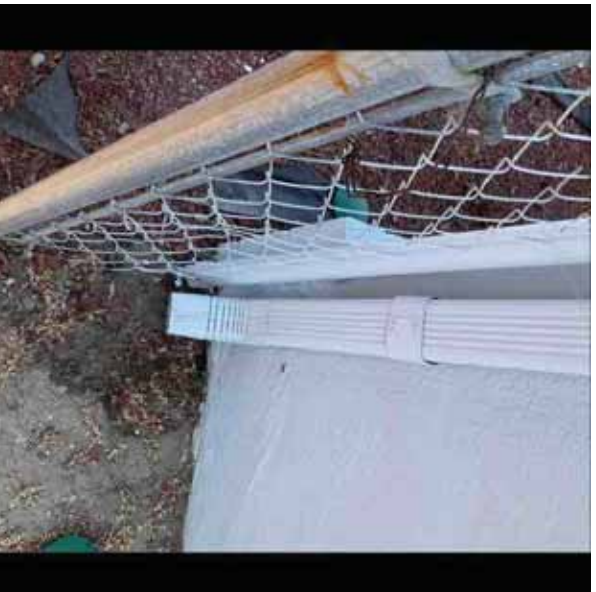
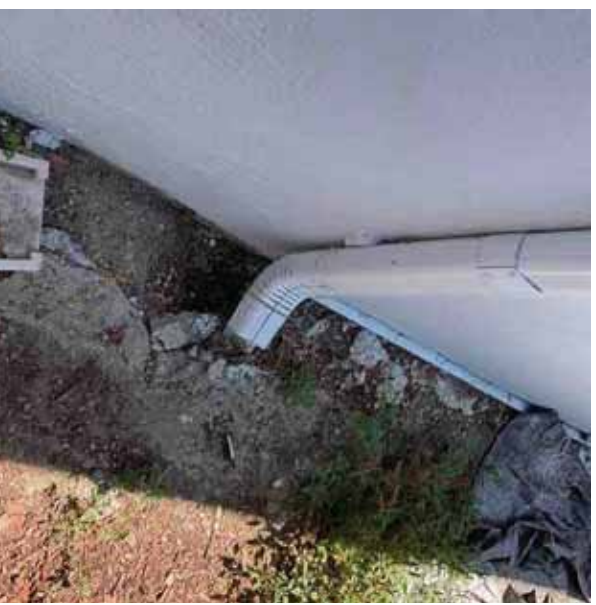
4.5.4 Downspouts improperly discharging water against foundation. Redirect and extend all downspouts away from foundation to help prevent water damage. **(Exterior Right)**

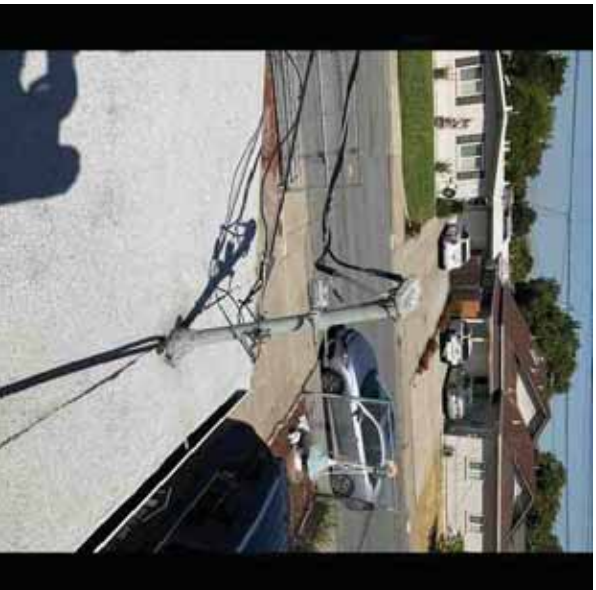
8.3.1 **The electrical mast is leaning. Repair as required for safety and to avoid any potential damages.**

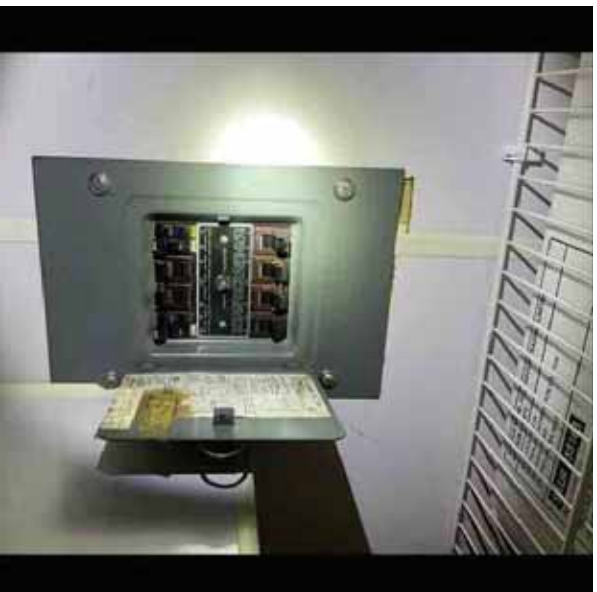
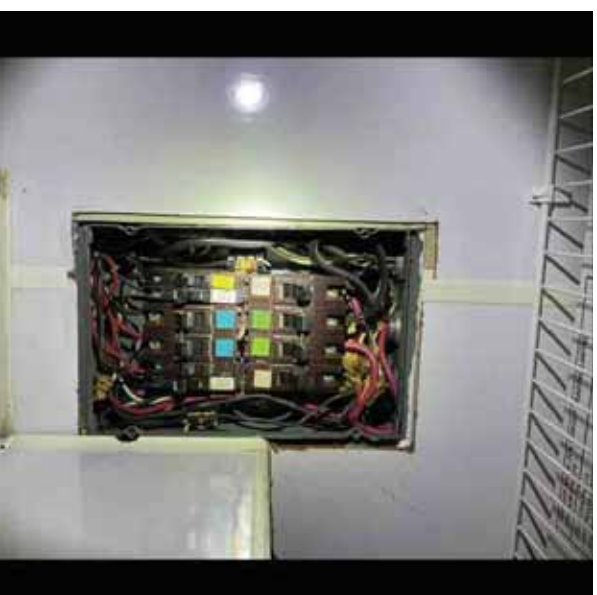
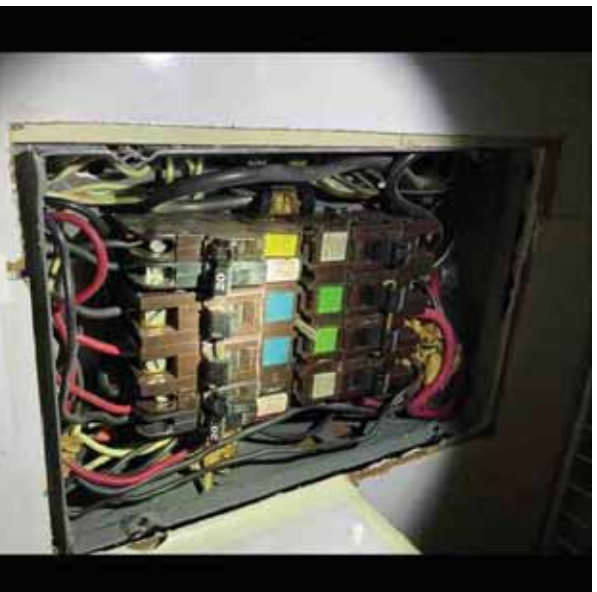
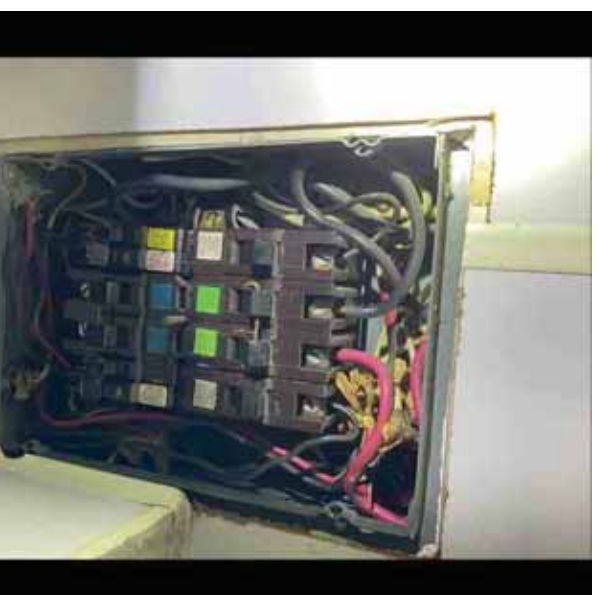
8.7.2 At the time of the inspection a Federal Pacific panel(s) was installed at this residence. While at one time they were extremely popular and installed throughout the country until the 1980's, many experts now consider the Federal Pacific panel obsolete by today's standards, and that some are known to have a higher than average rate of failure which can create a hazardous condition. Even though at the time of the inspection, the inspector may not have observed any visual defects within the panel(s), there are mixed opinions from licensed electricians as to the integrity and performance of Federal Pacific panels. For safety and peace of mind, recommend a qualified electrical contractor that is experienced with the potential hazards and dangers of Federal Pacific panels to perform a thorough evaluation of the electrical panel(s) and if needed any estimate cost of repairs or recommended upgrades before contingency period ends. (Garage)

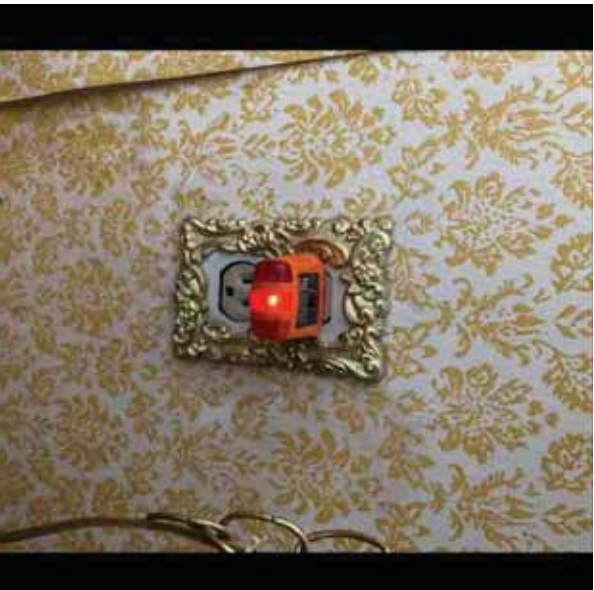
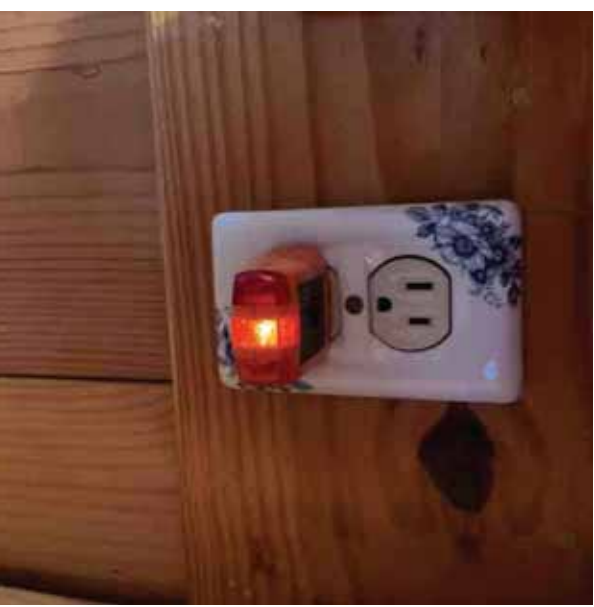
8.10.2 **There are ungrounded three-prong receptacles. A qualified electrician should further assess and correct as required for electrical safety. (Various locations)**

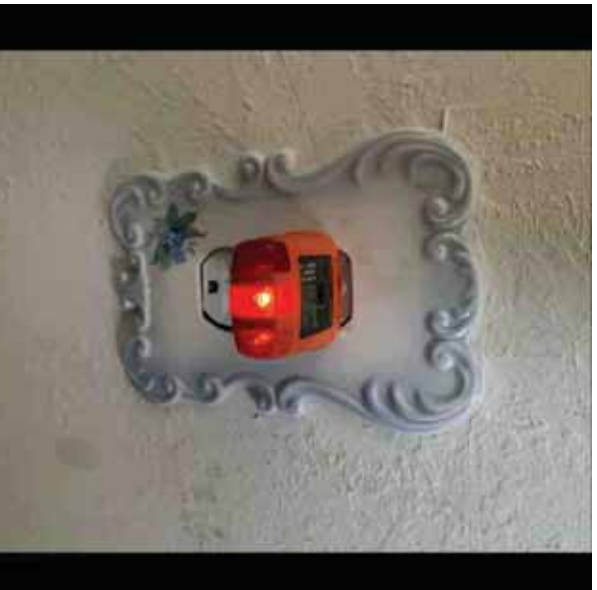
8.10.3 **Dim / Flickering lights on the outlet test usually indicates a loose / poor connections or possible voltage bleeding. Further assessment to evaluate the system by a qualified professional is needed to determine the cause and associated repairs for improved electrical safety. (Bedroom 3)**

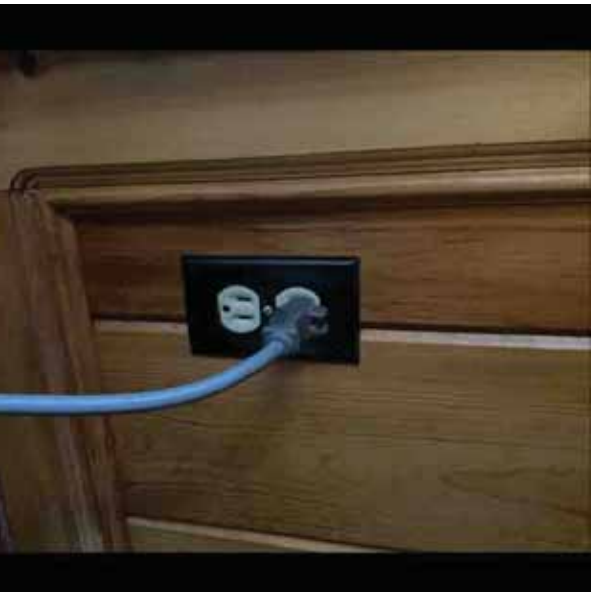
8.10.4 **The receptacle(s) are loose. A qualified electrician should correct as required for electrical safety, to avoid stress on the wires and loose connections. (Various locations)**

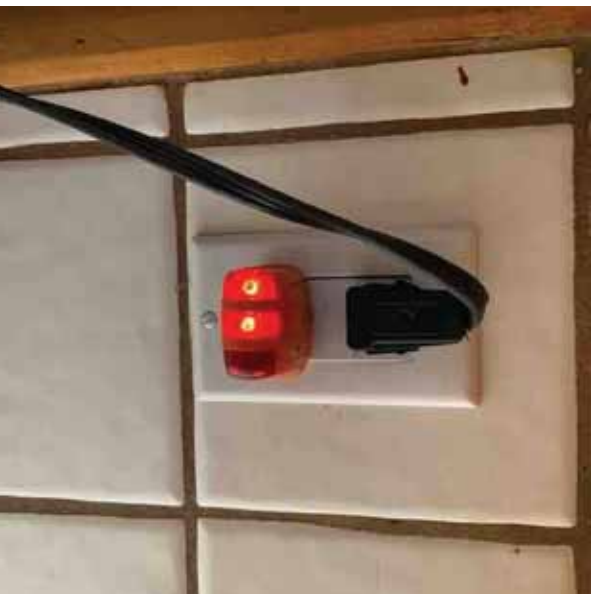
8.13.3 Receptacle(s) are not properly GFCI protected, it is recommended that proper GFCI protection should be installed to improve electrical safety. Upgrade as needed. (Kitchen)

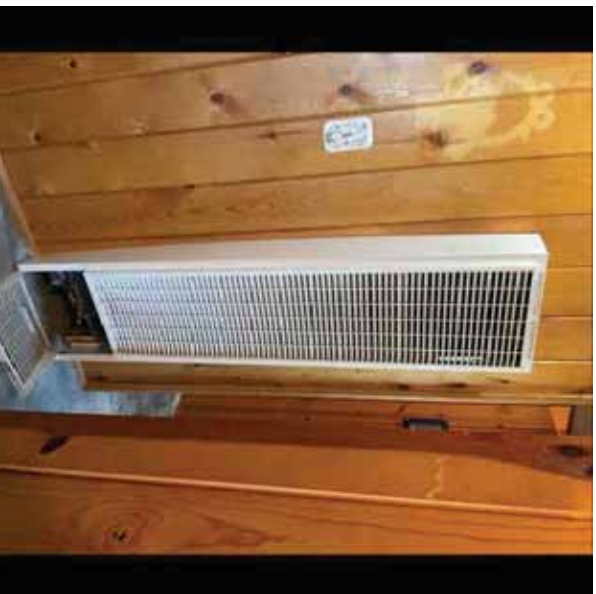
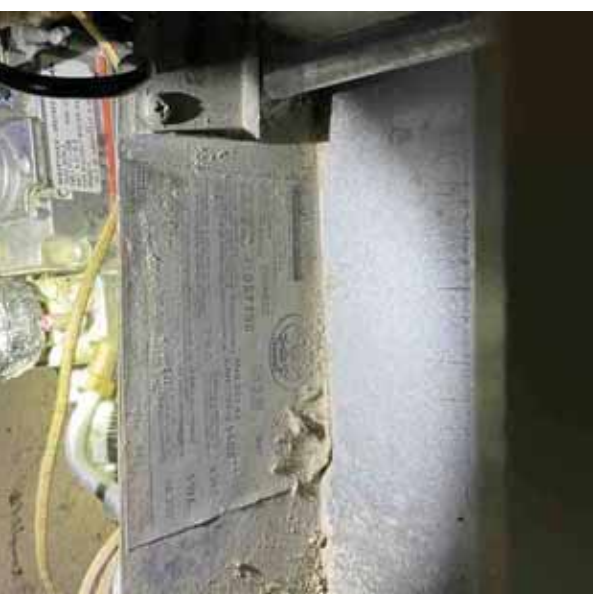
- 9.8.1 The average life expectancy of a furnace is around 20 years, this unit was manufactured in : 2005 (Hallway)

- 9.8.2 The floor / wall furnace did not respond to normal operating controls due the gas line being shutoff. A qualified HVAC contractor should further assess and repair / replace as required to restore proper function. (Hallway)

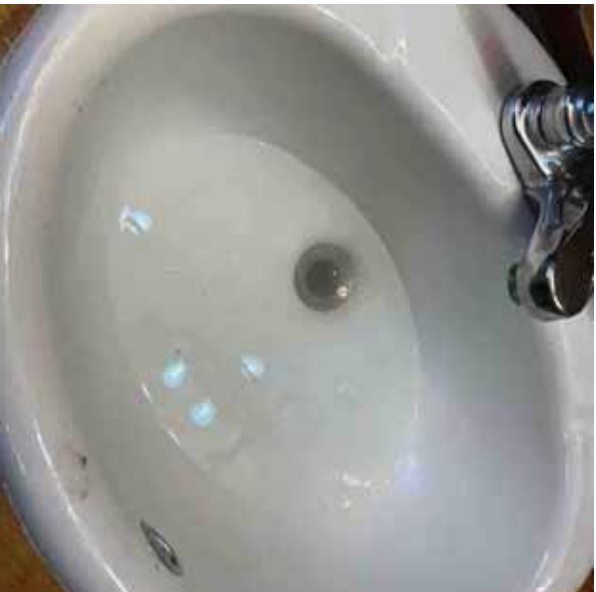
10.10.2 The sink has a slow drain, repair and/or remove obstruction as required to restore proper drainage. **(Hallway Bathroom)**

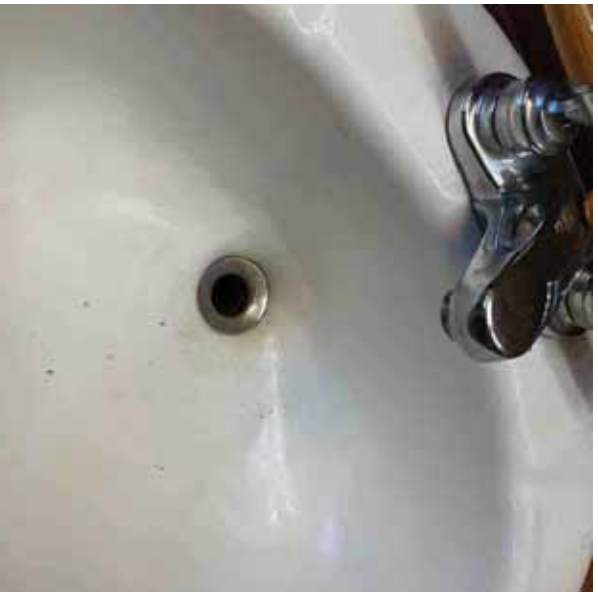
10.10.3 The drain stopper in the sink is inoperative/missing. Repair/replace as required to regain proper function. **(Hallway Bathroom)**

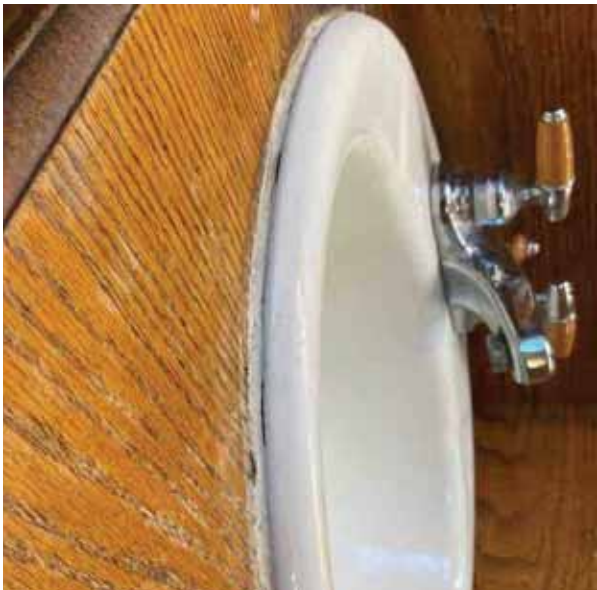
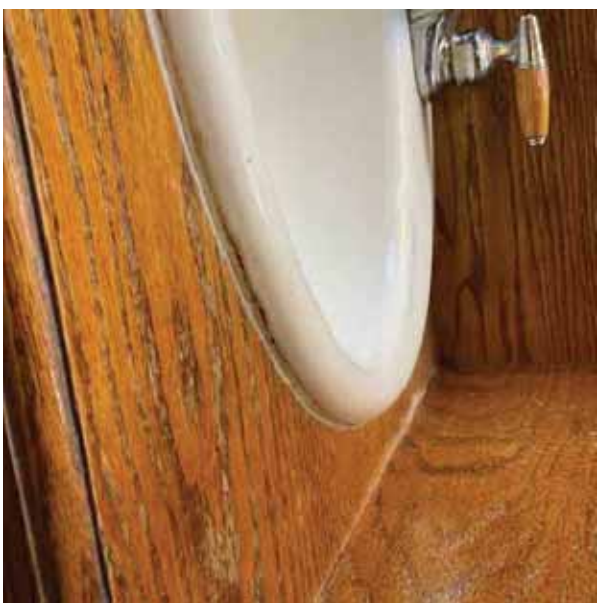
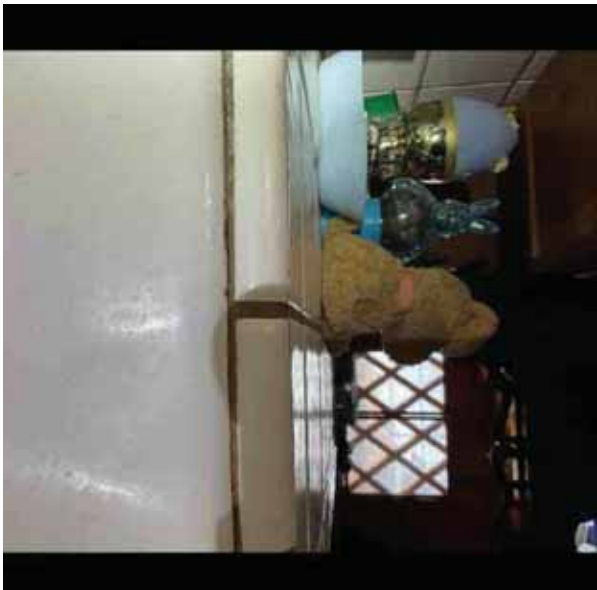
10.10.4 Build up and mineral deposits noted at the supply line connection(s), repair/replace proactively to avoid further deterioration and possible water leakage. **(Hallway Bathroom)**

10.10.5 The sink is not sealed around the entire perimeter. Apply appropriate sealant to prevent possible water penetration and related water damage.

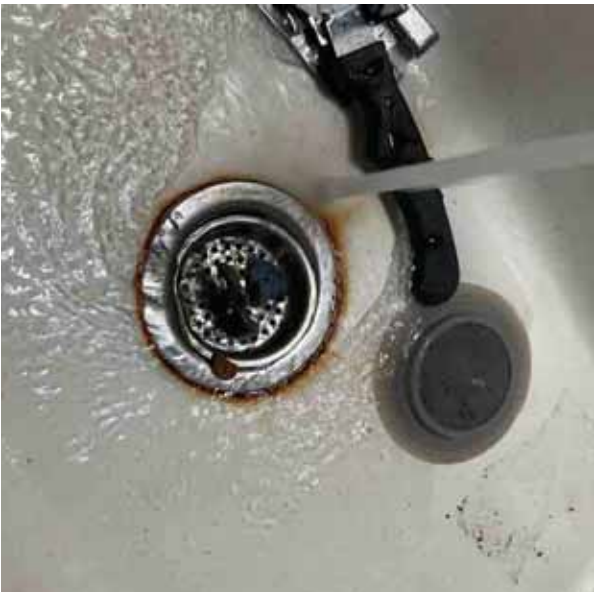
10.10.6 The sink is corroded. Further assessment is needed by a qualified professional to recommend next course of action, if repairs or replacement is needed to avoid further deterioration and/or possible water leakage. **(Kitchen)**

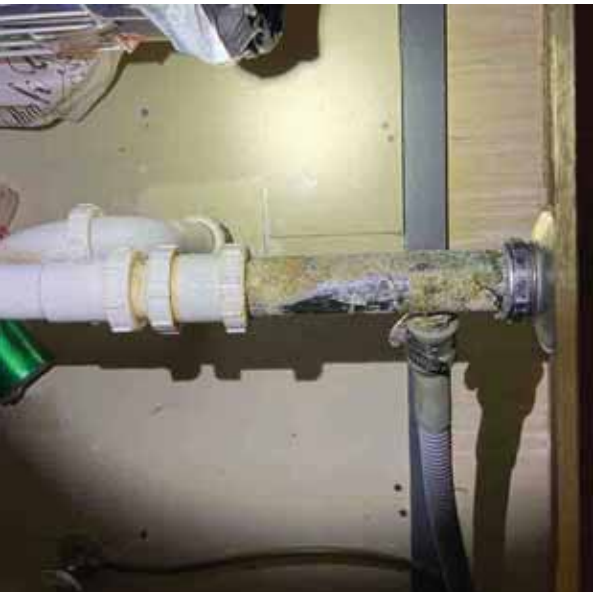
10.10.7 The drain pipe under the sink and/or undercabinet of the sink has evidence of prior leakage. Although no active leaking was present at the time of inspection monitor the installation for water leakage. **(Kitchen)**

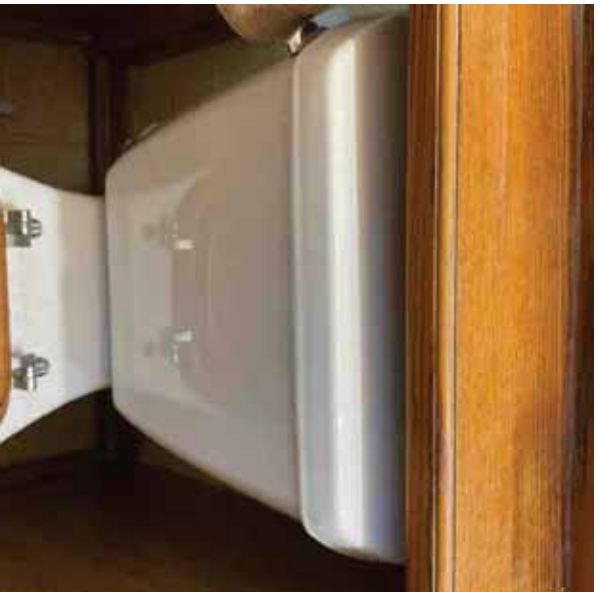
10.11.3 The tank is loose and not secured to the bowl, secure as needed for stability and to avoid potential leakage. (Hallway Bathroom)

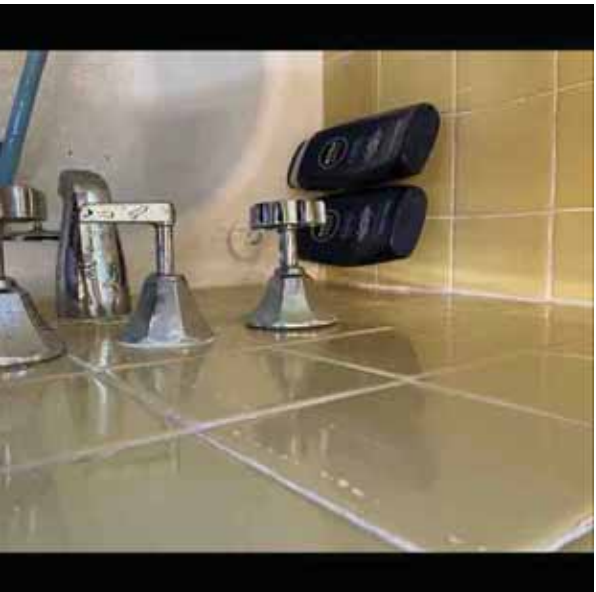
10.12.2 The faucet/fixture handle is leaking, further investigation is needed to determine the extent and associated repairs, if a leak is occurring in the wall. (Hallway Bathroom)

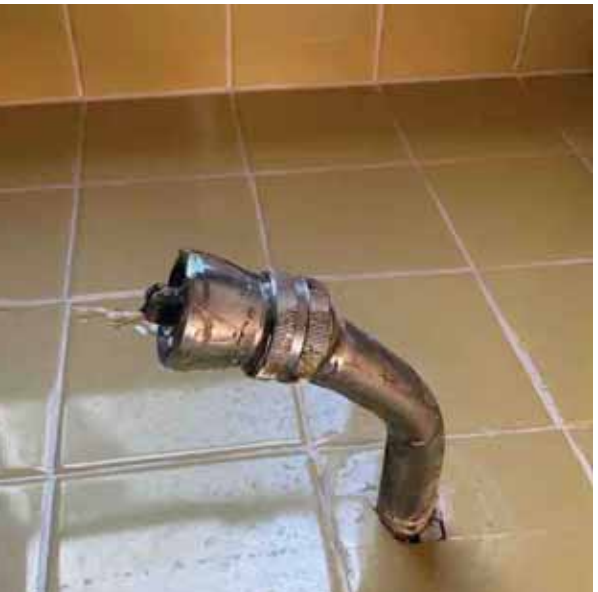
10.12.3 The shower head is leaking at the connection, repair/replace as needed to restore intended functionality. (Hallway Bathroom)

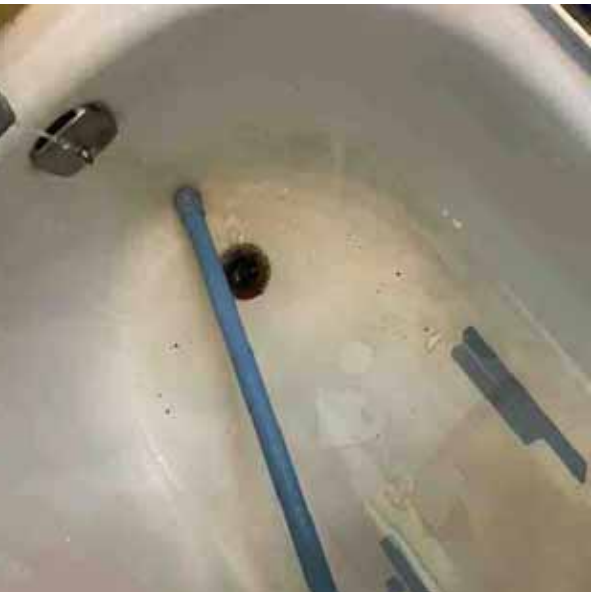
10.12.4 The tub/shower has a slow drain, repair as necessary to restore proper drainage. **(Hallway Bathroom)**

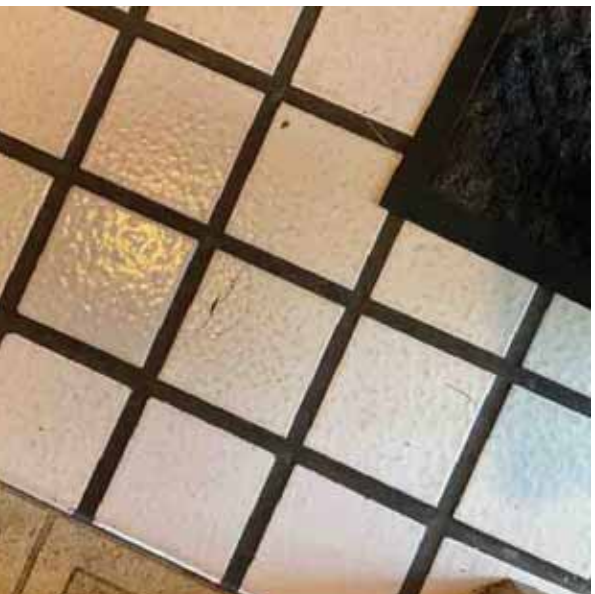
11.2.5 The flooring material is cracked. Repair or replace as desired for cosmetic / aesthetic reasons.
(Entryway)

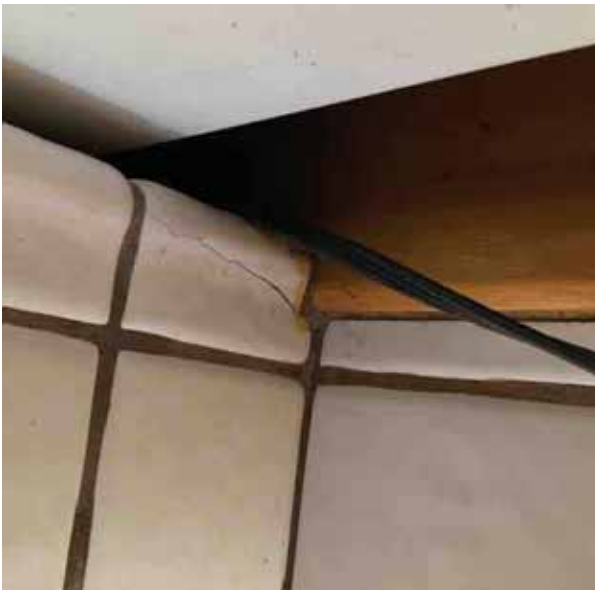
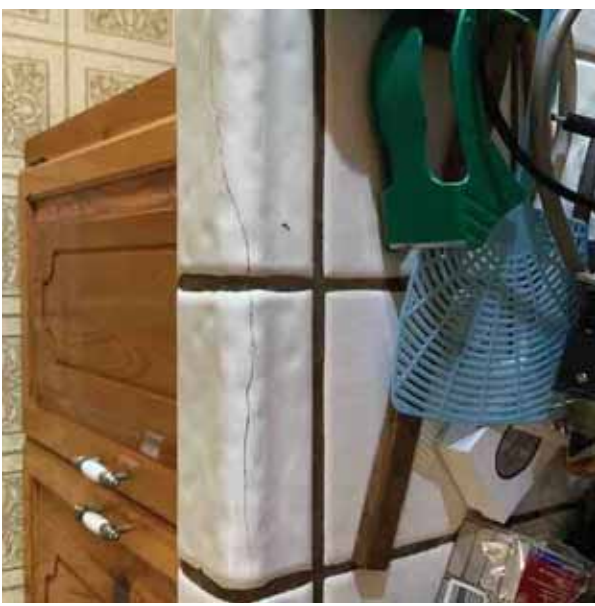
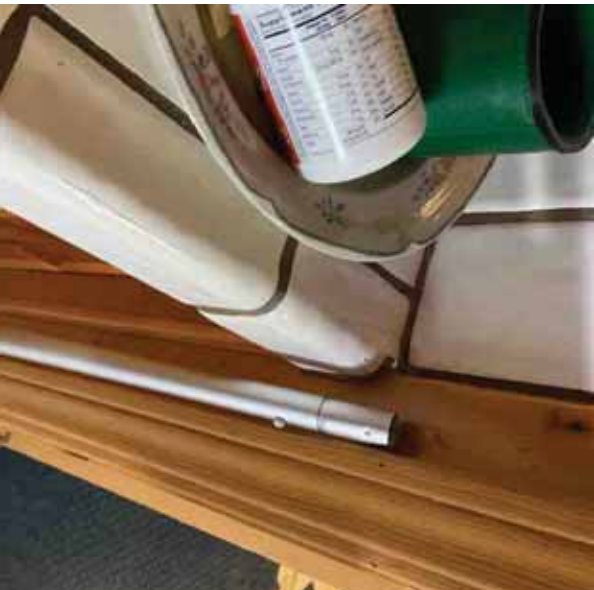
11.7.2 The kitchen countertop(s) are cracked. Repair or replace as required for improved function and aesthetics. **(Kitchen)**

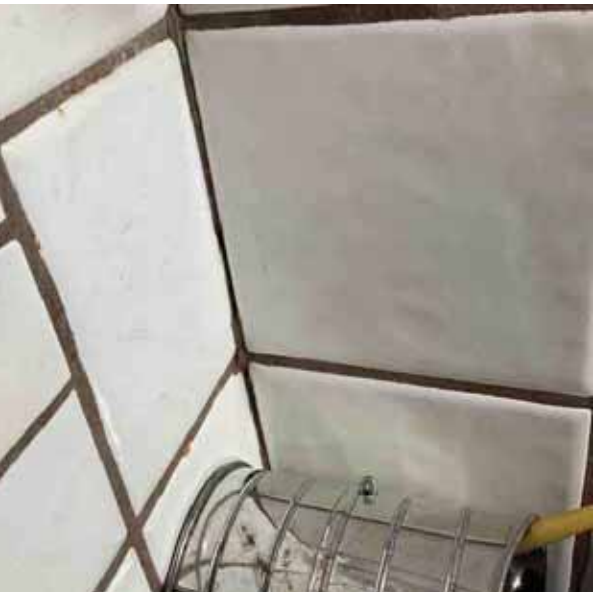
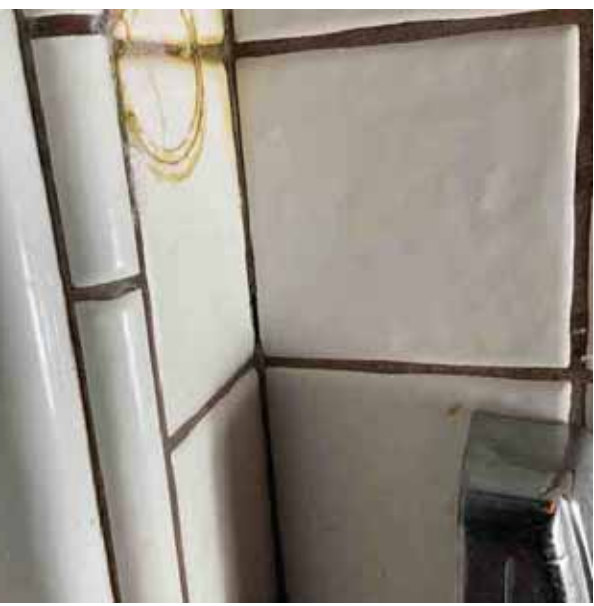
11.7.3 Missing or deteriorated caulking/grout at countertops and backsplash. Correct/repair/seal where needed to prevent possible water intrusion and related damage around walls, floors, cabinets and other finishes. **(Kitchen)**

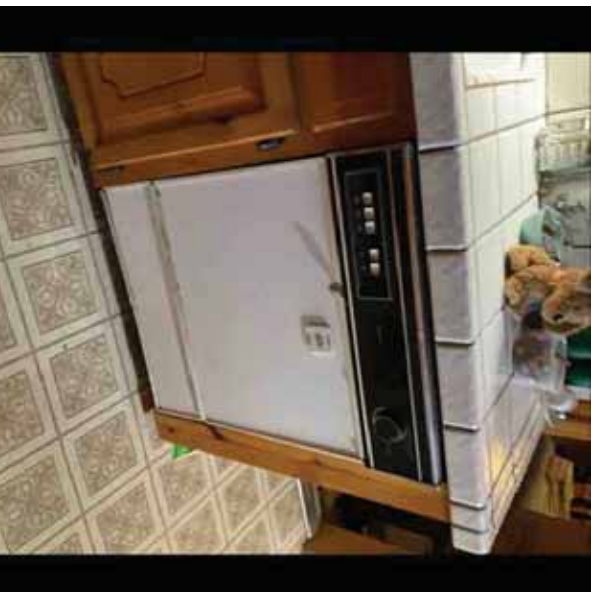
- ☑ Built-in
- ☑ High Loop/Air Gap Installed
- 12.4.1 The dishwasher is inoperative and has been shut off due to water related leaking. An appliance repair technician should further assess and repair or replace as required for proper operation. (Kitchen)

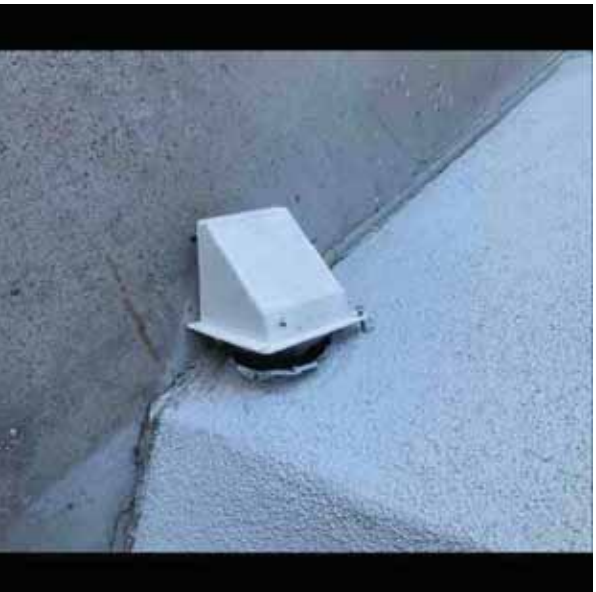
12.6.1 The dryer exhaust cover / port is poorly installed. Secure, repair and seal as needed to restore intended function. **(Exterior Front)**
