problem solve
PRODUCT PERFORMANCE FEEDBACK REPORT

IFAD MOTORS LTD

Ref.No: Ra F.R SI NO# 01 Date: 15.06.2021

Model # TVS KING Duramax

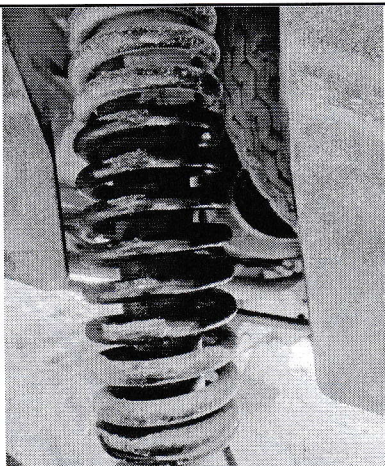
Failure Parts Photo

1. Rear Shockabsorber oil EN NO Full # OL4NL4800045 ✓

leakage Sale Date # 09.06.21 Present Kms # 1042

Obserbation:- Rear lesft side Shockabsorber oil Leakage

Action Taken:- We did the tast left side rear shockabsorber oil leakage and has been canged from milon bazar dealer.

SL	Part NO	Part Name	Qty	Vendor code	Approved	Rejected
1	G2090100	Rear Skockabsorber	01 pc	Gabrial		
2						
3						
4						
5						
6
