National Energy
Board

**30 September 2009 release of gas and
subsequent fire at the Enbridge Gas
Distribution Inc. Lisgar Gate Station in
Mississauga, Ontario**

November 2012

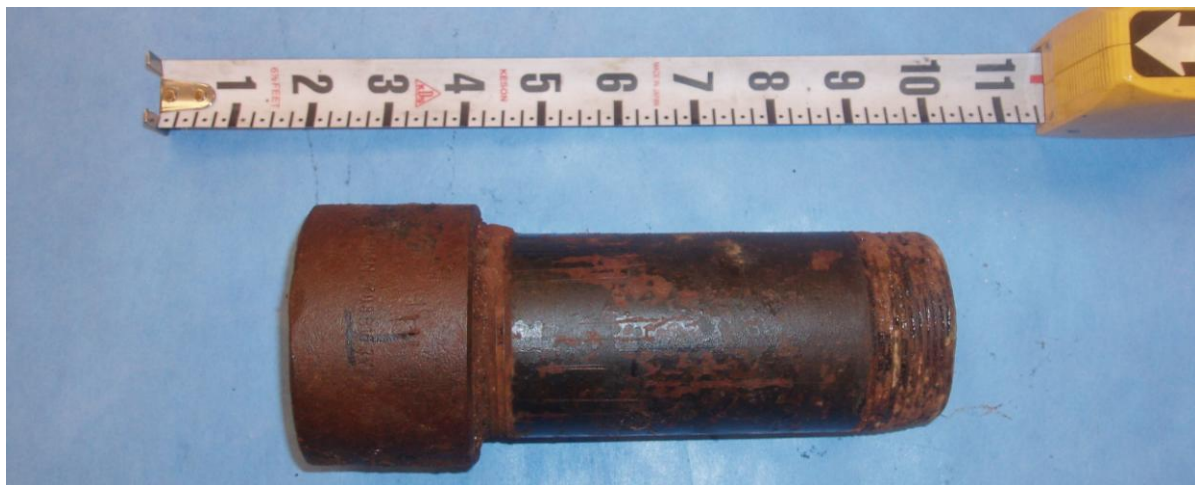
The metallurgical examination of the pipe nipple noted dents on the nipple cap and damage to the threads. The examination also revealed that the threaded section of the nipple had been bent and that thread crests were deformed. Damaged threads were also noted on the blind flange where the nipple had been attached.

Figure 2. Pipe nipple that had been installed in the centre of the flange.

NEB staff developed schematics and calculations to determine the rotational movement required to create the conditions that could have resulted in failure of the nipple. These calculations are provided in Appendix II. The calculations support the conclusion that if the contractor completed the second rotational movement of the section of pipe being welded, as interviews revealed, then this section of pipe would have contacted the nipple and possibly bent it as the pipe was moved into its desired position.

When asked if the damage observed on the nipple and blind flange was consistent with this possible scenario, the author of the metallurgical examination indicated that it was.

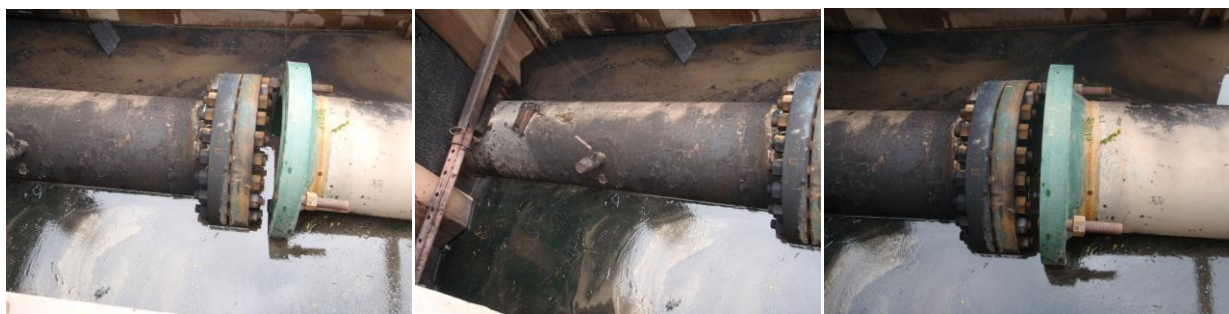
Photos taken after the incident revealed that there was a blow-down nipple installed on the pipe within ten feet of the blind flange which could have been used to evacuate gas from the pipe. The investigation also revealed that EGD had planned to install a 2-inch valve and another short nipple to the nipple already on the blind flange to enable evacuation of gas from the section of pipe that was to be pressurized. The contractor informed EGD that they were introducing a hazard with this configuration, and the contractor and the company agreed to install the blind flange with a nipple and cap only. From the blind flange, the pipeline extended approximately 300 yard to a 24-inch line valve. EGD decided to keep this line valve open to enable detection of leaks. Consequently, with the line valve open, this section of pipe was at line pressure of 370 psi, even though it was not needed for system operation. This decision unnecessarily introduced a significant hazard to the workers.

Figure 3. Photos showing the valve and nipple in the pipe close to the blind flange - Provided by TSSA

upstream of a blind flange that contains a nipple, or at a maximum one pipe length⁶ from the flange, to allow a margin of safety in the event that the nipple is damaged or fails during construction activities. This practice limits the volume of gas release at most to that contained in one length of pipe. In the case of this incident, the duration of the release would have been significantly shorter had the line valve been closed, even with 300 feet of line pipe under pressure, and it likely would have resulted in less damage.

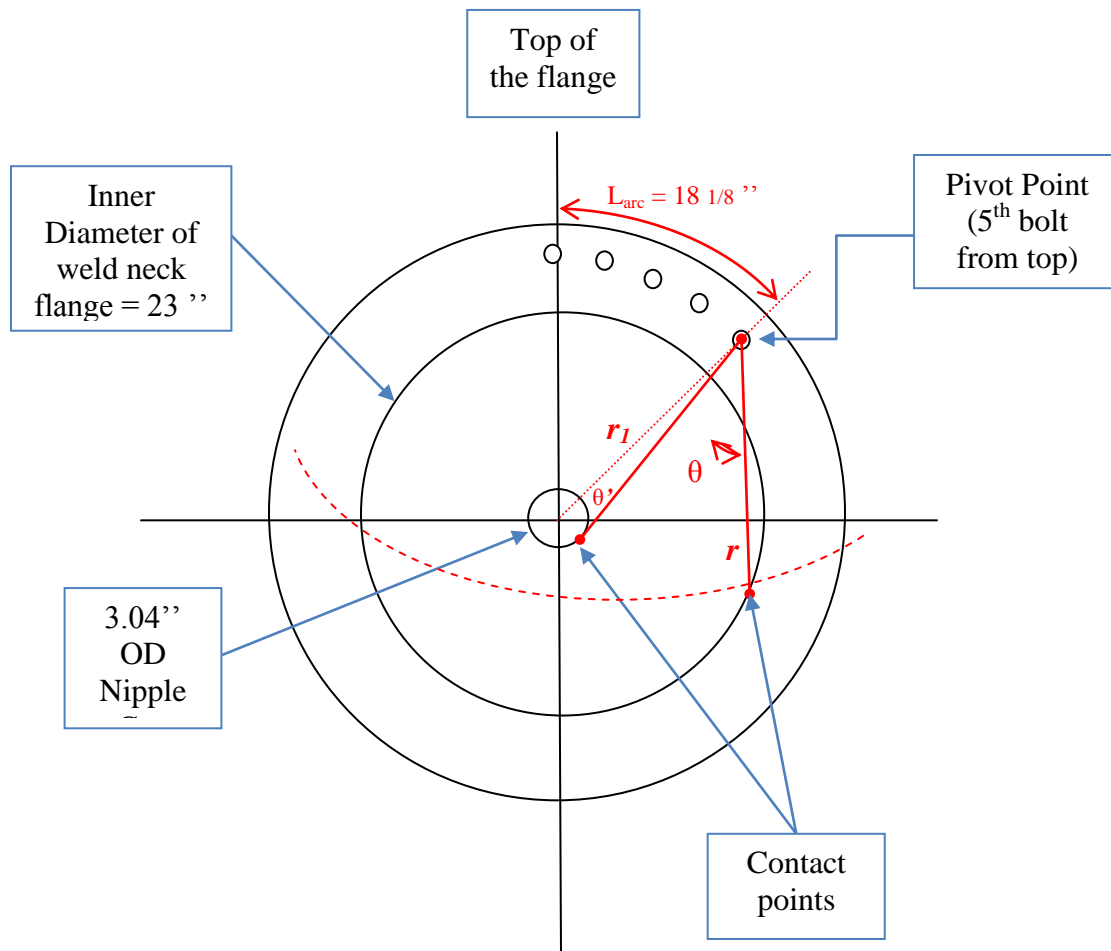
Figure 1: Schematic of the flanges and nipple assembly (not to scale)

This schematic represents the flange and the nipple prior to the rotation movement initiated for completing the cap weld on the 45° tee connection. Calculations below will determine the angle of rotation θ , which would be necessary for the inside surface of the weld neck flange to contact the nipple cap using the 5th bolt from the top as a pivot point, as per the rotation movement that occurred just prior to the incident.

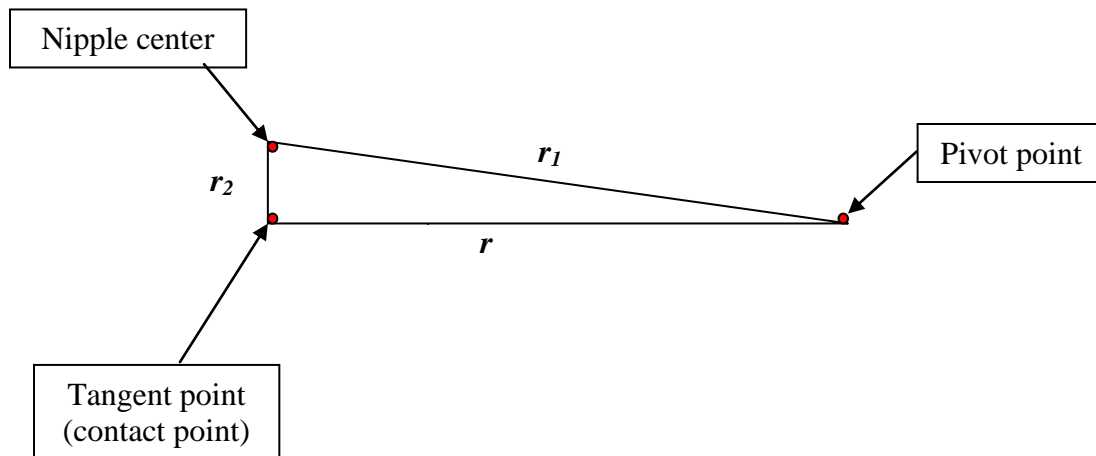
Figure 2: Right angle triangle made by the pivot point, the tangent point, and the center of the nipple

And the angle θ' is: $\theta' = \cos^{-1}(r/r_1) = 5.3^\circ$

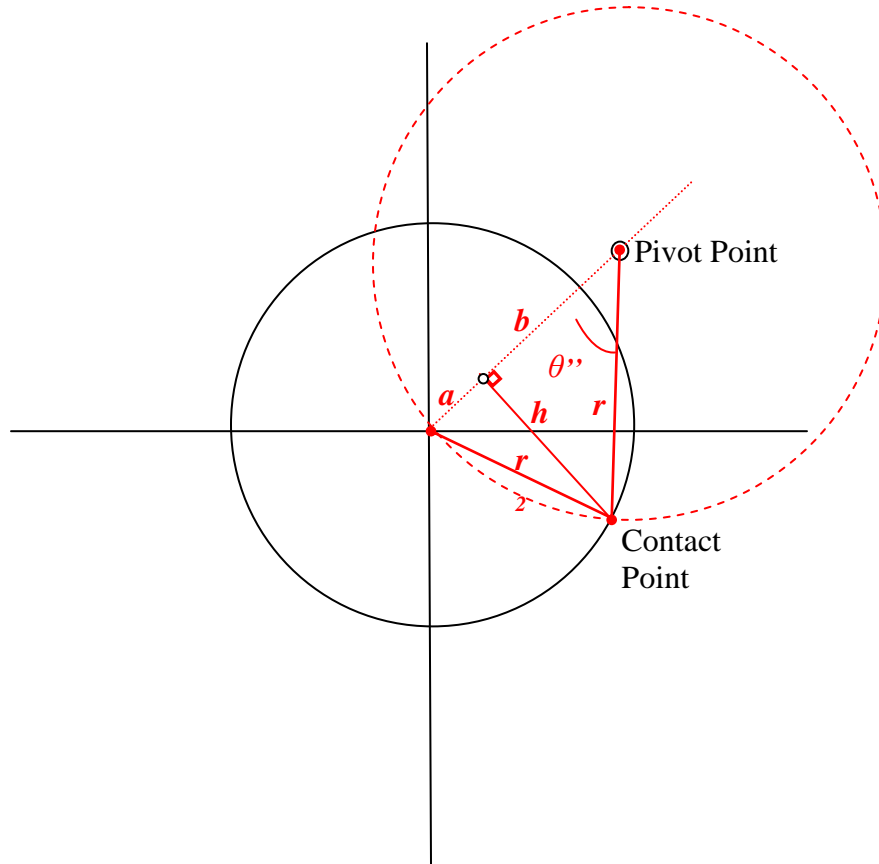
Figure 3: Determining θ'' , the rotation angle between the contact point on the inner surface of the weld neck flange and the center of the flange (not to scale)

Two right angle triangles of height h are forming the bigger triangle made of the center of the flange, the pivot point, and the contact point on the inner surface of the weld neck flange. The first right angle triangle is made of the segment a , h and r_2 , r_2 being the inner radius of the weld neck flange (11.5 inches). The second right angle triangle is made of the segment b , h , and r , r being the radius of the arc between the contact points (16.43 inches). Also, the sum of the segments a and b is equal to the distance between the pivot point and the center of nipple which is r_1 (16.5 inches). Solving for the 3 equations below, we can determine that segments a and b are 4.08 inches and 12.42 inches respectively. Consequently:
