Pipeline Incident Report

**Natural Gas Pipeline Rupture near
Fort St. John, British Columbia**

15 May 2002

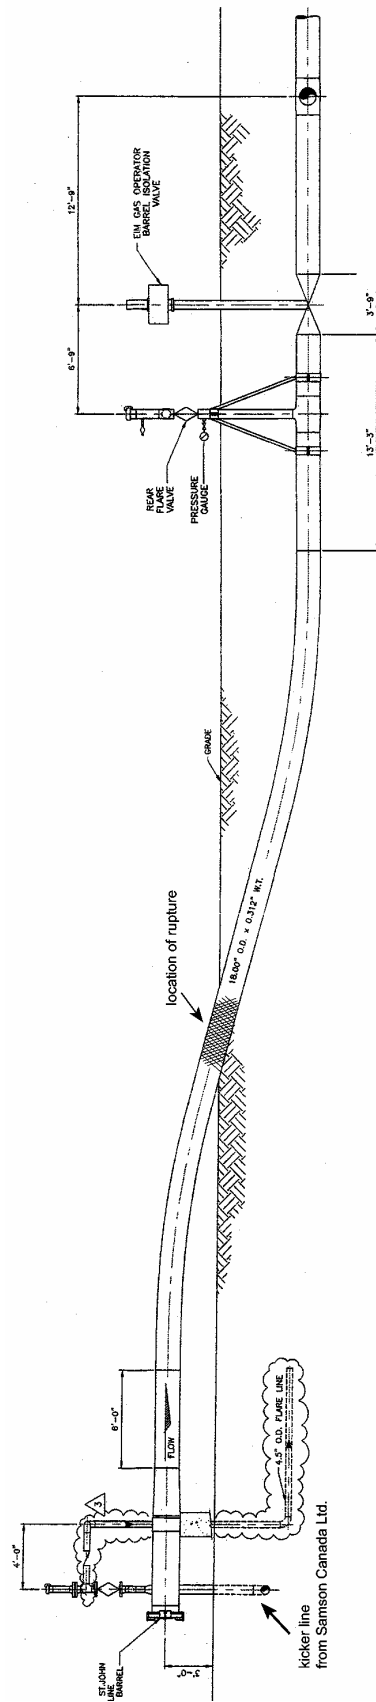
Figure A2: Schematic of Sending Barrel

Visual examination of the ruptured pipe revealed that the rupture initiated at a large lamination² in the pipe that was created during the original plate manufacturing process. It is well known that wet hydrogen sulphide inside the pipe dissociates to form iron sulphide and then releases atomic hydrogen. Over time, atomic hydrogen diffused

into the steel and accumulated as elemental hydrogen at the lamination in the centerline of the pipe wall. At the rupture origin, the accumulated gases had formed a large hydrogen blister³ bulging inward from the lamination and separating the inner ply from the opposing layer of material. Yielding of the inner layer of steel occurred, resulting in a permanent bulge and significant residual stresses associated with the bulge. Sulphide stress corrosion cracking (SSCC) was found on the inner ply of the steel that penetrated to the inside surface of the outer ply of steel. Shallow SSCC was also found on the inside surface of the outer ply of steel. The SSCC occurred in and around the bend zone, due to continuing hydrogen sulphide dissociation and the high residual stresses associated with the bulge.

At the time of the incident, the sending barrel pipe was in a weakened condition caused by the large centerline laminations that had accumulated elemental hydrogen which created inward bulging. Fracture analysis determined that the sulphide stress corrosion cracking and the cracking associated with the bulging effectively removed more than 50 per cent of the load-bearing carrying capacity of the pipe. Fracture stress analysis indicated that an additional stress beyond that created by line operating pressure was required to initiate the fracture.

As a temporary repair, the barrel, S-bend, and isolation valve were removed and an end cap installed in order to return the 18-inch Fort St. John pipeline to service. Westcoast returned the pipeline to service on 18-May 2002.
