File OF-Surv-Inc 2008-030  
13 February 2009

**Report Issued by the National Energy Board February 2009 entitled *Investigation under the National Energy Board Act into the Death of Mr. Henri St. Pierre at the Enbridge Pipelines Inc. Kerrobert Pump Station on 24 March 2008***

National Energy  
Board

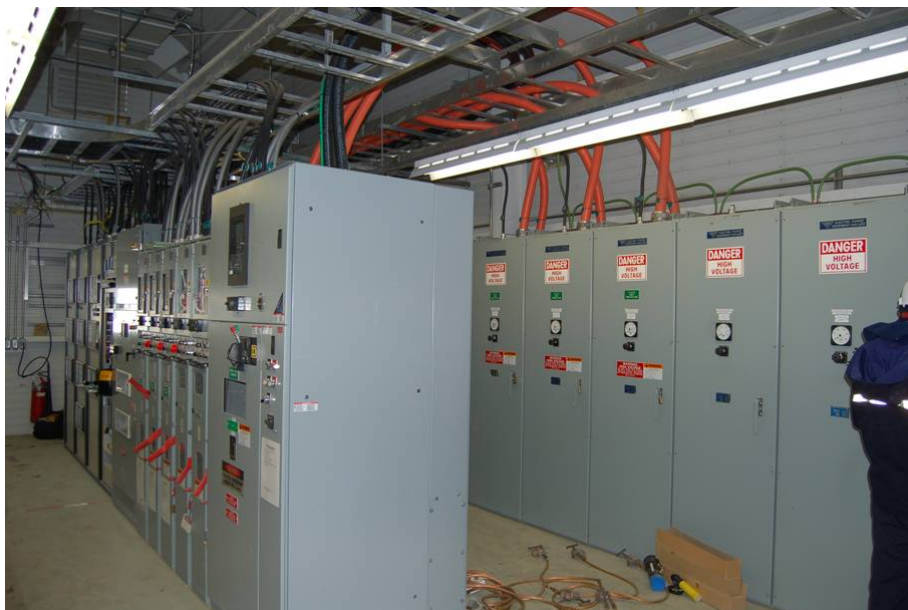
Photo 5.2 shows the relative positions of the five unit starters (left) and the five power factor capacitor cells (right). The grounding cables in use at the time of the incident can be seen lying on the floor in front of the power factor capacitor cells. Also seen in the photo is the overhead lighting that was used by Mr. Halter to test the function of the voltage probe prior to conducting a sweep inside the cell with the probe.

Photo 5.2: Unit starters and power factor capacitor cells.

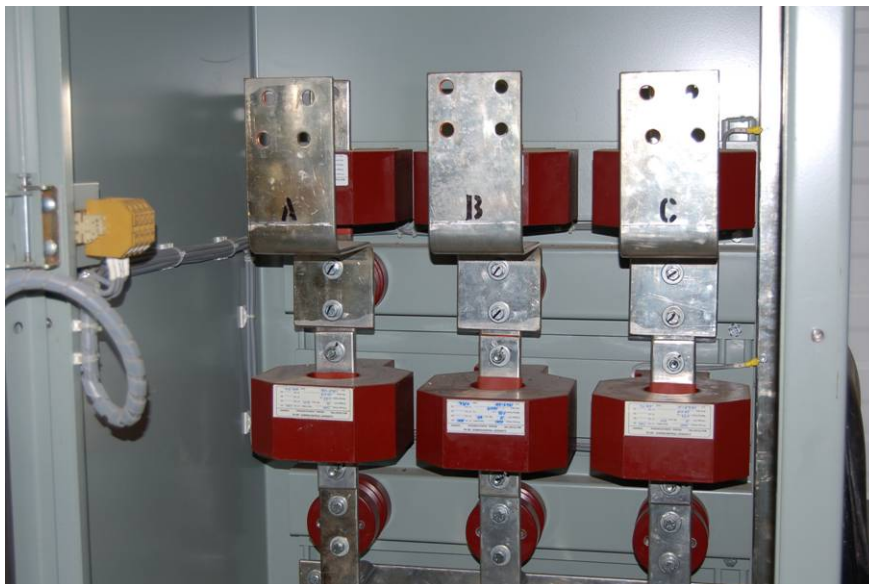
Photo 5.4 shows the inside of power factor capacitor cell 4-U-2. The metal bus bars are labeled A, B and C. After racking out the unit, grounding is accomplished by connecting the three tail ends of the grounding cables to the three bus bars and then the lead end of the grounding cables to a ground point.

Photo 5.4: inside of power factor capacitor cell 4-U-2.
