## Silicon Errata for the CYT2BL Series Rev. A

Document Revision: 2.0

Date: 2023-10-17

This document describes the errata for CYT2BL Rev. A Series of devices. Details include trigger conditions, scope of impact, available workarounds, and applicable silicon revisions. Contact your local Infineon Sales representative for further questions.

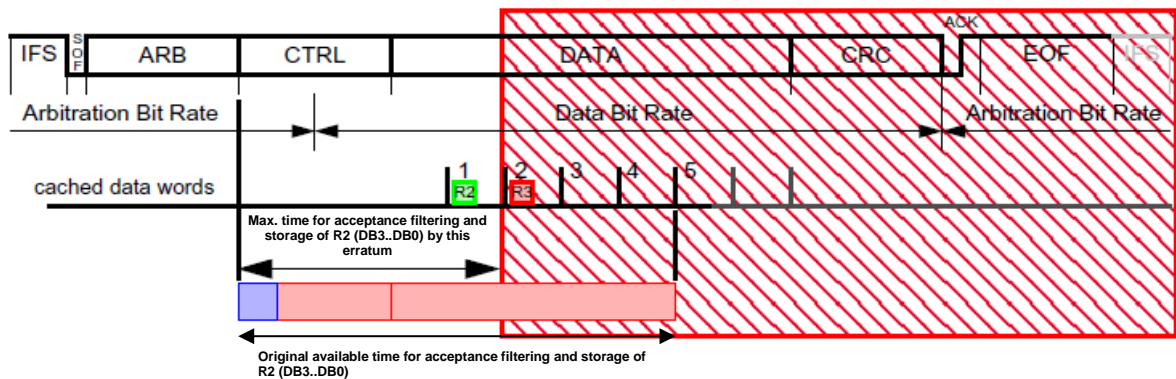
Figure 2. CAN Frame with  $DLC > 4$

Under the following conditions a received message will have corrupted data while the received message is signaled as valid to the host.

- 1) The data length code (DLC) of the received Message is greater than 4 ( $DLC > 4$ )
- 2) The storage of  $R_i$  of a received message into the Message RAM (after acceptance filtering is done) has not completed before  $R_{(i+1)}$  is transferred from the CAN Core into the cache of the Rx Handler (where  $2 \leq i \leq 5$ ).
- 3) While condition 1) and 2) apply, a concurrent read of data word  $R_i$  from the cache and write of data word  $R_{(i+1)}$  into the cache of the Rx handler happens.

The issue may occur in FD Frame Format as well as in Classic Frame Format.

Figure 2 shows how the available time for acceptance filtering and storage is reduced.

Due to condition 3) the issue occurs only sporadically. Use an end-to-end (E2E) protection (for example, checksum or CRC covering the data field) and add it to all messages in the CAN system, to detect data corruption in received frames.
