## Silicon Errata for the CYT4BF Series Rev. D

Document Revision: 2.2

This document describes the errata for CYT4BF Rev. D Series of devices. Details include trigger conditions, scope of impact, available workarounds, and applicable silicon revisions. Contact your local Infineon Sales representative for further questions.

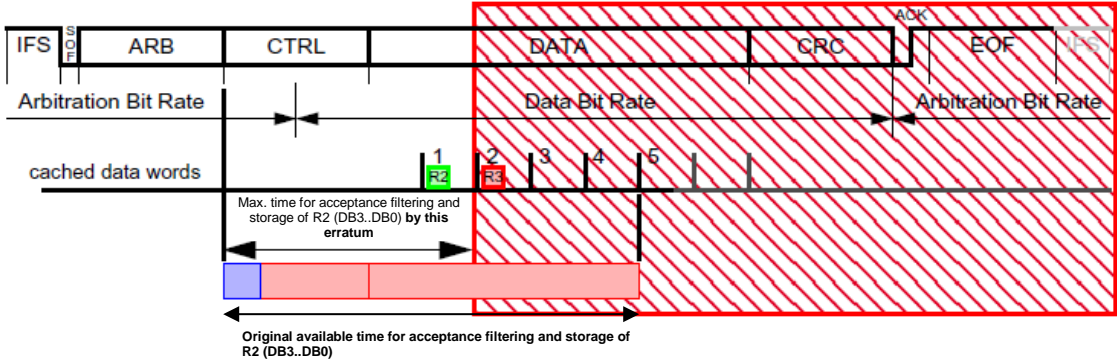
Figure 2. CAN Frame with  $DLC > 4$

Under the following conditions a received message will have corrupted data while the received message is signaled as valid to the host.

- 1) The data length code (DLC) of the received Message is greater than 4 ( $DLC > 4$ )
- 2) The storage of  $R_i$  of a received message into the Message RAM (after acceptance filtering is done) has not completed before  $R_{(i+1)}$  is transferred from the CAN Core into the cache of the Rx Handler (where  $2 \leq i \leq 5$ ).
- 3) While condition 1) and 2) apply, a concurrent read of data word  $R_i$  from the cache and write of data word  $R_{(i+1)}$  into the cache of the Rx handler happens.

The issue may occur in FD Frame Format as well as in Classic Frame Format.

Figure 2 shows how the available time for acceptance filtering and storage is reduced.

Due to condition 3) the issue occurs only sporadically. Use an end-to-end (E2E) protection (for example, checksum or CRC covering the data field) and add it to all messages in the CAN system, to detect data corruption in received frames.
