Silicon Errata for the CYT6BJ Series Rev. A

Document Revision: 1.2

Date: 2023-10-17

This document describes the errata for CYT6BJ Rev. A Series of devices. Details include trigger conditions, scope of impact, available workarounds, and applicable silicon revisions. Contact your local Infineon Sales representative for further questions.

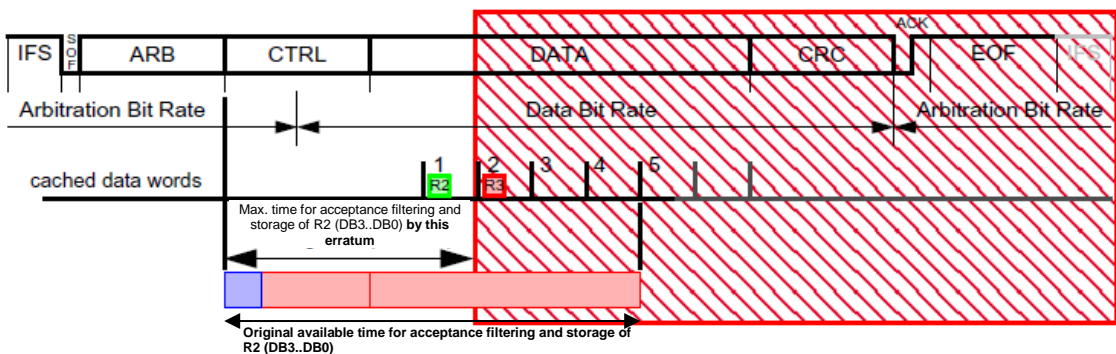
Figure 2. CAN Frame with $DLC > 4$

Under the following conditions a received message will have corrupted data while the received message is signaled as valid to the host.

- 1) The data length code (DLC) of the received Message is greater than 4 ($DLC > 4$)
- 2) The storage of R_i of a received message into the Message RAM (after acceptance filtering is done) has not completed before $R_{(i+1)}$ is transferred from the CAN Core into the cache of the Rx Handler (where $2 \leq i \leq 5$).
- 3) While condition 1) and 2) apply, a concurrent read of data word R_i from the cache and write of data word $R_{(i+1)}$ into the cache of the Rx handler happens.

The data will be corrupted in a way, that in the Message RAM $R_{(i+1)}$ has the same content as R_i .

Figure 2 shows how the available time for acceptance filtering and storage is reduced.
