Silicon Errata for the CYT2B9 Series Rev. C

Document Revision: 2.3

Date: 2023-10-17

This document describes the errata for CYT2B9 Rev. C Series of devices. Details include trigger conditions, scope of impact, available workarounds, and applicable silicon revisions. Contact your local Infineon Sales representative for further questions.

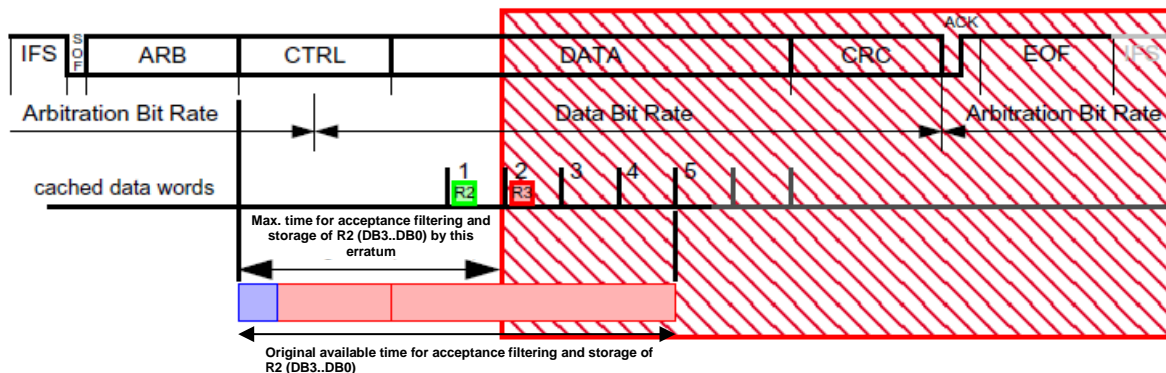
Figure 2. CAN Frame with DLC>4

Under the following conditions a received message will have corrupted data while the received message is signaled as valid to the host.

- 1) The data length code (DLC) of the received Message is greater than 4 ($DLC > 4$)
- 2) The storage of Ri of a received message into the Message RAM (after acceptance filtering is done) has not completed before R(i+1) is transferred from the CAN Core into the cache of the Rx Handler (where $2 \leq i \leq 5$).
- 3) While condition 1) and 2) apply, a concurrent read of data word Ri from the cache and write of data word R(i+1) into the cache of the Rx handler happens.

The issue may occur in FD Frame Format as well as in Classic Frame Format.

Figure 2 shows how the available time for acceptance filtering and storage is reduced.

Due to condition 3) the issue occurs only sporadically. Use an end-to-end (E2E) protection (for example, checksum or CRC covering the data field) and add it to all messages in the CAN system, to detect data corruption in received frames.
