Silicon Errata for the CYT3BB/4BB Series Rev. B

Document Revision: 2.2

Date: 2023-10-17

This document describes the errata for CYT3BB/4BB Rev. B Series of devices. Details include trigger conditions, scope of impact, available workarounds, and applicable silicon revisions. Contact your local Infineon Sales representative for further questions.

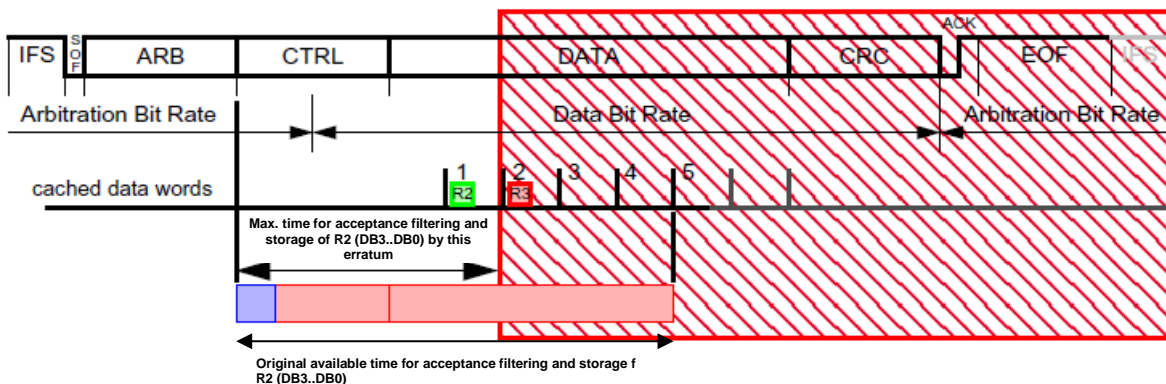
Figure 2. CAN Frame with $DLC > 4$

Under the following conditions a received message will have corrupted data while the received message is signaled as valid to the host.

- 1) The data length code (DLC) of the received Message is greater than 4 ($DLC > 4$)
- 2) The storage of R_i of a received message into the Message RAM (after acceptance filtering is done) has not completed before $R_{(i+1)}$ is transferred from the CAN Core into the cache of the Rx Handler (where $2 \leq i \leq 5$).
- 3) While condition 1) and 2) apply, a concurrent read of data word R_i from the cache and write of data word $R_{(i+1)}$ into the cache of the Rx handler happens.

The issue may occur in FD Frame Format as well as in Classic Frame Format.

Figure 2 shows how the available time for acceptance filtering and storage is reduced.

Due to condition 3) the issue occurs only sporadically. Use an end-to-end (E2E) protection (for example, checksum or CRC covering the data field) and add it to all messages in the CAN system, to detect data corruption in received frames.
