24 Parkside Gardens Eastville Birmingham B23 4JH

17/04/2010

Re: 24 Parkside Gardens Eastville Birmingham B23 4JH

The property is a 3 bed semi detached house consisting of solid wall brick construction built around the 1920's.

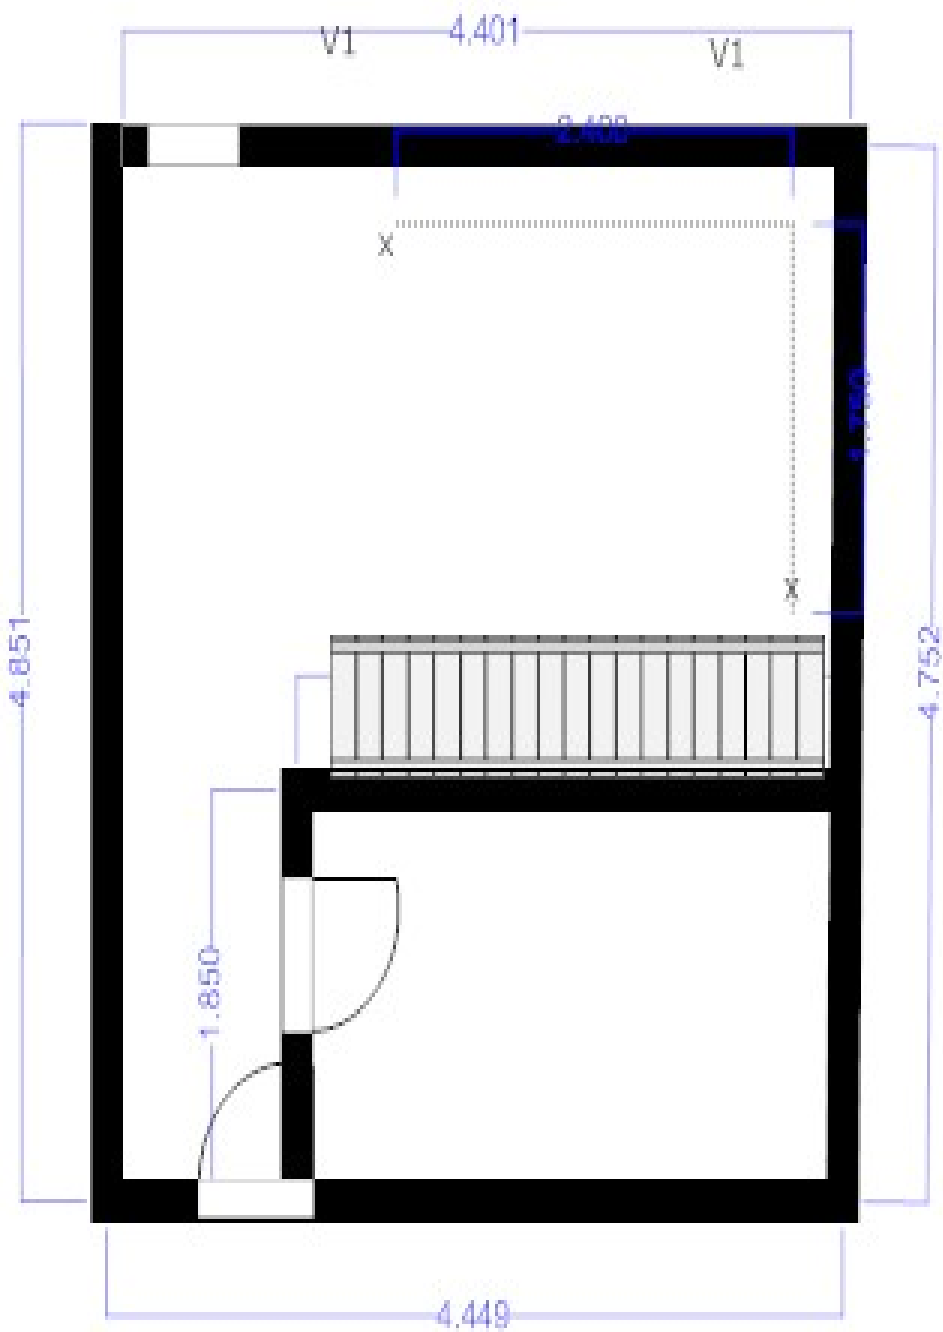
Sketch Plan

The exterior of the building appeared to be in reasonable condition, however it was noted that there appeared to be insufficient sub floor ventilation to the areas indicated in the enclosed sketch plan, lack of ventilation in these areas are a significant cause of decay to the floor joists and due to this area remaining concealed this decay can go unnoticed and potentially lead to the onset of dry rot, therefore we would suggest increasing the ventilation in these areas.

Moisture readings were taken at the base of all accessible load bearing wall surfaces, from these readings a moisture profile was created and analysed. All of what we would regard as 'abnormal' readings were investigated and from the evidence available to us at the time of our inspection there was evidence to suggest that rising dampness has been present in the walls indicated in the enclosed sketch plan.

At the time of our inspection there was visible evidence of condensation which have been indicated in the enclosed sketch plan.

Overall the property appears to be in reasonable condition and there is no evidence to suggest that there is any areas which would be of major concern, we would suggest installing additional air vents to the areas indicated in the enclosed sketch plan to increase the ventilation to the sub floor timbers and have submitted a quotation for your information, however as access was limited in several areas we strongly suggest a further visit when full access is available.

Item Ref.	Description
001	Install additional air vents By increasing the ventilation, this will allow for a far more efficient way in which the air is circulated in this area which will decrease the amount of moisture which can be transferred to the sub floor timbers.
002	Install retrofit DPC The survey highlighted that the existing damp proof course had failed in the areas highlighted in the enclosed sketch plan, therefore we would propose installing a new DPC in this area to prevent future outbreaks of reising dampness.
