TECHNICAL MEMORANDUM

Date: 09/29/2021	Study No: 47-1XXIA003, 0000024741
To: Pavement Analysis and Design Branch	Tech Memo No: NTP 22-01-1
From: Research Team	Revision No:
Subject: Pavement Evaluation of Roller Compacted Concrete Pavement in Leahey

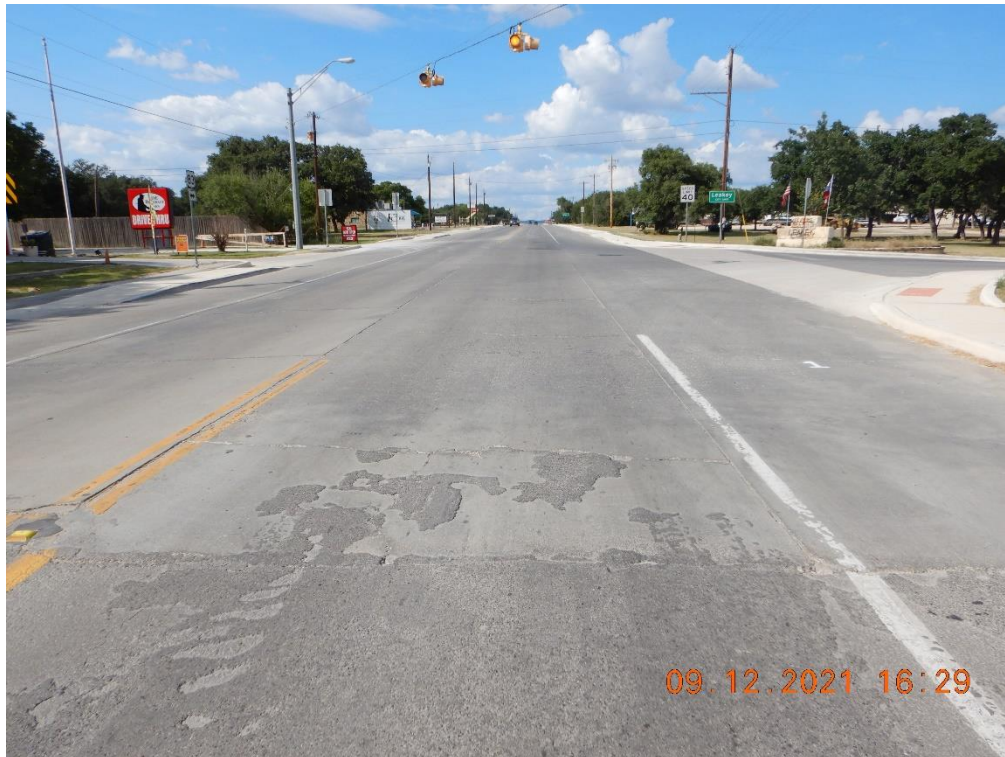
Figure 4 Present condition of RCC pavement on US 83

Figures 4 presents typical condition of the RCCP on US 83. Visual condition survey indicated few mid-slab and longitudinal cracking, as well as faulting at a number of transverse contraction joints in both US 83 and RM 337. Faulting was widespread throughout the projects, and noise from traffic driving over faulted joints was quite noticeable.

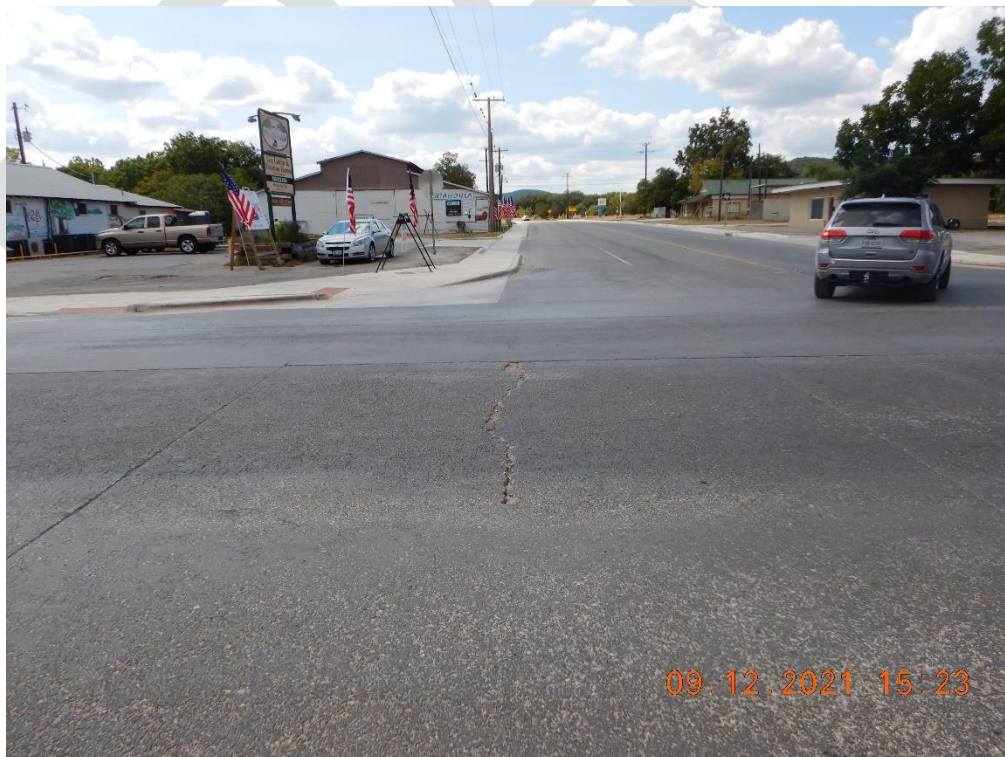
Figure 5 Typical mid-slab transverse crack on RCC pavement on US 83

Figure 5 shows a typical mid-slab transverse crack, while Figure 6 illustrates a typical longitudinal crack. Identifying the causes of mid-slab and longitudinal cracking was beyond the scope of this investigation; however, it appears that well-known mechanisms for both cracking were also at play over here, which will be discussed later.

In this RCCP project, cracking and faulting were two major distresses observed. Transverse cracking observed in this project is different from normal mid-slab cracking observed in CPCD. As discussed earlier, transverse joint spacing is 15-ft, and it is believed that stresses in RCCP due to temperature and moisture variations were well below tensile strength of RCC due to short joint spacing and low drying shrinkage. However, transverse cracks were observed that appeared to have developed from wheel loading applications. These cracks were not in the middle of the two adjacent transverse joints; rather, they occurred close to the joint right after trucks pass over it, as shown in Figure 7. Two transverse cracks are observed; one in the northbound, and the other in the southbound (the picture was taken facing east). The crack in the northbound lane – the lane on the other side of the centerline – is closer to the joint on the right, while the crack in the southbound lane is closer to the joint on the left. It appears that impact loading from truck traffic driving over a faulted joint caused excessive wheel loading stresses a transverse crack developed.

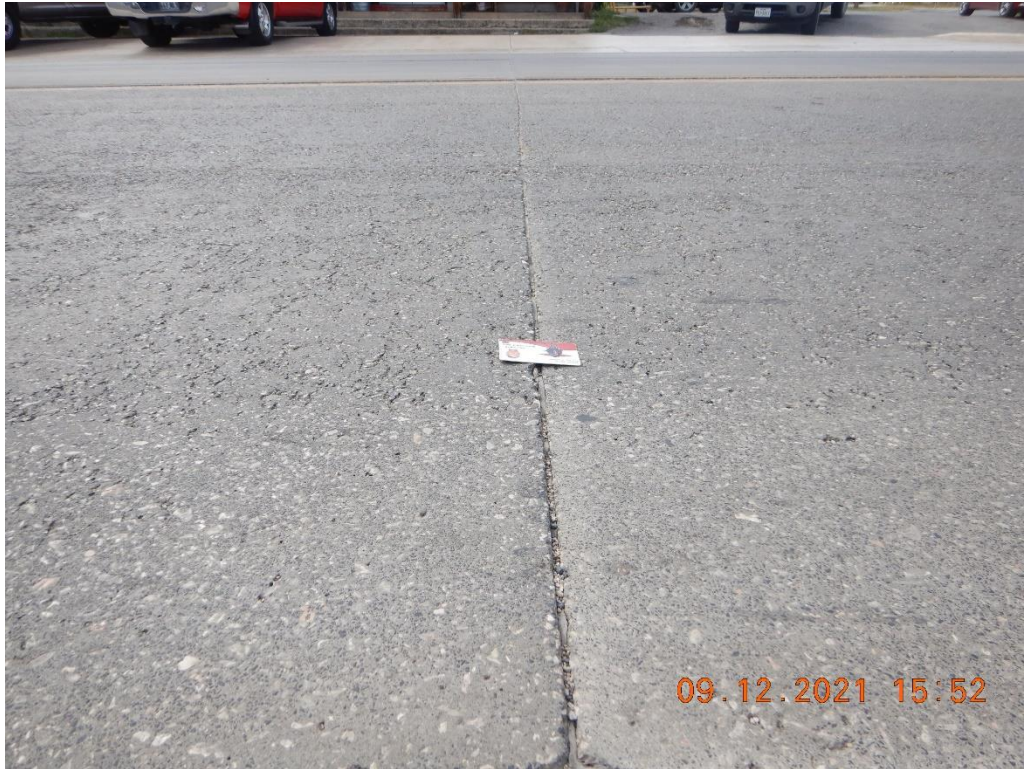
Figure 8 Faulting at the joint in RCC pavement

In CPCD, faulting is the most serious distress, since faulting impacts ride quality negatively as well as causes noise issues, while cracking does not necessarily affect ride quality as long as slab support is adequate. In general, if the average faulting is 2.5 mm (0.1-in) or greater, it causes noise and degrades ride quality. If the faulting is greater than 4.0 mm (0.15-in), the condition is considered poor and diamond grinding or other measures need to be performed. Accurate measurement of faulting requires specific tools, such as Georgia fault meter. The research team does not possess the device and faulting was not measured. However, faulting was not small in some areas, as shown in Figure 8. Even though the speed limit in this highway is low – 30 mph or 45 mph – noise was quite noticeable, which should not be acceptable to both traveling public and TxDOT.

- 1) Until new design/construction methods are incorporated that will ensure good load transfer at transverse joints, the use of RCCP in main lane highways is not recommended.
- 2) Construction and/or materials specifications need to be developed that will facilitate the compaction of RCC materials in RCCP.

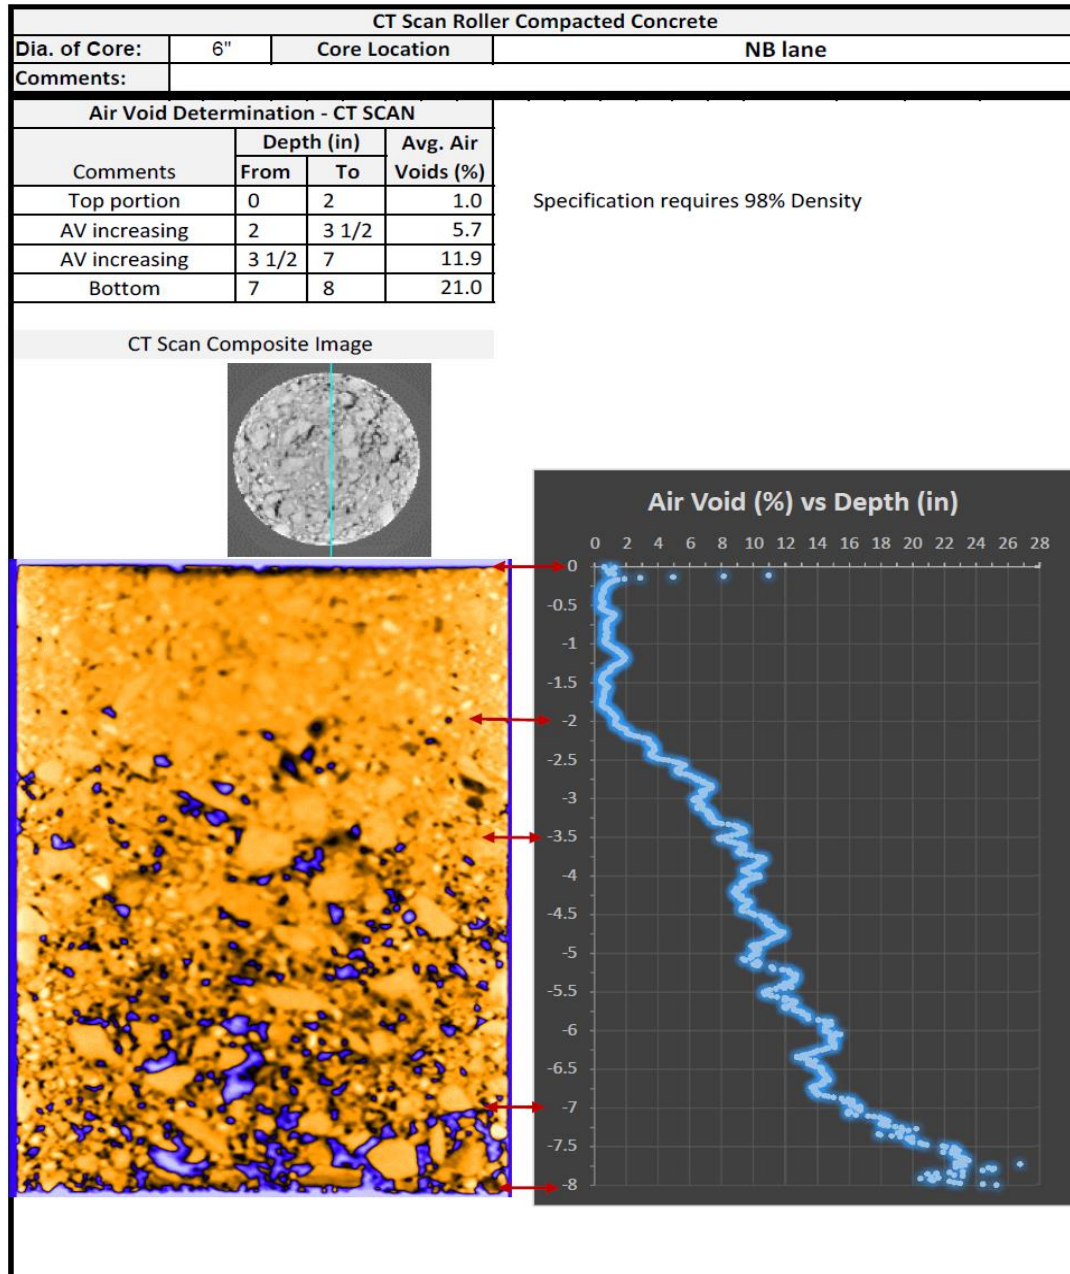
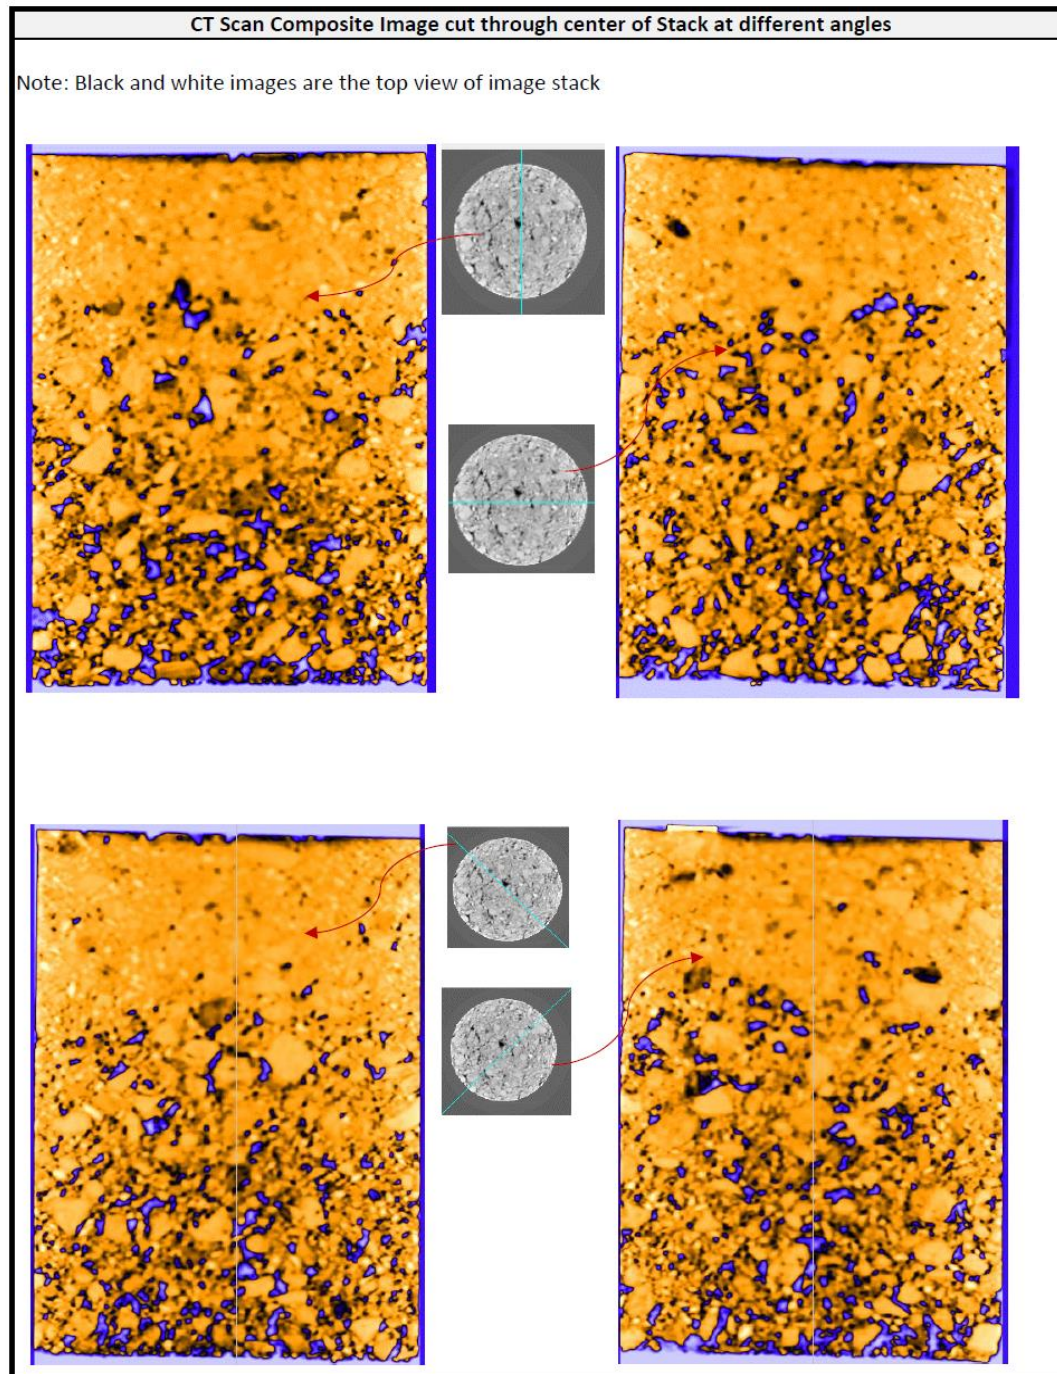
Since the completion of the RCCP construction, it appears that there have been several evaluations made on the condition of this RCCP section – one by TTI and the others by MNT. TTI research team evaluated RCC density from cores taken at US 83 section by CT scan. **Figure 9** illustrates its findings, showing large variations in RCC density through the slab depth, with a good density near the top of the slab and quite large voids or low density near the bottom of the slab. The density starts to decrease from about 2-in from the top, with the voids greater than 20 % near the bottom of the slab. As discussed earlier, 4 % more void than in the laboratory prepared specimens in RCC resulted in 45 % reduction in compressive strength. In **Figure 9**, it is observed that void at 2.5-in depth is about 6 %. Even though this data is from only one core, with the assumption of this core representing the whole project, it could be concluded that the compressive strength of the RCC in this pavement section below 2.5-in from the surface could be significantly low – maybe less than a half of the strength of the top quarter of the slab. If fatigue cracking is considered as a failure criterion of RCCP in this project, as has been the case for CPCD, the life expectancy of this RCCP could be severely reduced. What may be working for this RCCP is low traffic for both US 83 and RM 337. The annual average daily traffic (AADT) in 2020 was 4,749 on US 83, with 86

Figure 9-a First page of the CT scan report of the RCC core sample

Figure 9-b Second page of the CT scan report of the RCC core sample

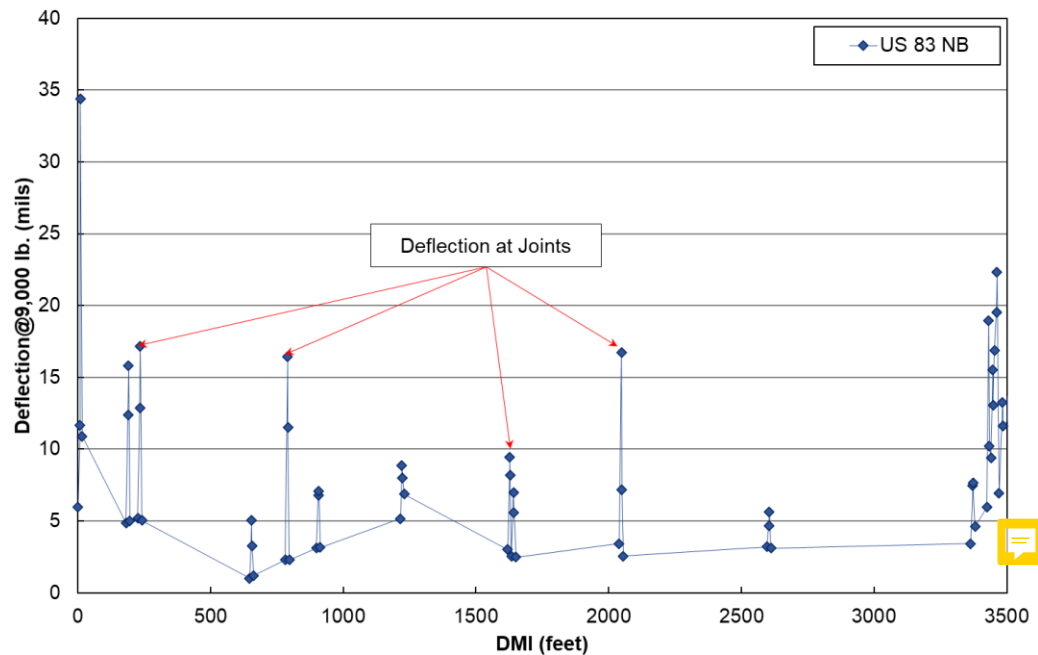
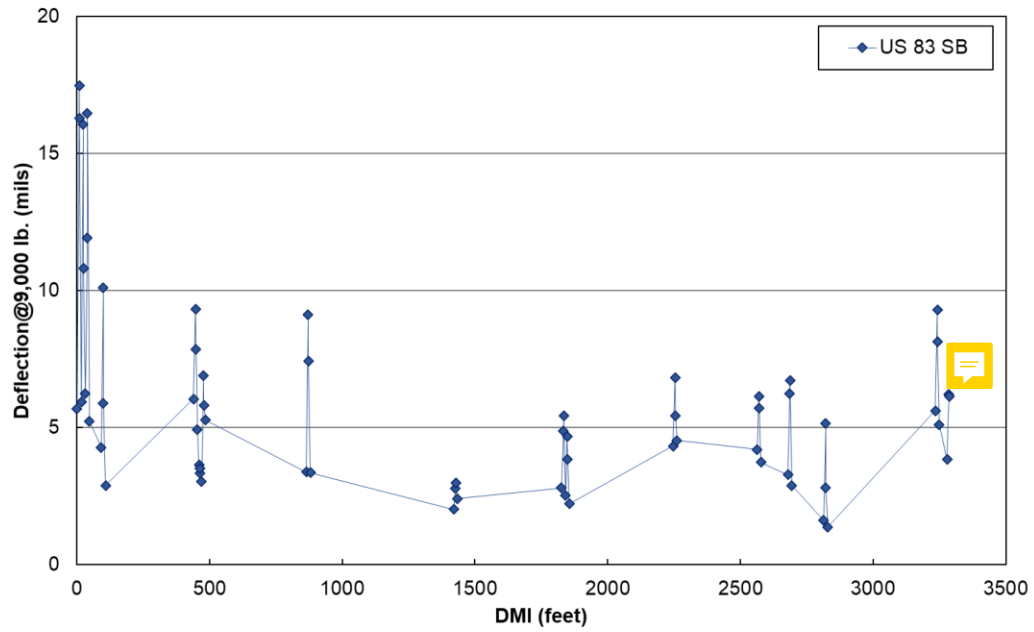
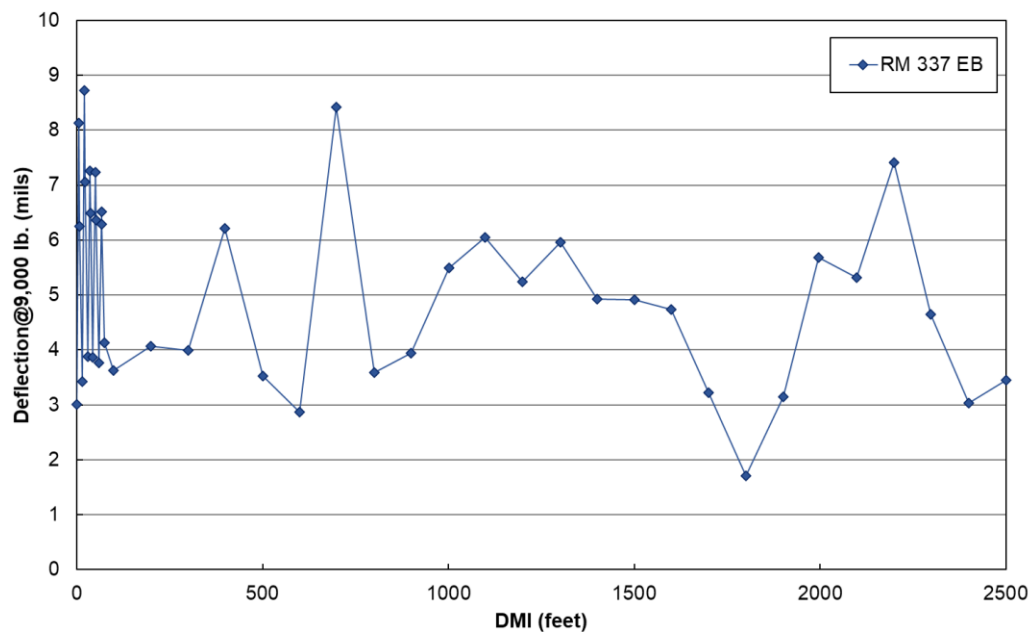
Figures 10-12 show that deflections at sawcut joints are higher than those at mid-slab. It is shown that the most deflections at the mid-slab across all 3 sections are 5 mils or less, while higher deflections were recorded at the joints/cracks. Intuitively, the larger deflections at cracks and joints than at mid-slabs indicate a low level of load transfer, which will be discussed in the next section of this memorandum. In addition, the deflections at mid-slab are small, as discussed above, indicating that the slab support under RCC slabs is satisfactory.

Figure 10 FWD deflections at US 83 northbound

Figure 11 FWD deflections at US 83 southbound

Figure 12 FWD deflections at RM 337 eastbound

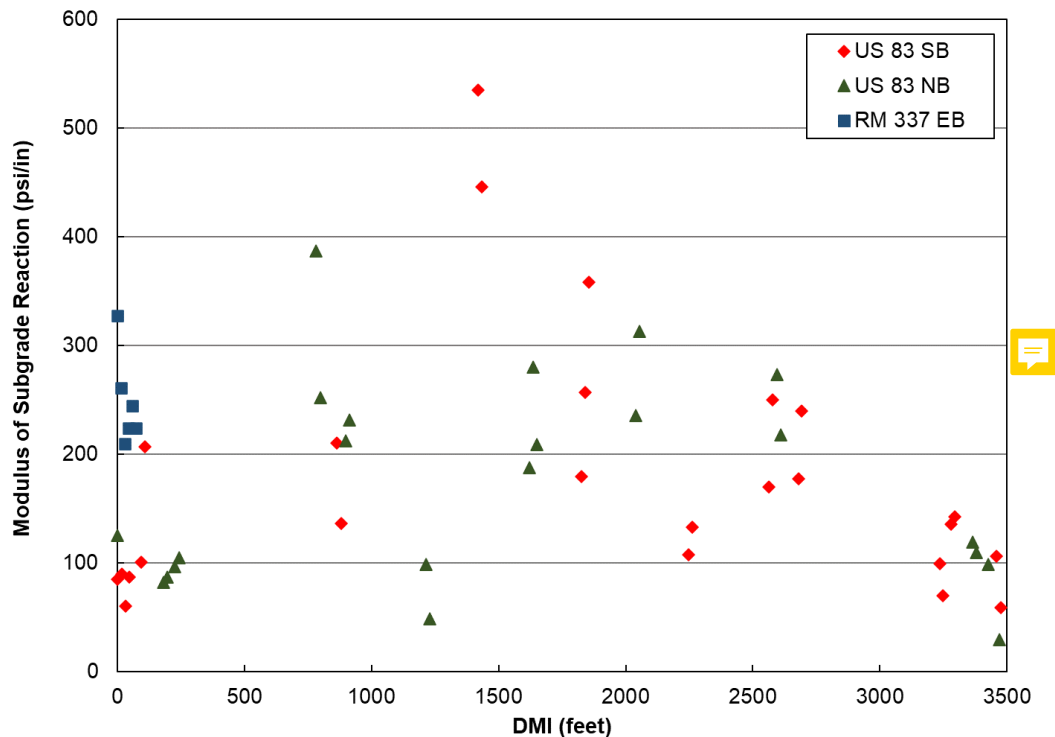
Figure 13 Modulus of subgrade reaction in the RCC pavement

Modulus of subgrade reaction (k-values) was estimated with the deflection data at mid-slabs using AREA method. Figure 13 shows static k-values obtained. It shows a wide variability in k-values in the areas evaluated, which may be a result of the absence of cement- or asphalt-stabilized base. The average k-values are 242, 240 and 248 psi/in for US 83 Northbound, US 83 Southbound and RM 337 Eastbound, respectively. A few points with values greater than 600 psi/in were excluded in developing Figure 13. Noise evaluations indicate that

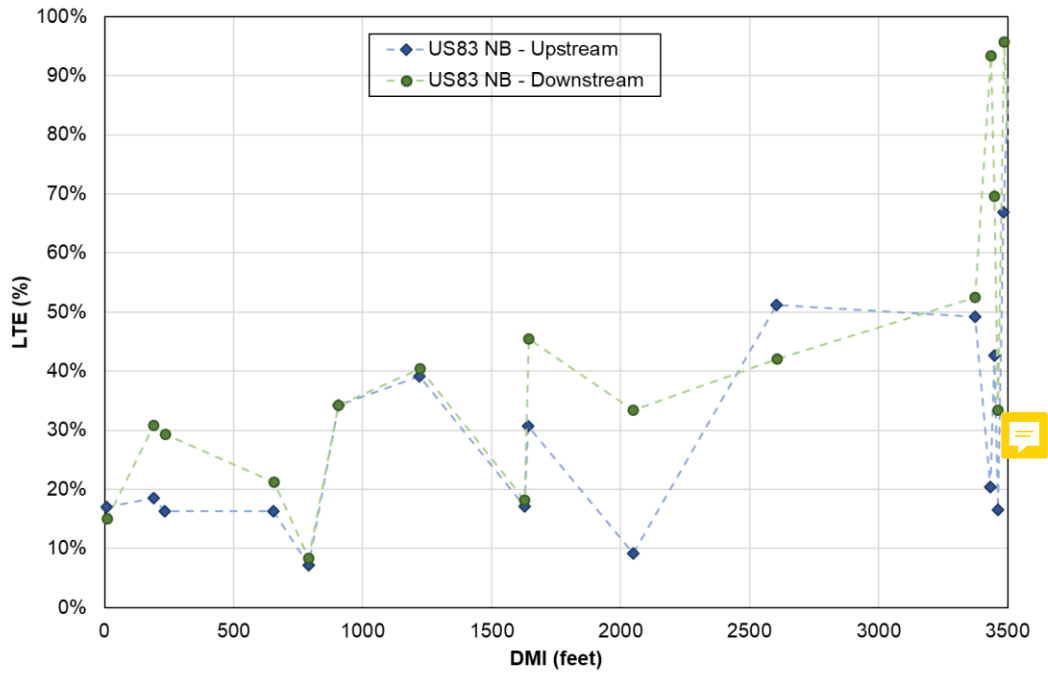
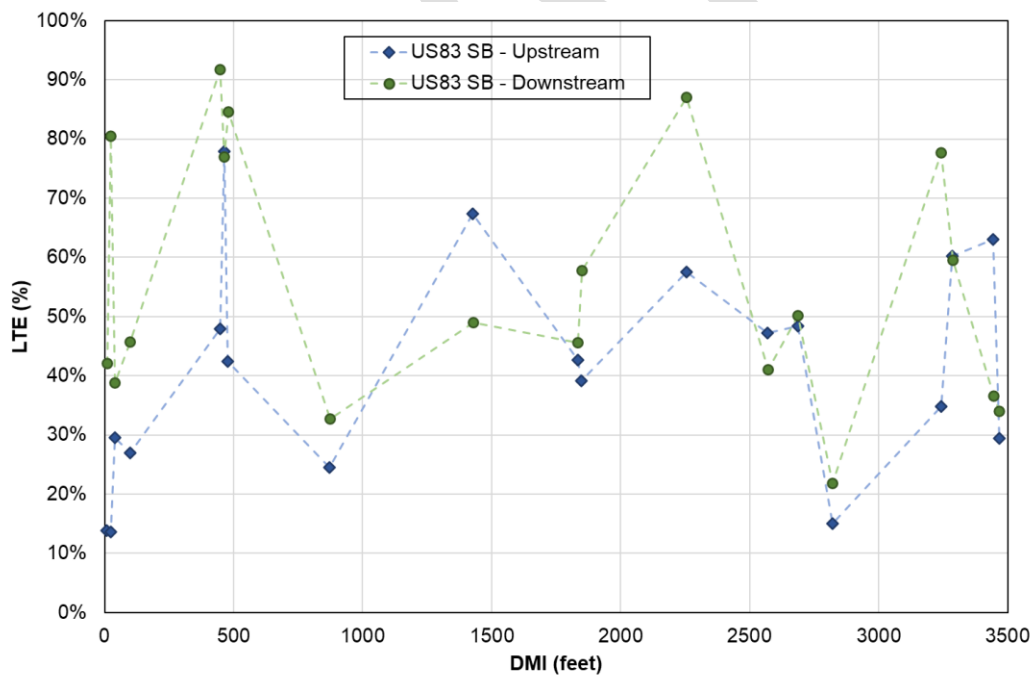
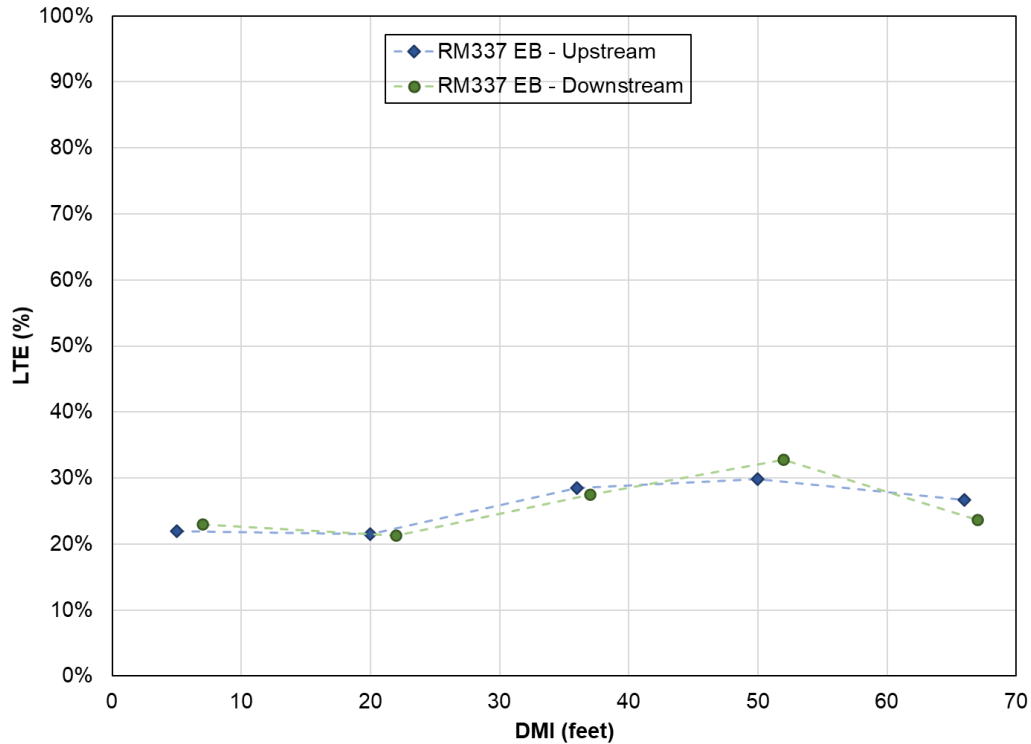
Figures 16, 17 and 18 present LTE values evaluated at US 83 northbound, southbound and RM 337 eastbound, respectively. It is observed that LTE values are quite low and these values fall within the LTE ranges reported by Pittman (1996). Low LTE values imply that almost all the joints popped and aggregate interlock at joints and cracks that exists in this RCC pavement is not sufficient enough to provide adequate load transfer for highway main lane pavement. Another observation is that there is a large difference between upstream and downstream LTEs at certain joints, especially on US 83 southbound. This indicates the cracks under the sawcut are deviating from a straight line, as well as low level of aggregate interlock. Compared with US 83, LTE values on RM 337 are quite low. It is not known for this low LTE values, since joint spacing is the same for both projects and the only difference in pavement structure is slab thickness – 8.0-in for US 93 vs 7.5-in for RM 337. This small difference in slab thickness should not result in this large discrepancy in LTE levels. There might be other causes.

Figure 16 Joint LTE at US 83 northbound

Figure 17 Joint LTE at US 83 southbound

Figure 18 Joint LTE at RM 337 eastbound

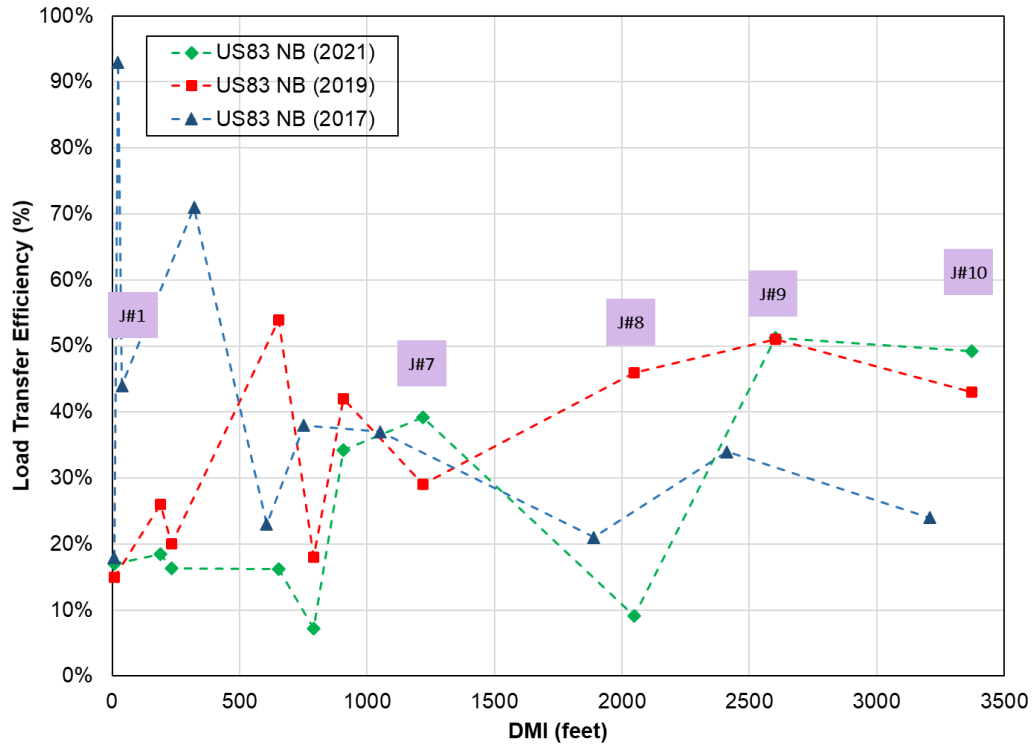
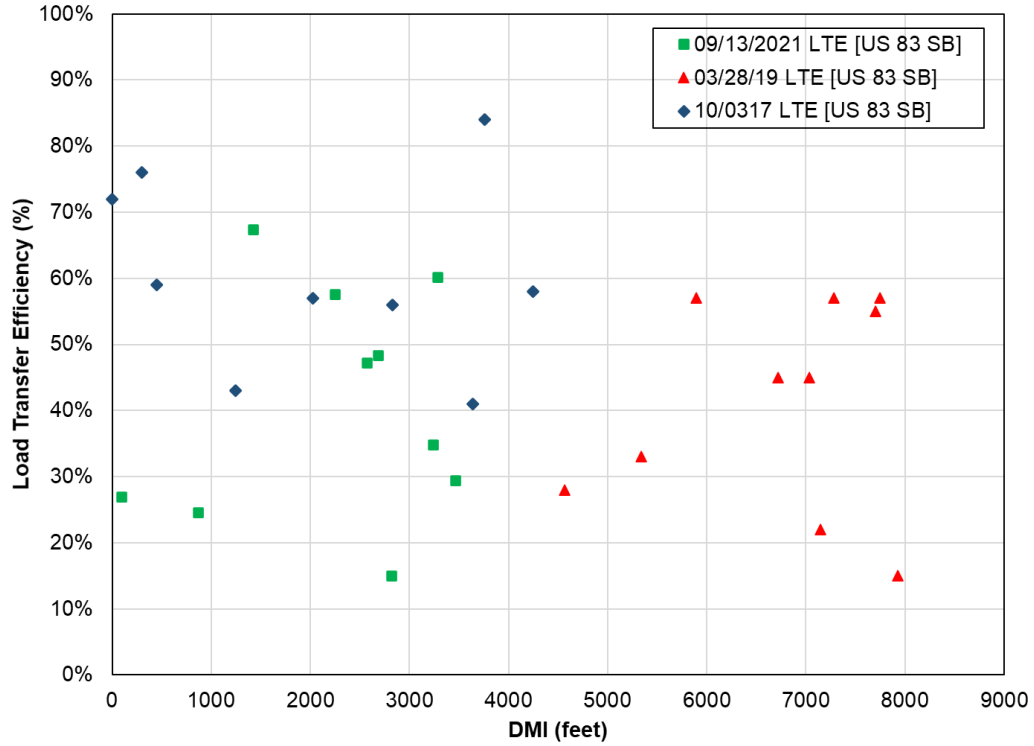
Figure 19 illustrates the variations in LTE over the last 4 years at US 83 northbound. It shows general decrease in LTE over time, even though there are other factors than age or traffic that have effect on LTE, such as testing season, time of the day of testing, so forth. Since detailed information on the day and time of the FWD testing conducted in 2017 and 2019, an accurate assessment is not feasible on the LTE trend over time; however, it appears that LTE values were quite low even after one year of construction, and they stayed low. Figure 20 illustrates the variations in LTE over the last 4 years at US 83 southbound. Since the locations of the joints selected for LTE evaluations in 2017 and 2019 are not the same as those selected for this investigation, direct comparisons in changes of LTE over time are not feasible. Rather, it shows large variations in LTE values along the project, and not much changes are observed in average LTE values over time.

Figure 19 Joint LTE comparison at US 83 northbound in 2017, 2019 and 2021

Figure 20 Joint LTE comparison at US 83 southbound in 2017, 2019 and 2021
