MDT EE Pit Commissioning Results and Status on MDT Configuration DB Works

Hok-Chuen Cheng
(University of Michigan)
28 May 2013

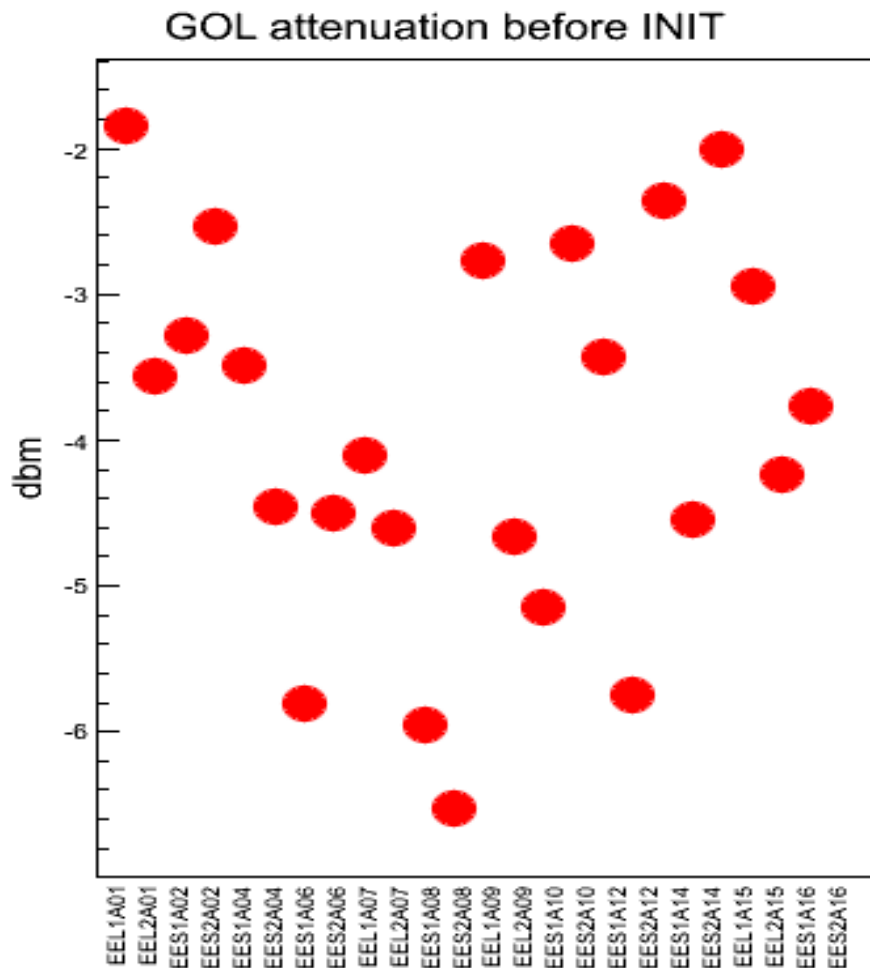
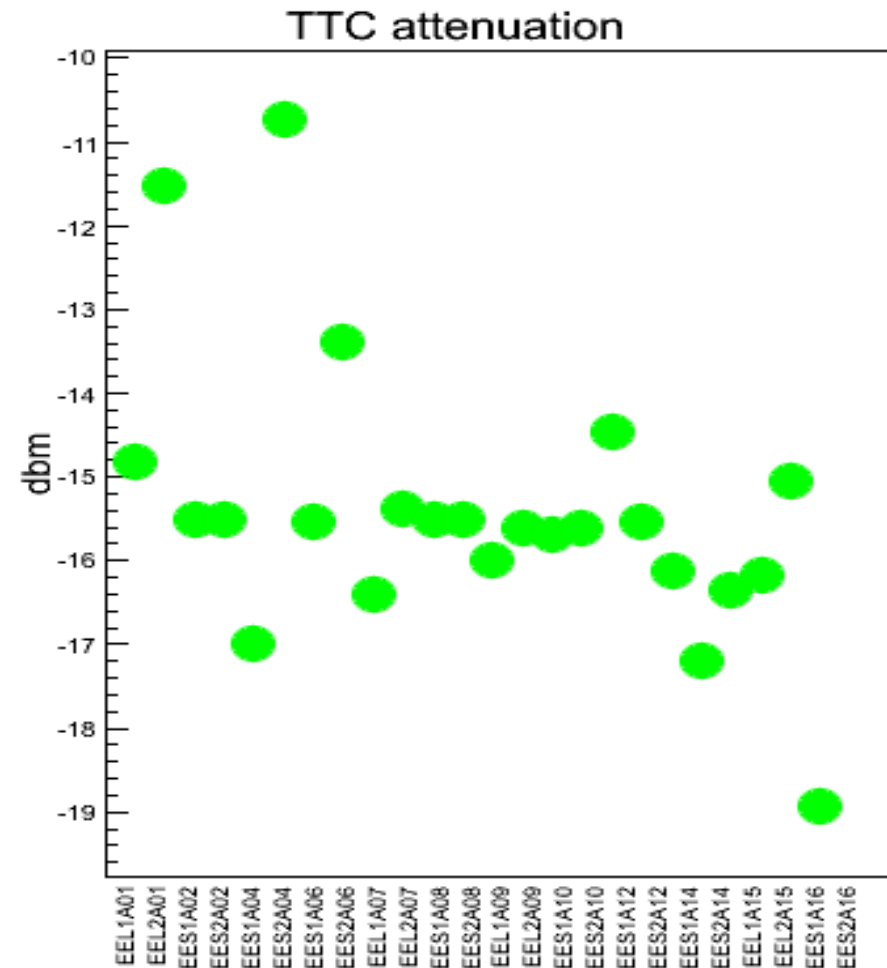
Fiber Light Measurements

EES1A06 fiber too weak, replaced week of 2 May

EEL1A15 fiber broken, switch to spare fibres last week

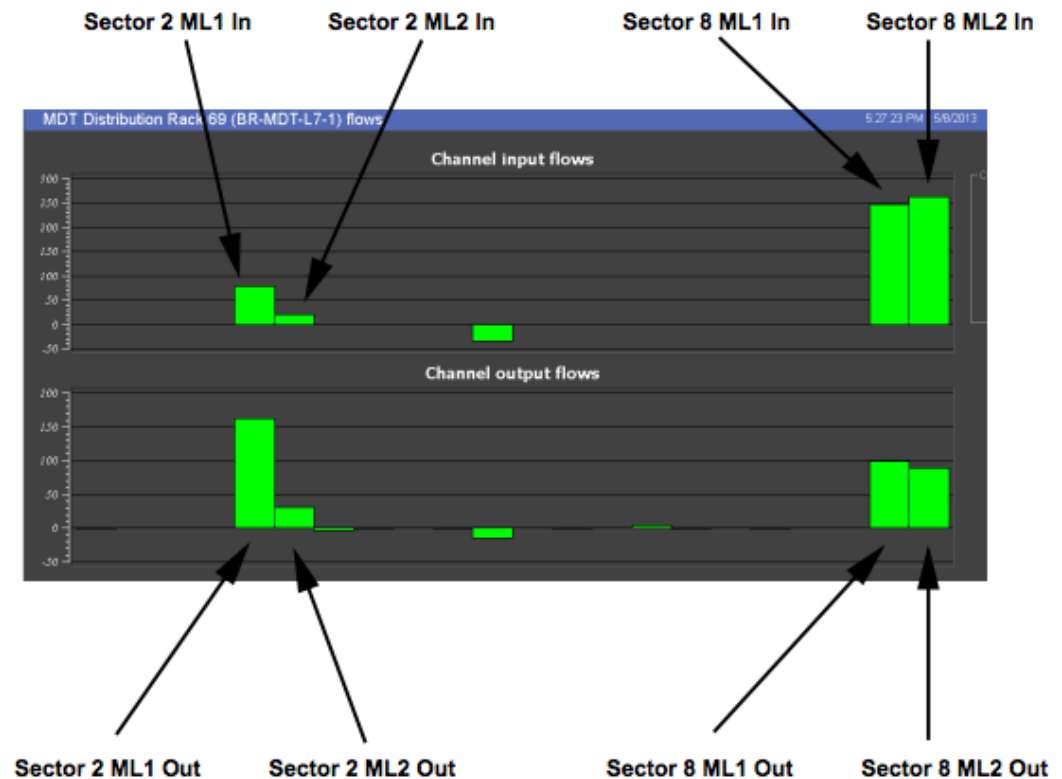
No major problems observed except in sector 2:

- Flow mismatch observed in sector 2 when started purging
- Traced to swapped connections between ML1 In and ML2 Out valves and manifolds for both EES chambers (pipes installed by TC in 2006), effectively connecting all ML either to only inputs or outputs.
- Fixed

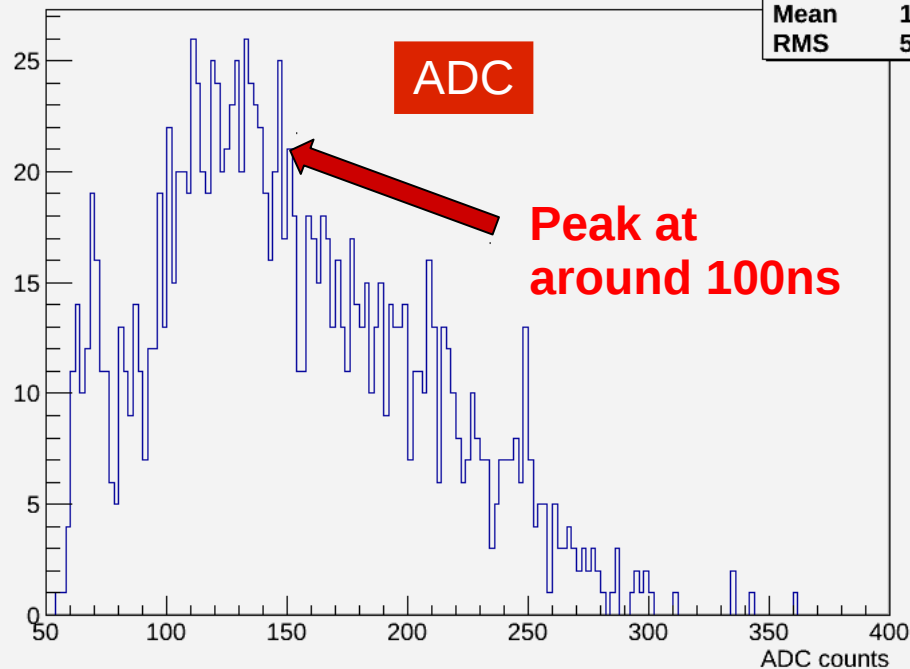
ADC distribution in EEL1A01 in ML 2

Reasonable ADC (peak at around 100ns) and TDC (flat) distributions.

ADC_ML2	
Entries	3281
Mean	151.7
RMS	54.56

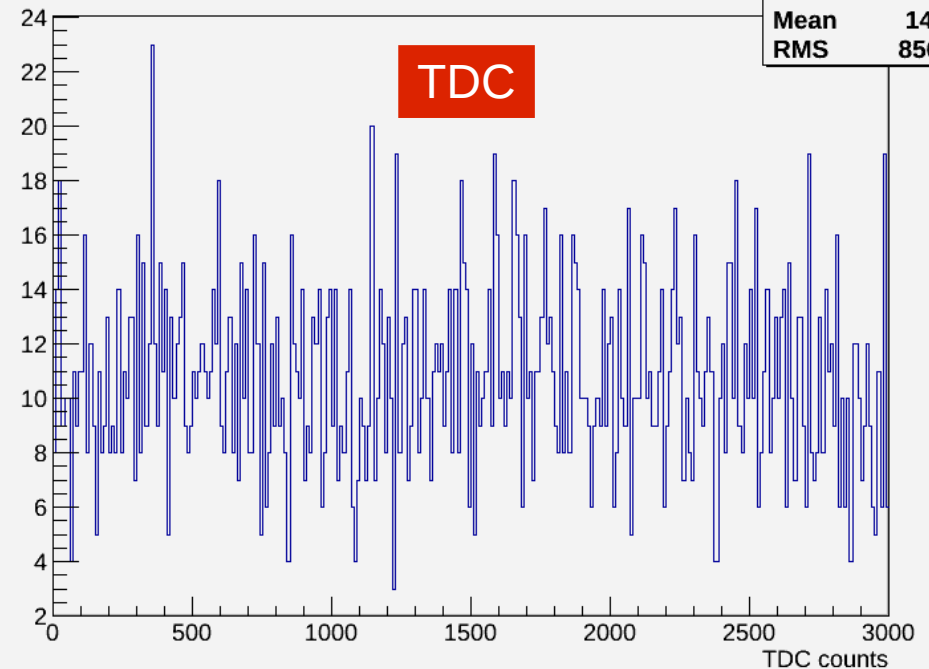
TDC spectrum in EEL1A01 ML2

TDC_ML2	
Entries	3361
Mean	1489
RMS	856.8
