Project:		Date/Time:	February 15 2022 - 10:54
Street and City:	BEECHNUT - HOUSTON	Weather:	Dry - No precipitation during survey
Owner:	COH	Inspection Status:	Complete Inspection
Customer:		Segment:	1622691
Surveyor Name and Certificate:	RUSSELL CHIPMAN U-0821-70402591	Direction:	Upstream
Reviewer Name and Certificate:	Johnny Dorsey U06180703002014	Up MH:	90264034
P.O. #		Down MH:	90264033

HOUSTON — February 15 2022	Up MH: 90264034
Pipe: 1622691	Down MH: 90264033

PACP Inspection Report
City of Houston (Active)

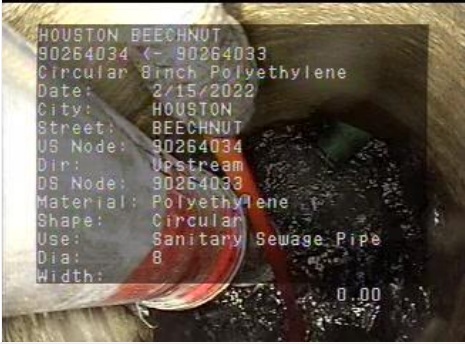
0	AMH - Manhole Remark = 90264033	00:00:34

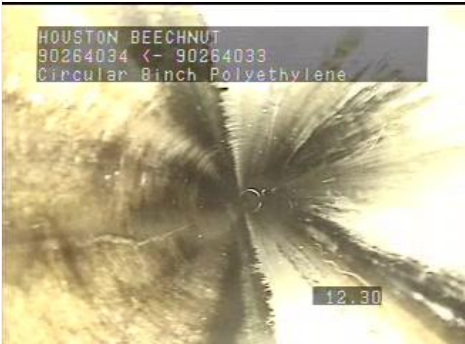
0	MWL - Miscellaneous Water Level Percent: 25	00:04:25

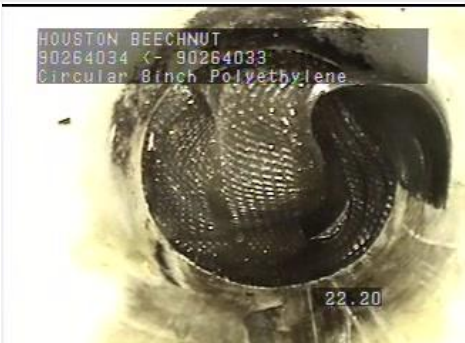
22.7	RPPD - Point Repair Patch Patch Defective Clock At 12 Remark = REPAIR CLAMP Grade = 4	00:05:45

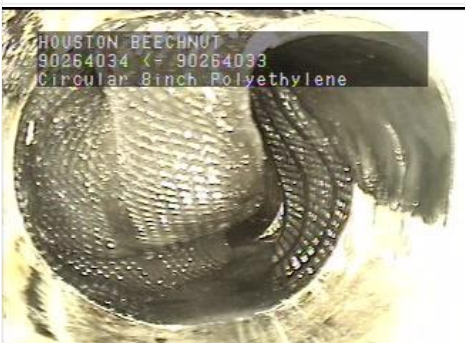
22.7	MSA - Miscellaneous Survey Abandoned Remark = RPPD	00:06:27
