## The Role of Forensic Engineering in the Diagnosis of Electrocution Fatalities: Two Case Reports

#### 3.1. Case report 1

### 3.2. Case report 2

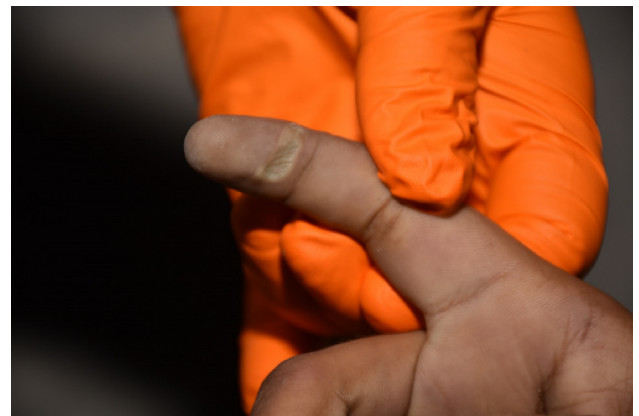
The first case took place in September 2021 within a construction site. At around 6PM on the day of the incident, a worker got electrocuted when they attempted to connect two cables to illuminate the lamp as it was getting dark. The investigation commenced with the forensic medico-legal examination of the deceased body, revealing a burned trace on the right index finger on both hands, as shown in Fig. 2, indicating that electrocution is a possible cause of death. Further investigation was required to ensure the validity of this finding. The forensic electrical engineering investigation started with a visual inspection of the site and its surroundings to identify several pieces of evidence (Fig. 3), which included:

Fig. 2. Burn trace found in the victim's right index finger during forensic medical examination of Case 1.

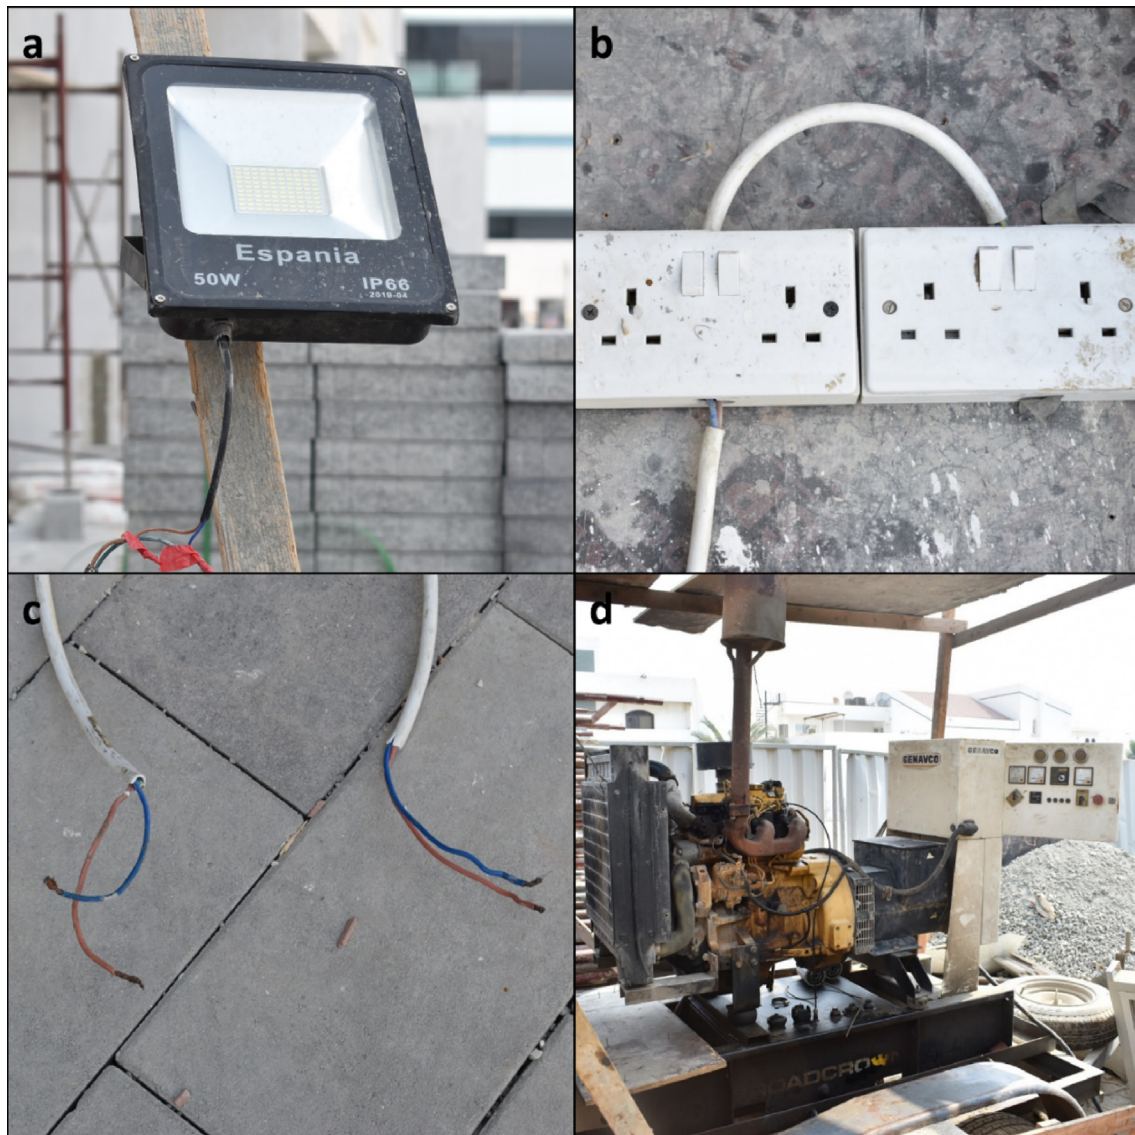
- A lamp fixed on a wooden base with an open-ended black cable (Fig. 3a)
- Two sockets installed on the ground (Fig. 3b)
- A white electric cable with two exposed ends (Fig. 3c)
- A generator connected to the socket outside the residential complex (Fig. 3d)

Technical examination of the evidence was required to determine the cause of the accident. The black cable of the lamp was found to have a missing earth wire. The current leakage test on the body of the lamp revealed that it did not leak excess current. The cables found near the body were then tested, and the earth wire in the white cable was found to be severed. The current on the wire was measured when it was connected to one of the sockets, which had a voltage of 240 V. The value of the current flowing through the cable was found to be 32.3 A.

The next phase of the investigation included the examination of the two sockets found on the ground. Both of these were double sockets, meaning that a total of four socket inlets were available. Three socket inlets were in the ON position, while the last one was in the OFF position. Each socket inlet supplied a voltage equivalent to 240 V. After examining the sockets, it was revealed that the sockets' cable did not have any earth wire. The sockets' cable was traced back to find the cable on the ground, next to the main distribution panel. The distribution panel was next to the generator outside of the residential complex. The cable was not connected to

**Fig. 3.** Evidences found during the forensic investigation of Case 1 at the site of incident which include (a) lamp, (b) sockets, (c) cables, and (d) generator.

the main distribution panel as it was supposed to, therefore invalidating the working of the main distribution panel in disabling the current flow in the event of a fault.

The generator was the last evidence examined at the site of the accident. The generator was directly connected to the socket. The generator produced a total power of 28 kW, with a voltage of 380 V. The overall current produced by the generator was 80 A. The technical examinations of the lamp, the socket, the main distribution panel, and the generator were concluded on the site. However, both the black and white cables required further examination. The trace evidence analysis was conducted on the collected cables in the lab. The microscopic image of the cable is shown in Fig. 4.

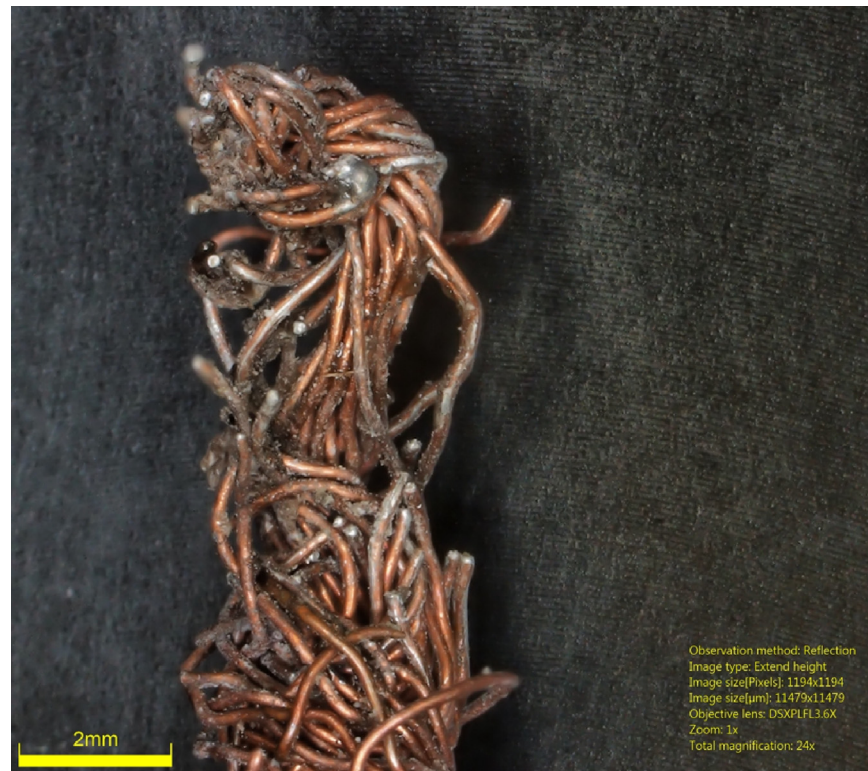
**Fig. 4.** Microscopic examination of copper wires in the cable for Case 1.

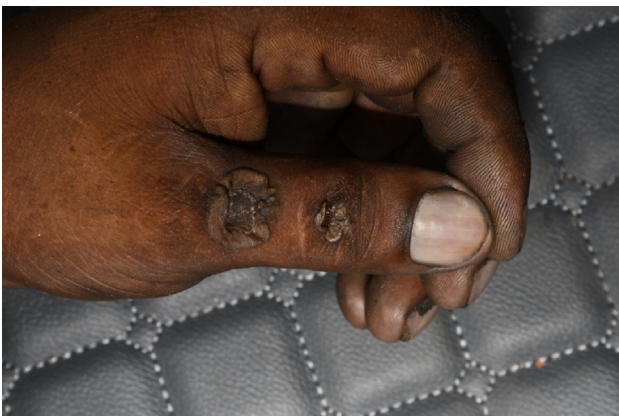
The second case occurred in June 2020 in a repair workshop, where the victim was found lying on the ground next to the bathroom after having used the laundry washing machine. It was revealed through an autopsy of the deceased body that electrocution is a possible cause of death due to the burn traces found in the

**Fig. 5.** Burn trace found in the victim's left thumb during forensic medical examination of Case 2.

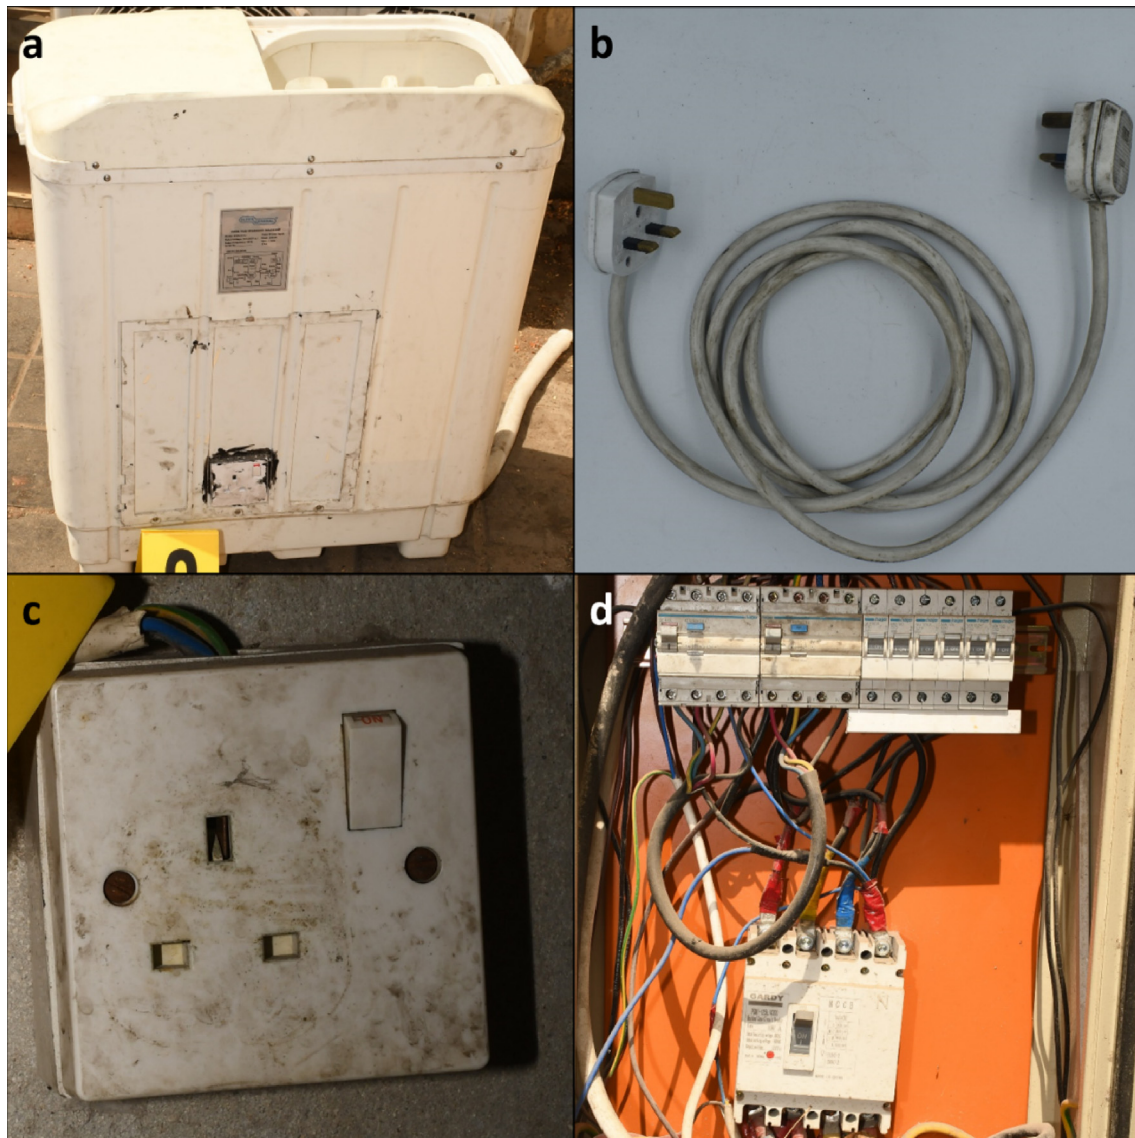
- A washing machine, which had adjustments made to its wiring, which included the removal of a part of the body of the washing machine to add a socket and the replacement of the original wires (Fig. 6a).
- A white electric cable with a plug on either side (Fig. 6b).
- A socket on the wall of the bathroom (Fig. 6c).
- A distribution panel that is connected to the socket on the bathroom's wall (Fig. 6d).

area and their purpose. It was concluded that the modifications were to enable the washing machine to operate using one special cable, which is the one found in the ground with a plug on either end of it. One end of the plug was inserted into the socket on the bathroom wall, while the other end was inserted into the built-in socket in the washing machine. The leakage current test was conducted using a multi-meter to ensure that the washing machine was not leaking excess current. The body of the washing machine was found to lack any defect that can cause it to leak excess current. The socket found on the bathroom wall, along with the distribution panel, was also inspected. All circuit breaker switches in the distribution panel were in the ON position, indicating they were operating during the incident. During this part of the investigation, two tests were conducted in each of the sockets and the circuit

The last phase of the investigation was on the cable with a plug on either end. The cable itself was of type British Standard (BS) 6500 with a cross-section of  $3 \times 2.5 \text{ mm}^2$  and can withstand voltages up to 300–500 V. The current flow through the cable was calculated to be  $\sim 229 \text{ mA}$ . This current is lethal if it flows through the human body because it exceeds the maximum current that the body can withstand without experiencing an electric shock. After conducting tests on the washing machine, the socket, and the distribution panel, it was found that they had no defects. However, the cable was collected for further examination in the lab. After the thorough inspection of the cable, the two main hypotheses that were concluded for the investigation are the absence of the earth wire and the bypassed fuse in the cable.

In the lab, dismantling both plugs in the cable revealed the wiring inside. It was found that the earth wire was connected to neither of the plugs. Moreover, the fuse in one of the plugs, the one that was connected to the washing machine, was altered to become a bypassed fuse. Aside from the earth wire, the fuse is also an essential safety component in the plug. The fuse is designed to protect electric circuits by creating an open circuit in the event of an overcurrent [14].

**Fig. 6.** Evidences found during the forensic investigation of Case 2 at the site of incident which include (a) washing machine, (b) cable, (c) socket, and (d) distribution panel.

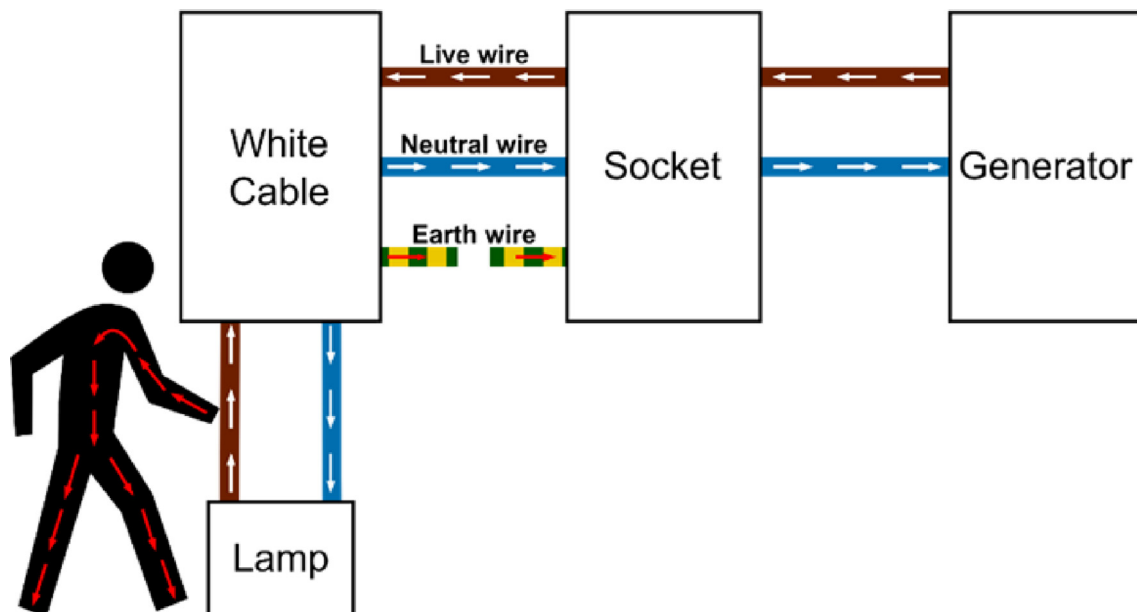
Fig. 8. Demonstration of how the accident in Case 1 took place.

In the first case, the victim was attempting to turn on the lamp when they got electrocuted as the current passed through them instead of its usual path through the earth wire. This incident occurred due to making contact with the white cable supplying live current while connected to one of the sockets in the ON position. The main contributors to the accident were the absent earth wire and the socket not being connected to the distribution panel, which would have stopped the current from flowing into the worker. Moreover, the worker was not wearing the required safety personal protective equipment, which could have prevented the electrocution. Fig. 8 demonstrates how the accident took place. In the second case, the victim had unplugged the side of the cable connected to the washing machine without initially turning off the switch on the socket on the bathroom wall. As evident from the burn traces found on the thumb of the deceased person, the cable was still supplying voltage at 230 V and 50 Hz when they removed the plug and had accidentally touched the conducting part of the live and neutral pins in the plug, which resulted in electrocution. The deceased person had been the one who made the adjustments to the washing machine and the plug. When modifying the plug, the deceased did not connect the earth wire to the earth terminal in the plug, an action that could have prevented the electrocution. Furthermore, the fuse was also tweaked to become a bypass fuse, which made it unable to discontinue the current flow during the electrocution. Fig. 9 demonstrates how the accident took place.

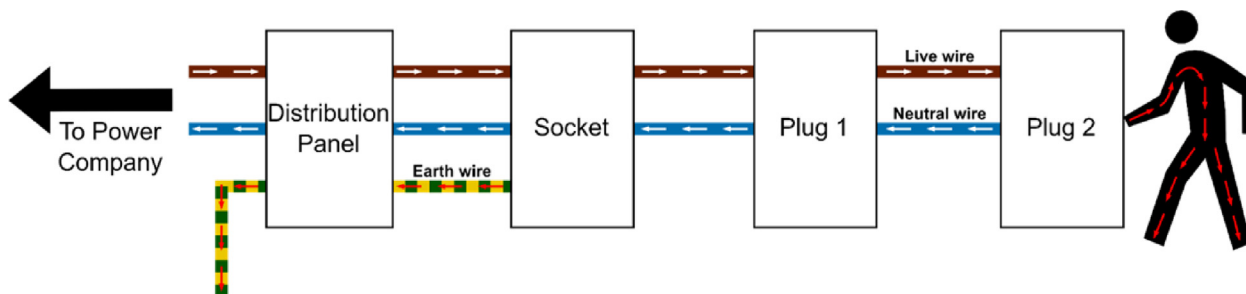
Fig. 9. Demonstration of how the accident in Case 2 took place.
