Letters to the Editor

The Author Response: A Case Study on Engineering Failure Analysis of Link Chain

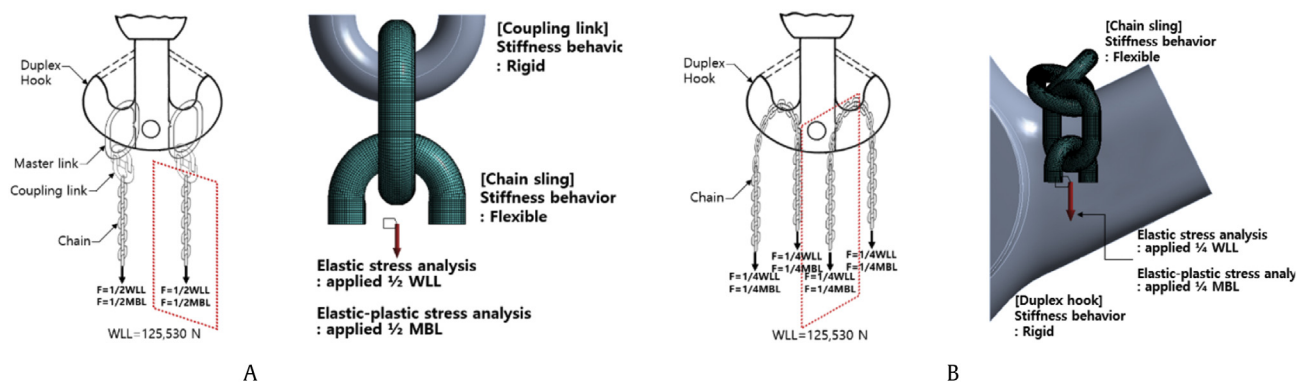
1. Response revised on FEA category in this paper: This article is written for supplementation of stress analysis parts (relatively idealised and straightforward structure, simplifying the loads and material property assumptions, etc.) for crane chain in the existing paper [1]. In material properties, an elastic material model for stress analysis, which was conducted in an existing paper, was used to re-evaluate plastic collapse due to the Working Load Limit (WLL) in each installation condition. The analysis results show that high stress (total stress) at the junction of the barrel and that of curvature of the crane chain are similar in the area where the crane chain was broken. Compared with the correct installation conditions, when high stress is applied, the incorrect installation condition evinced a breakage. For determining the membrane and bending stress components, the total stress distribution was obtained from elastic stress analysis, and linearised on stress component integrated along the cross-section of Stress Classification Lines (SCLs) through

Fig. 1. Boundary and loading conditions of elastic stress analysis in each installation condition. (A) Correct installation condition. (B) Incorrect installation condition.

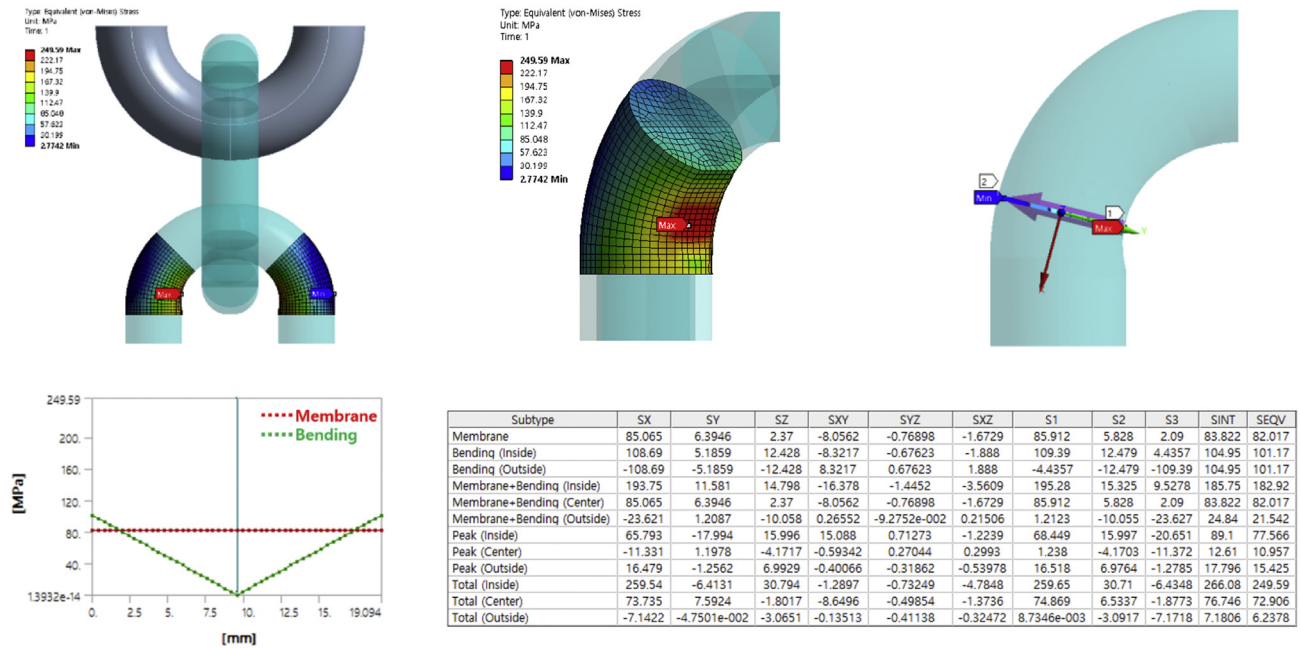
Fig. 2. Results of elastic stress analysis of correct installation condition.

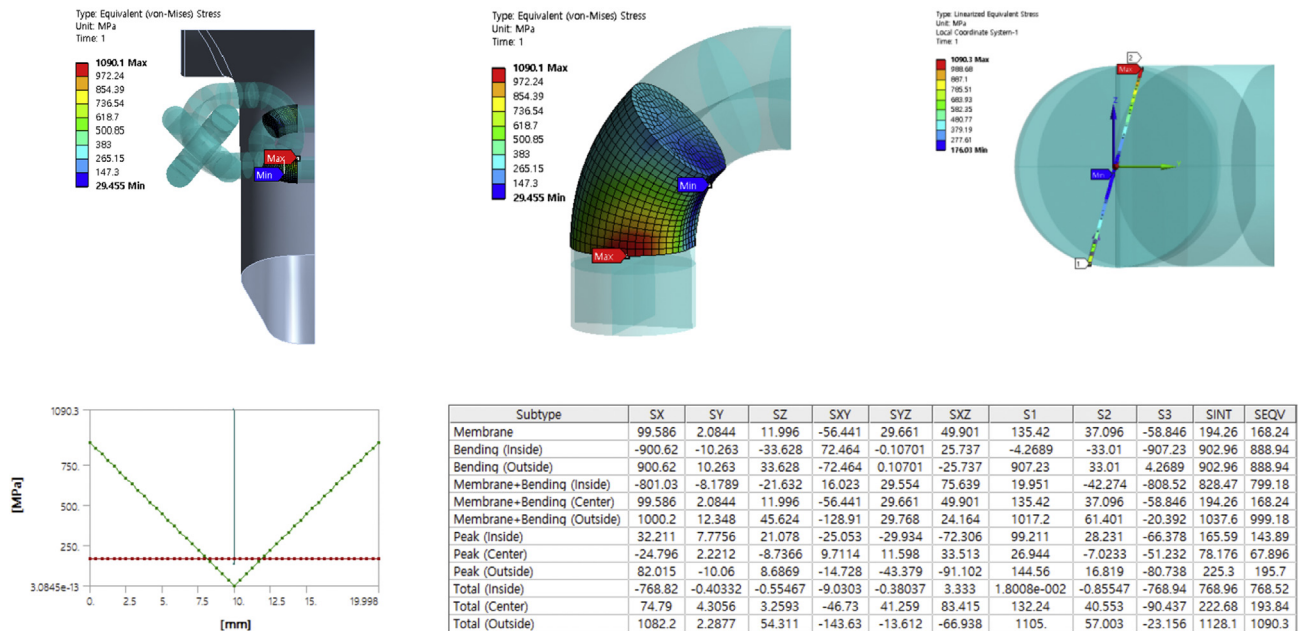
2. Additional explanation of the fractographic analysis: According to your comments on the paper, you claim that “the crack likely initiated around the chain inner surface, where the presence of high tensile stress under tension load or small stresses under bending load while a ‘crushed damage’ area was found there.” However, the crushed damage observed in the chain's inner surface cannot be formed by uniaxial tension load because the inner surface of the chain at this position was not contacted with other chains on the condition that the crane chain was installed correctly, as shown in Fig. 7 [1] A in the paper. Accordingly, we concluded that the crushed damage was possibly formed by an improperly installed crane chain inducing abnormal interlocking of the chains (Fig. 3).

Fig. 3. Results of elastic stress analysis of incorrect installation condition.
