ISURE Flight Readiness Report

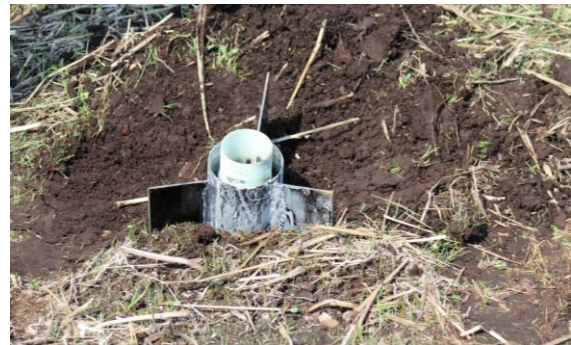
Bottom of dart after second test launch.

As of the latest test launch, the top portion of the dart was not recoverable. This includes the transition area, nose cone, and parachute. The shoulder for the coupler separated from its original piece and lodged inside the bottom portion of the dart. The fins and bottom shoulder are still intact. In order to recover this bottom portion, the shock cord that ran throughout the length of the dart had to be severed (for a second time). This would cause an added variable for failure if another shock cord had to be tied to the short length that is inside now.

1. Order and receive a:
 - a. Coupler
 - b. Shoulder
 - c. Nose cone
 - d. Parachute
2. Cut, sand, and epoxy the coupler to the required length.
3. Cut, sand, and epoxy the shoulder for both the nose cone and transition.
4. Repair or replace the shock cord.
5. Reinstall a safety switch.
