Women in Aerospace

University of Illinois at Urbana-Champaign

1. Rocket Operation Assessment

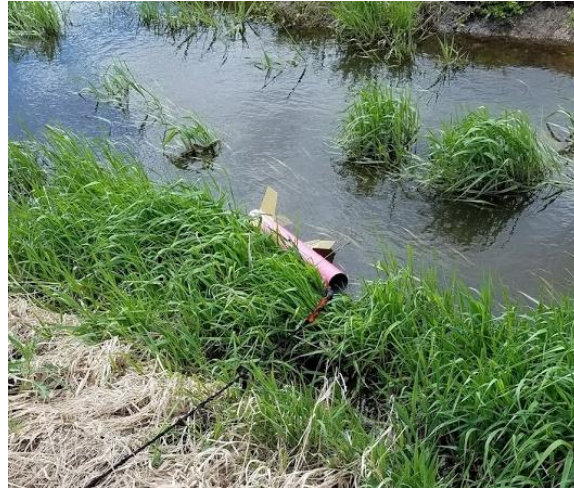
After the first flight the rocket landed partially in a drainage ditch containing water, as seen in Figure 2. The booster section, which housed the active drag, was partially submerged. The other sections of the rocket remained dry. One of the active drag fins took the brunt of the landing and was consequently damaged- the rod was wobbling around where it should have only been allowed to rotate.

Figure 2. Booster section in drainage ditch.

The booster tube and active drag system were further inspected for damage. The section itself suffered no major damage and was safe to fly again. Unfortunately, the 3D printed donut holding the active drag was broken. The system was deemed irreparable with the tools available and hence unsafe to fly. The entire system was dismantled for the second flight. After the next flight, in which the main parachute did not deploy, the impact on landing was fortunately soft enough as to not damage any part of the rocket. Photos of the rocket on the ground after the second launch are shown in Figure 3.

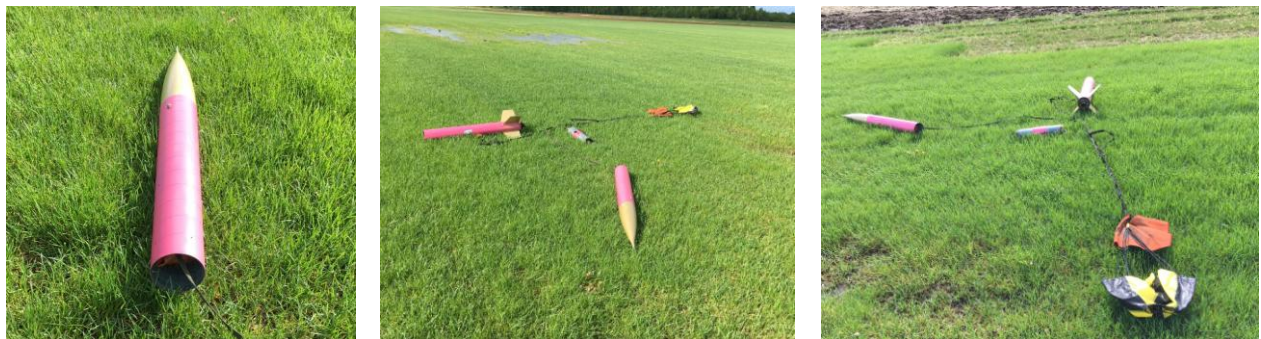
Figure 3. Rocket after second flight landing.

Upon inspection of the rocket on the ground, it appeared the up and down facing cameras had become detached at some point during the flight. They did not appear to be in the local proximity of the landing site.

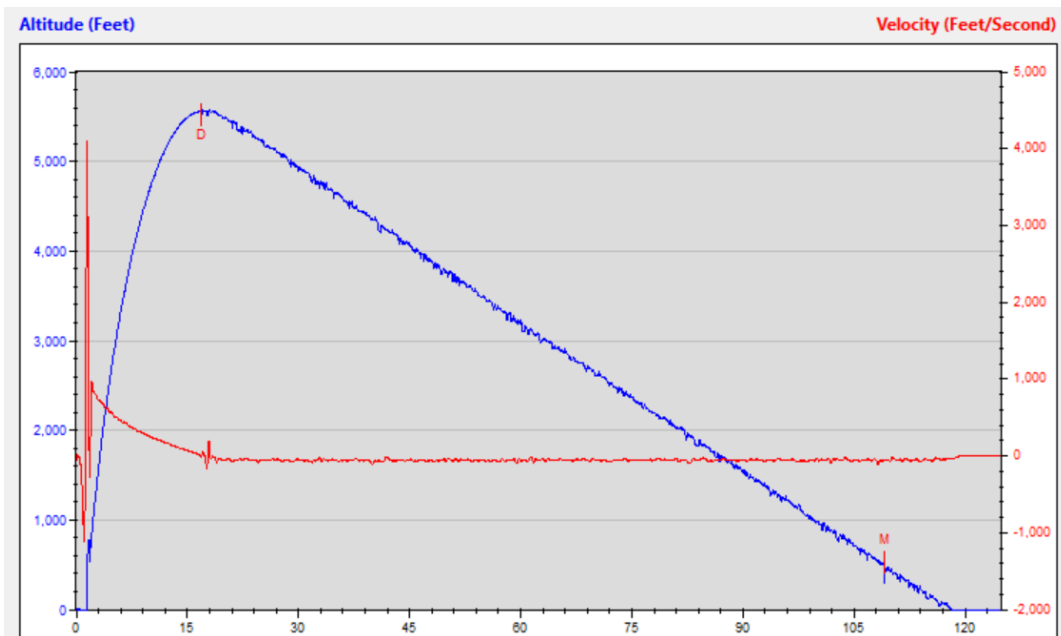
Figure 7. Altitude and velocity data collected from the Stratologger for the second flight.

In both flights, the actual peak velocity was higher than the predicted velocity. The predicted J motor peak velocity was 495 ft/s, while the peak velocity of the first flight was 610 ft/s. This may have been due to assuming a higher coefficient of drag for the rocket during the flights without active drag than the actual value. The predicted K motor peak velocity was 695 ft/s, while the peak velocity of the second flight was about 950 ft/s. As can be seen in figure 7, the Stratologger did not record very good data during motor burn, as evidenced by a reading of 4000 ft/s.

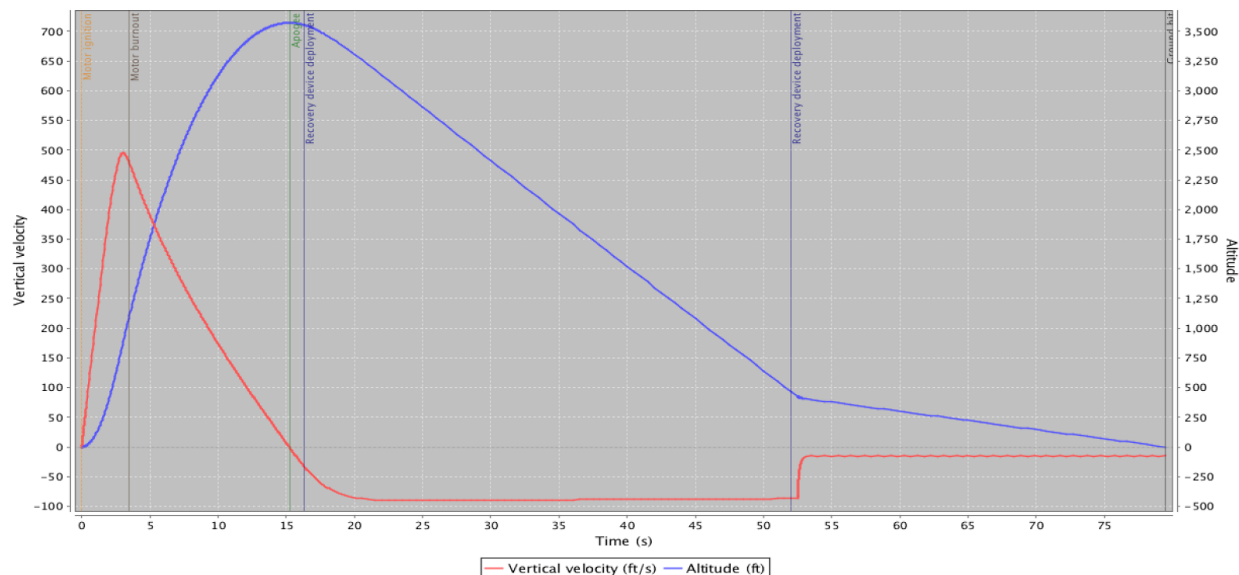
Figure 8. Predicted altitude and velocity.

The actual and predicted flight path trajectories were not identical. The simulation predicted that the rocket would go several hundred feet higher than what the rocket actually achieved. The prediction did not account for the area of the solenoids, cameras, and external wires. It is likely that the increased drag from these objects drove down the peak altitude.

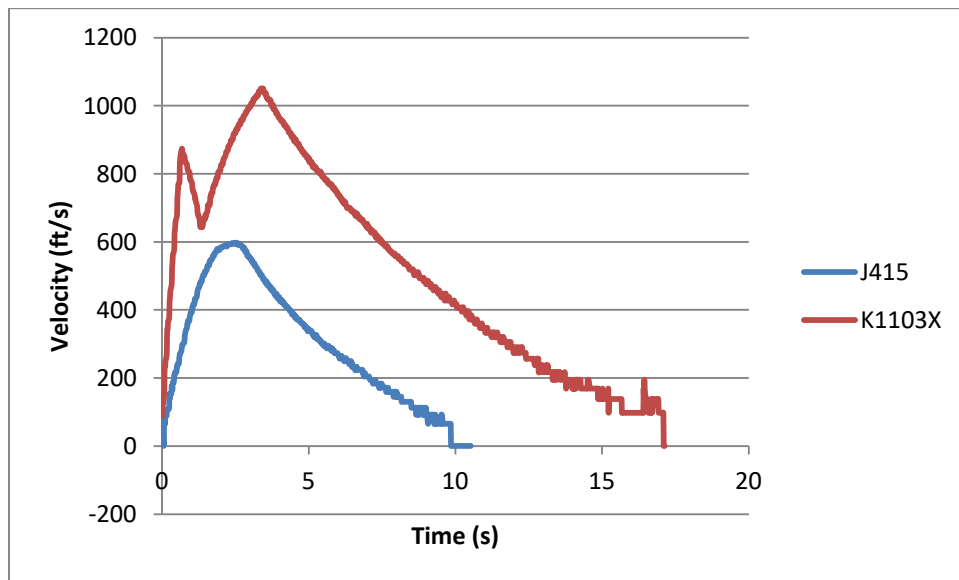
The custom built velocity measuring package worked with minimal faults. The first flight yielded very accurate velocity readings and a peak velocity of 600 ft/s compared to the actual 610 ft/s. The second flight did however present some faulty data. There are two peaks in the velocity curve. A possible source of this error is viscous effects and turbulent flow as the rocket approached mach 1. Despite this, the resulting velocity curve is overall nicer than that of the Stratologger which gave velocity readings up to 4000 ft/s during motor burn. The custom velocity reading curves are plotted in figure 8.

Figure 8. Velocity versus time on custom built package until apogee
