NASA's Space Grant Midwest High Power
Rocket Competition
2014-2015

Post- Flight Report

University of Minnesota - Twin Cities
Freshman Team
5/29/2015

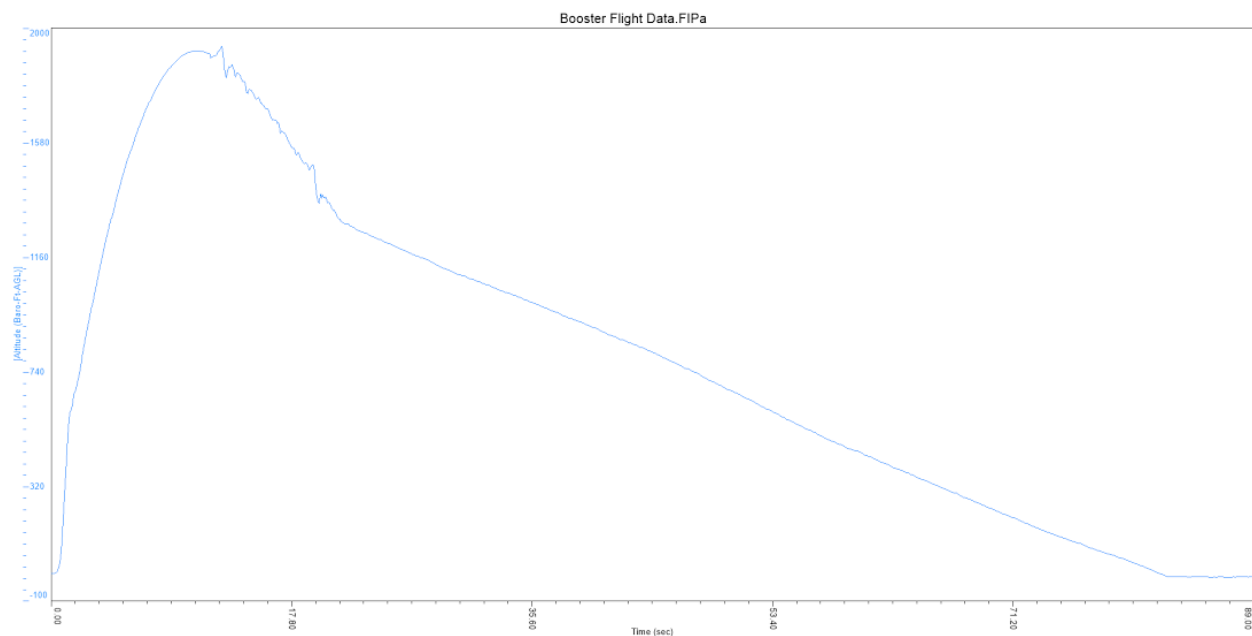
Peak Altitude Comparison

actual: 1935 feet above ground (as reported by the barometer)

predicted: 2378.61 feet above ground

The actual peak altitude value of the booster for the competition flight was 1935 feet above ground-level (as reported by the barometer), compared to the computer simulation-based predicted value for this altitude of 2378.61 feet. The difference between these values is 444 feet, for a margin of error for the booster's altitude of -22.9%. This value is fairly small compared to the other abnormalities that occurred within this competition flight. This error between the actual and expected values can likely be explained by the rather non-vertical nature of the flight.

The computer simulation used predicted a vertical flight, and the Raven used to measure actual altitude measured the vertical altitude, rather than the distance travelled by the booster until apogee. Had this flight been perfectly vertical, as the simulation that resulted in the predicted value was, it seems probable that the predicted and actual values would be extremely close to one another.

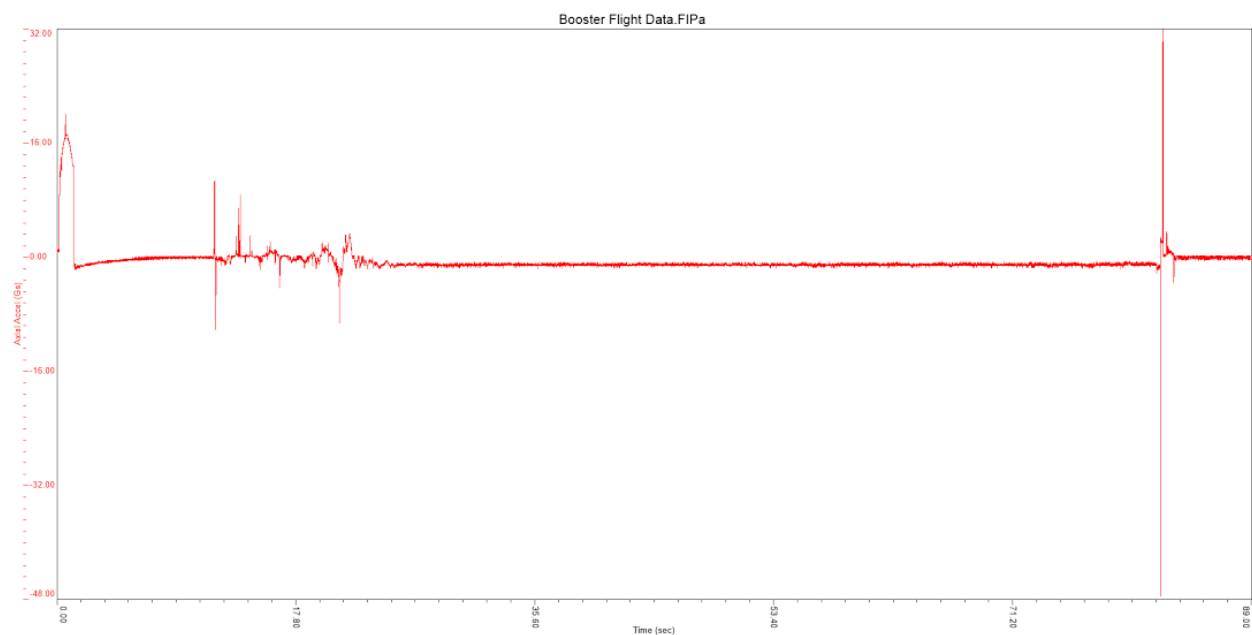
Peak Acceleration Comparison

actual: 20.10 Gs

predicted: 20.24 Gs

The peak acceleration value of the booster for the competition flight was 20.10 Gs, compared to 20.24 Gs predicted acceleration value for the booster acquired by the computer simulation. The difference between these values is .14 Gs, with a margin of error for the acceleration of -0.7%. This is very small and indicates that in regards to the propulsion section of the competition flight, all went as planned and simulated. Because of the fact that this

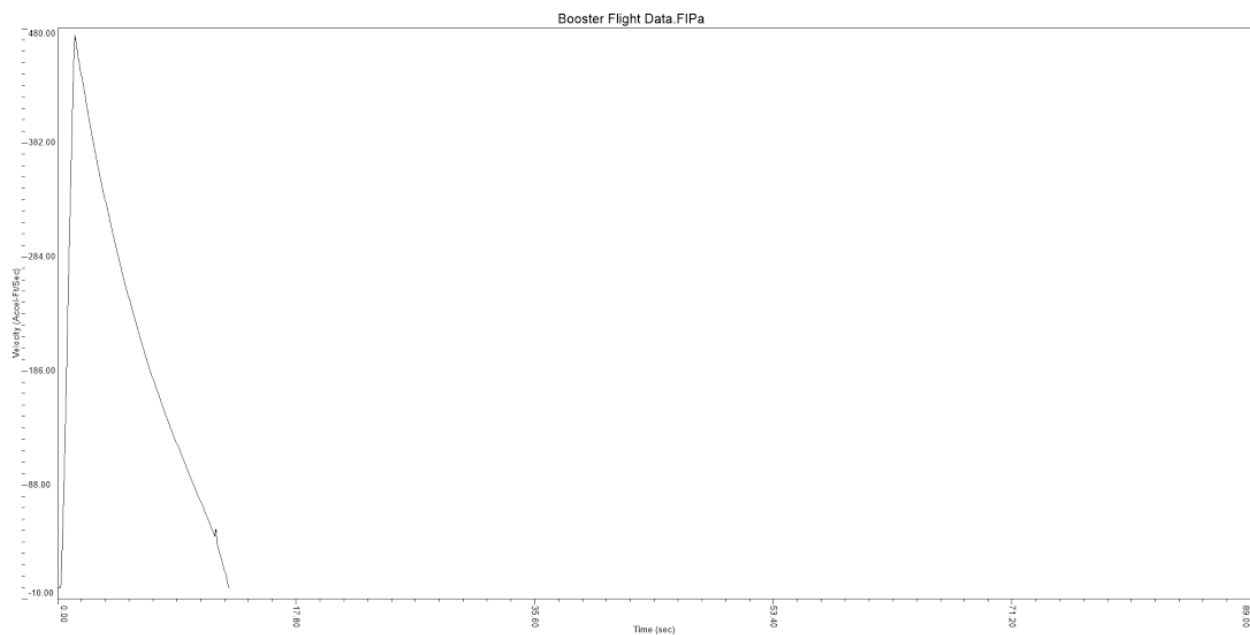
Peak Velocity Comparison

actual: 475 feet per second, as determined by the accelerometer

predicted: 568.6 feet per second

The peak velocity value of the booster for the competition flight was 475 feet per second, compared to the 568.6 feet per second predicted velocity value for the booster acquired by the computer simulation. The difference between these values is 94 feet per second, with a margin of error for the peak velocity of -19.8%. This value is fairly small in comparison to the other problems that this flight faced. It is interesting to note that the margin of error for peak velocity

of -19.8% is very close to the peak altitude margin of error value of 22.9%. These values are likely closely linked and are therefore very similar. The reason that the peak altitude margin of error mimics the peak velocity margin of error is that neither of these measurements take the curved trajectory of the booster and dart into account. Similarly to the peak acceleration, the peak velocity of the dart is also equal to that of the booster for both the actual and predicted flights. This means that all that was discovered about the peak velocity for the booster also holds true for the dart.
