# Post-Flight Report

University of Wisconsin - Platteville

Pioneer Rocketry

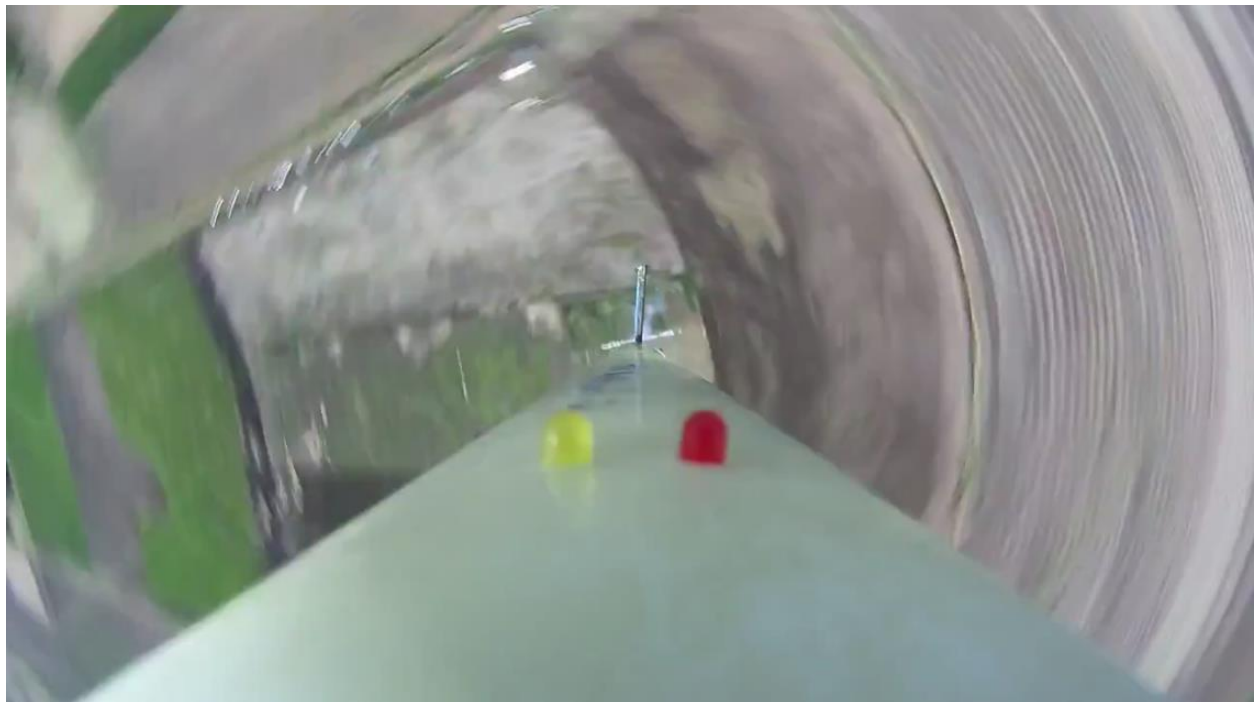
There were a few anomalies during the competition flight of the rocket. The first was excessive spin. All rockets have a spin inherent in the system. The rocket should have had minimal spin because we zeroed the fins and flew in a “dumb” configuration, with how accurately we aligned the fins before launch, the spin on Mr. Rogers should have been minimal. After analysis, excessive spin may have been due one of the collars on a fin’s shaft slipping. This is one of the major problems we have had throughout the project. The grub screw that holds the D-profile shaft into place will become worn down, or break, after repeated use. We believe this may have been the case during launch, and as a result, one of the fins shifted. In Figure 1, the excessive rolling can be seen.

*Figure 1 Mr. Rogers rolling quickly during ascent.*

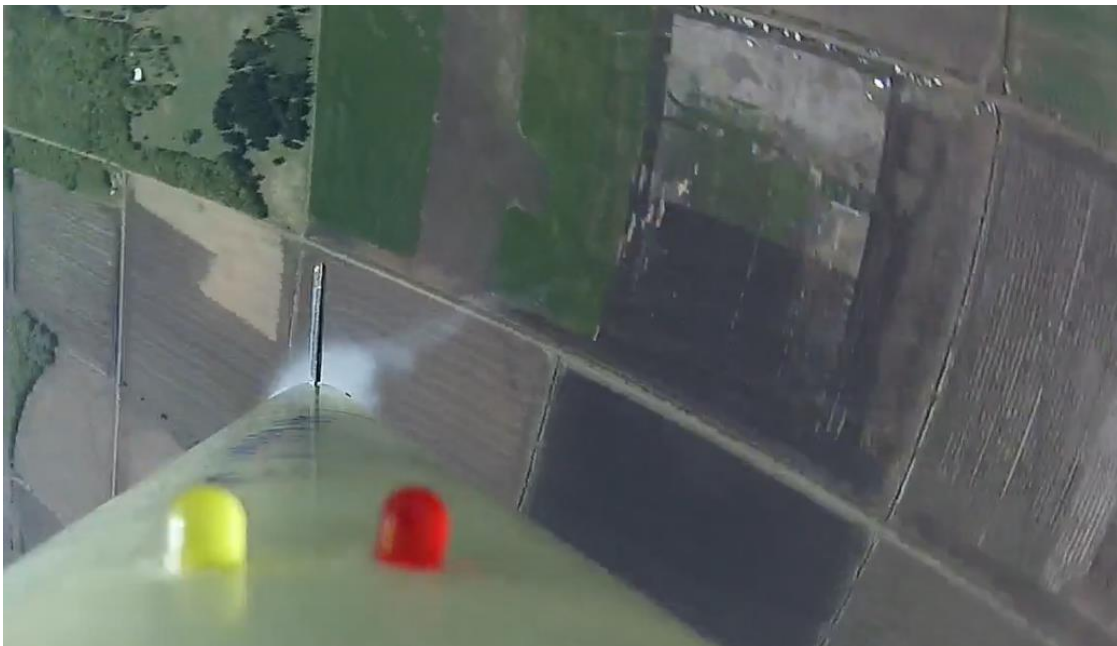
The trajectory of the rocket was nominal. Mr. Rogers did not experience a lot of weather-cocking during the flight, which might be due to the excessive amount of spin experienced by the rocket and the low winds during the launch. In Figure 2 it can be seen that lateral movement of the rocket during flight was minimal. The rocket reached an apogee of 2911 ft, which is under the goal apogee. We believe a considerable amount of energy was transferred into the rocket's spin, which made the fins act as air brakes.

*Figure 2 The rocket at near-apogee with the launch site visible.*

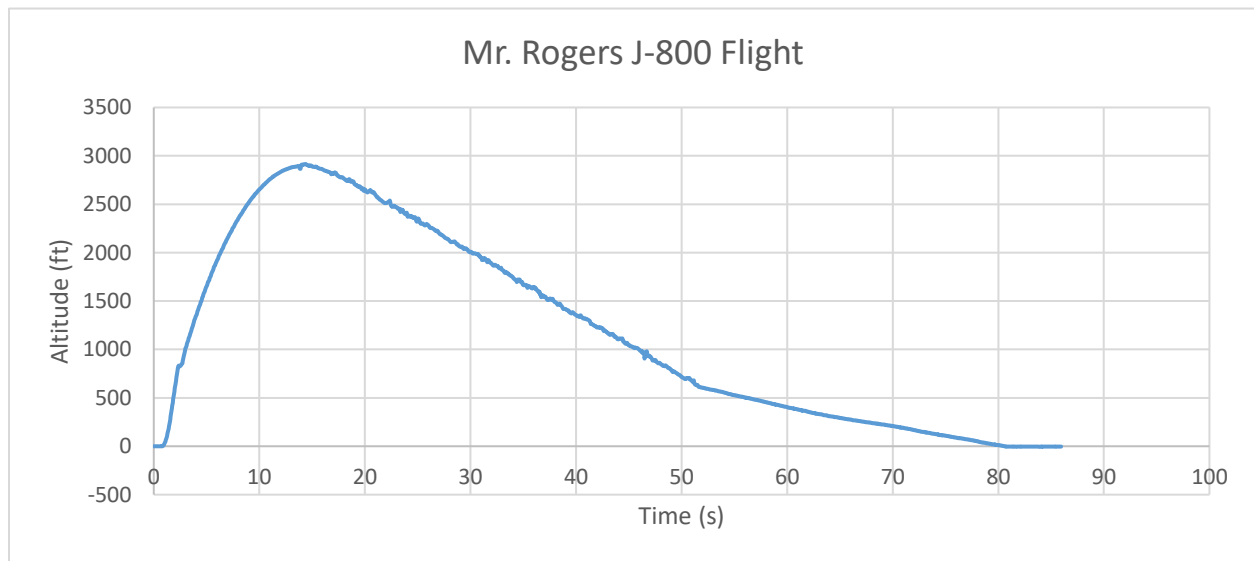
The flight plan for Mr. Rogers included deployment of a 48 in. drogue at apogee, with a 60" main deploying at 700'. drogue at apogee, with a 60 in. main deploying at 700 ft. The recovery system worked as expected. Figure 3 shows the graph of altitude vs time of the flight. After apogee, the rocket descended at 61 ft/s on the drogue. While on the main parachute, the rocket descended at a safe 21 ft/s.

*Figure 3 Plot of Mr. Rogers altitude throughout the flight.*

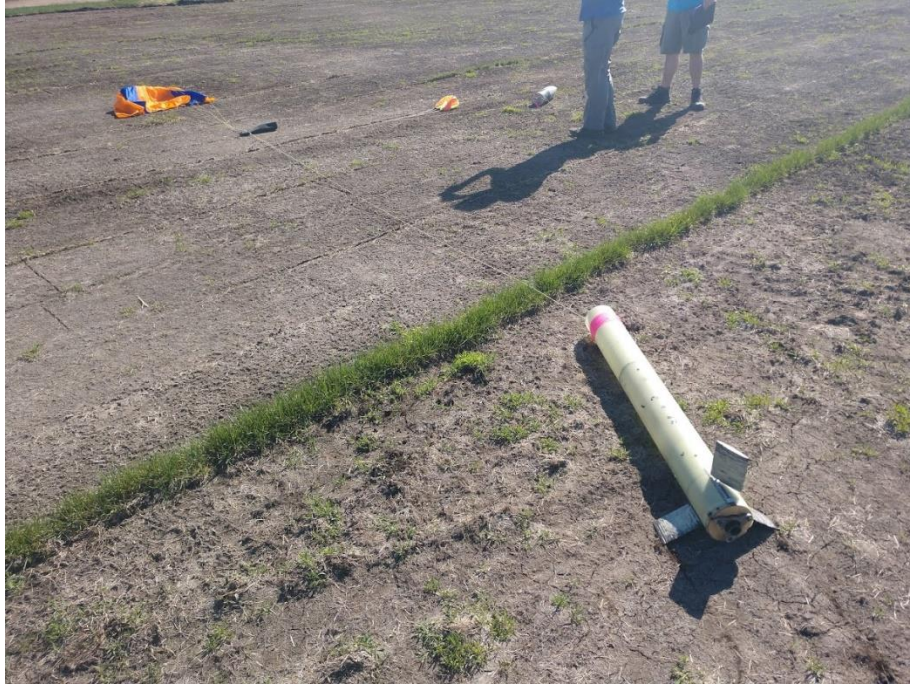
The rocket landed only a few meters from the launch site and in good condition. During recovery, the fins appeared to be broken. This was only because they were deactivated. The power to the servos was entirely removed during chute deployment. This behavior can be seen in Figure 4, as the fin was no longer being held in alignment.

*Figure 4. The landed rocket before recovery.*

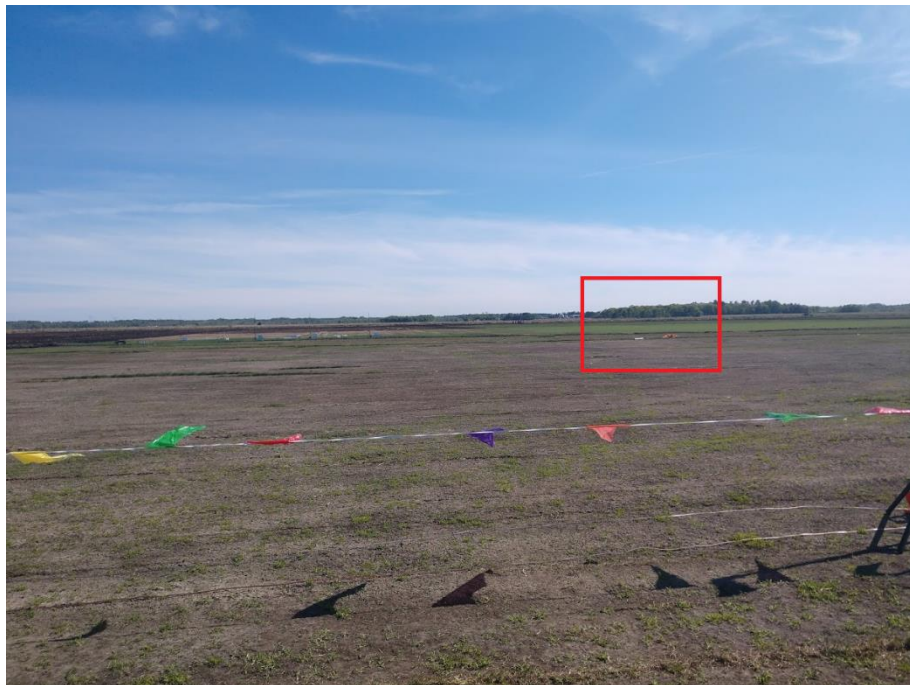
The landing site of the rocket was only a few meters from the launch area. The distance between the landing location and the launch rods can be seen in Figure 5. This allowed for a speedy and easy recovery.

*Figure 5. The rocket landing spot in relation to the launch rods.*

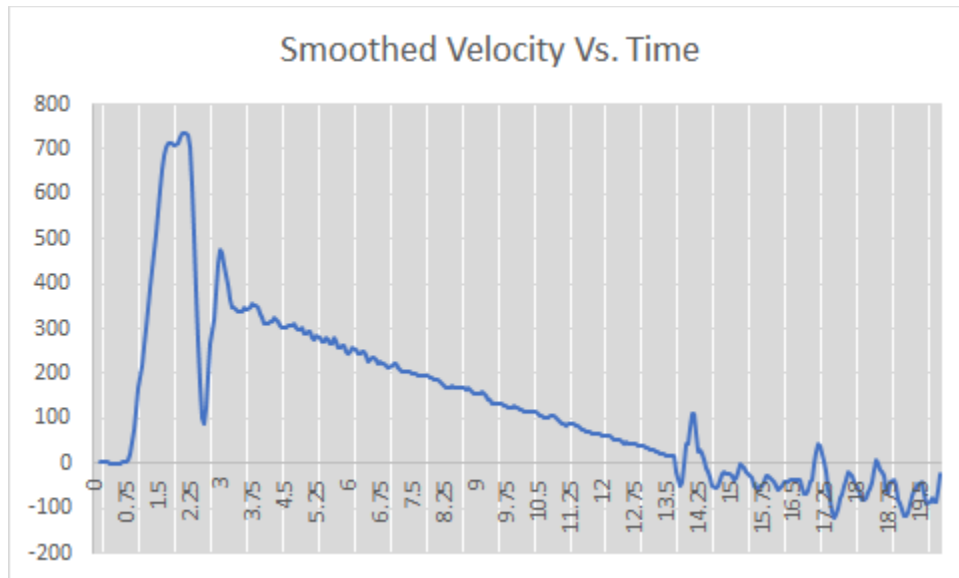
The peak velocity derived from altimeter data shows a maximum velocity of 750 ft/s. The simulations of Mr. Rogers on the J800 predicts a maximum velocity of 566 ft/s. Noise was removed from the raw altimeter data by applying a moving average filter to the data. The rate of the smoothed altimeter data was then found, and the maximum data point is 750 ft/s.

Figure 7. Smoothed velocity derived from smoothed altimeter data using boxcar averaging every three values for the first 20 s of flight. The maximum velocity of 750 ft/s was reached approximately 2 s into the flight.

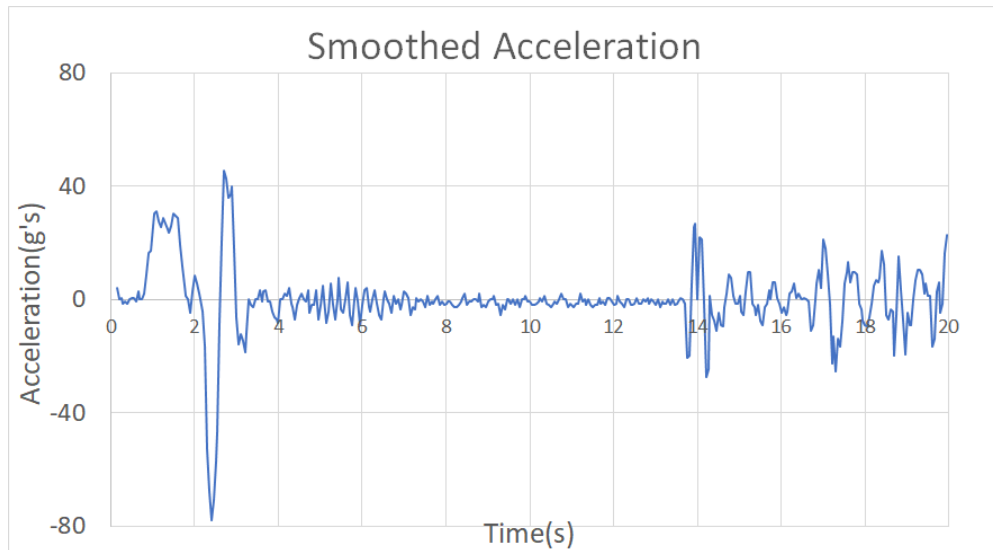
The open rocket simulation estimated a maximum acceleration of 17.8 G. However, looking over the altimeter data we retrieved, the maximum acceleration was actually 77.8 G. This is assumed to be an error caused by noisy data. The velocity and acceleration can be seen in Figures 7 and 8, respectively.

Figure 8. Smoothed acceleration derived from smoothed altimeter data using boxcar averaging every three values for the first 20 s of flight. The maximum acceleration of 77.8 g was reached approximately 2.25 s into the flight.

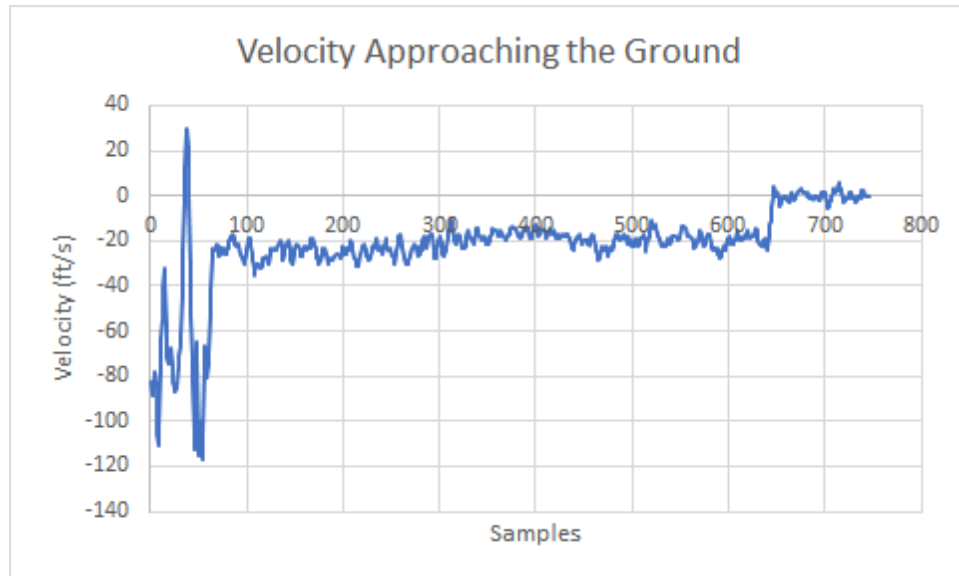
Figure 10. The final moments before Mr. Rogers landed.

*The average velocity just before hitting the ground was 20.5 ft/s, which was within 1.2 ft/sec of the predicted value.*
