Exocoetidae

Illinois Space Society

May 9, 2018

Post Flight Report

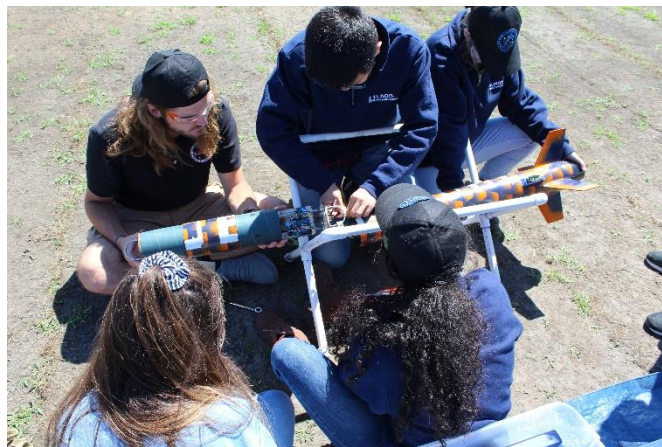
During the first attempt to mount the rocket onto the launch rail, the team noticed the rotary switch holes (which are further described in the Flight Readiness Report) did not correctly align with the rotary switches as intended. After removing the rocket and examining the issue - seen in Figure 1 - members found the avionics sled to have been positioned further down the length of conjoining threaded rod, which resulted in a change of the rotary switch locations. After readjusting the avionics bay, reassembling the rocket and testing the rotary switch holes again, the *Exocoetidae* was mounted once more on the rail and ready for launch.

Figure 1: Team Troubleshooting Prior to the First Flight

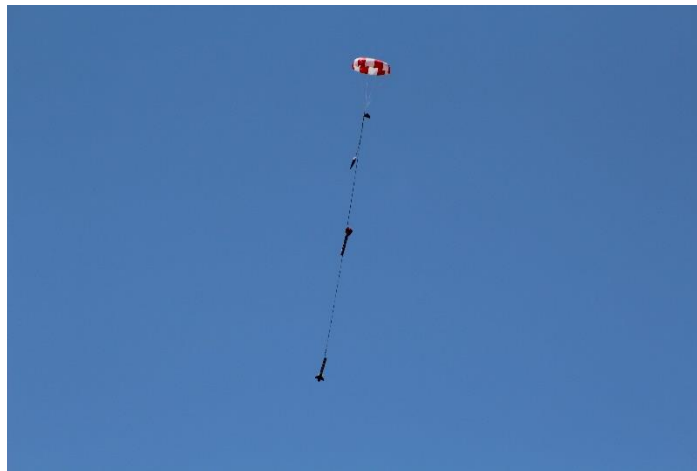
Detailed in FRR, the coded main deployment heights were 600 ft AGL for the primary Stratologger and 500 ft AGL for the backup altimeter. The team has reason to believe the main chute deployed as a result of the backup ejection charge – therefore, at 500 ft AGL. Recovery of the rocket revealed that primary main ejection charge was not ignited, and subsequent examination of the Stratologger data showed that maximum current across the primary main charge was only 1A instead of the typical 4 or 5 amps. The rocket and shock cord system remained intact and reached the ground at a descent speed of 18.505 ft/s.

Figure 3: Rocket Post-Main Deployment during Flight 1

The sole detected flight anomaly occurred during the first competition flight with an unexploded ejection charge. Upon undergoing ground recovery, the team discovered the main chute’s primary ejection charge did not go off, while the backup had. Members believe there to have been a minor break in the altimeter's continuity, as witnessed on the ground computer during that portion of the launch. After checking the Stratologger data, however, the loop still experienced 1.0 ampere of current during this time, so the team's explanation was most likely incorrect. Individuals are still in discussion to explain the anomaly. The situation, nevertheless, was handled safely and appropriately, and the rocket did not experience any damage as a result.

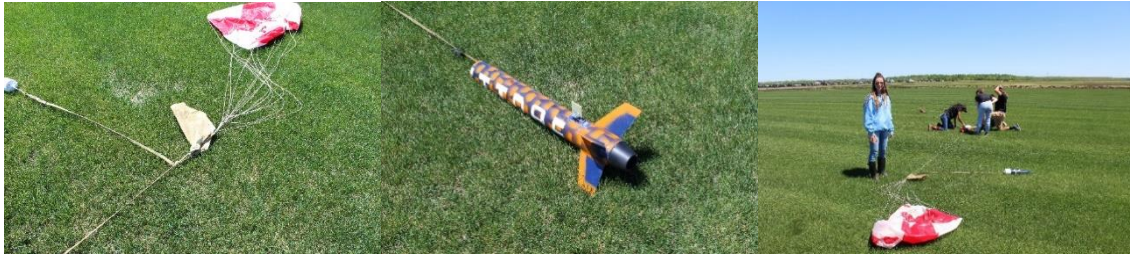
The rocket fell within the team's line of sight, so while the tracker was attached to the booster tube's length of shock cord, the team did not have to use the device to detect location. As seen in Figure 4, all rocket components were in good shape to be flown again. According to the launch procedures, as found in Section 1.4, the team checked for any unexploded black powder charges and found the main's primary to be active. More information regarding this anomaly can be found in Section 1.5. After listening for the appropriate beep sequences, members safely removed the charge and prepared the *Exocoetidae* for the subsequent flight.

Figure 4: Recovered Rocket Components (Left and Middle), Team Examining Condition (Right)

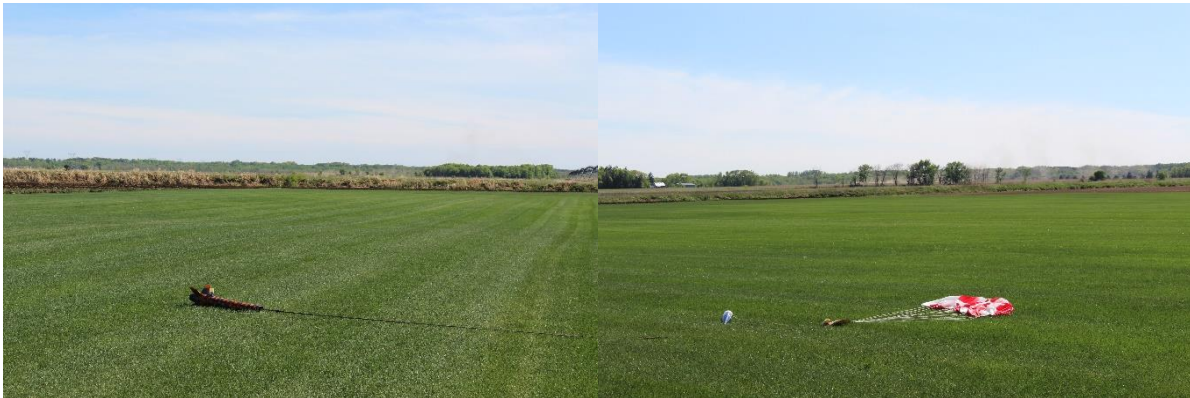
Figure 6: Ground Recovery After Flight 2

Once more, the rocket fell within the team's line of sight, so members did not utilize the tracker. The *Exocoetidae* landed in nearly the same location as it did during the first flight. As seen in Figure 6 above, the rocket did not experience any damage and correctly followed through the recovery timeline. After submitting the necessary information to the judges, the team disassembled and stored the rocket after a successful launch day.

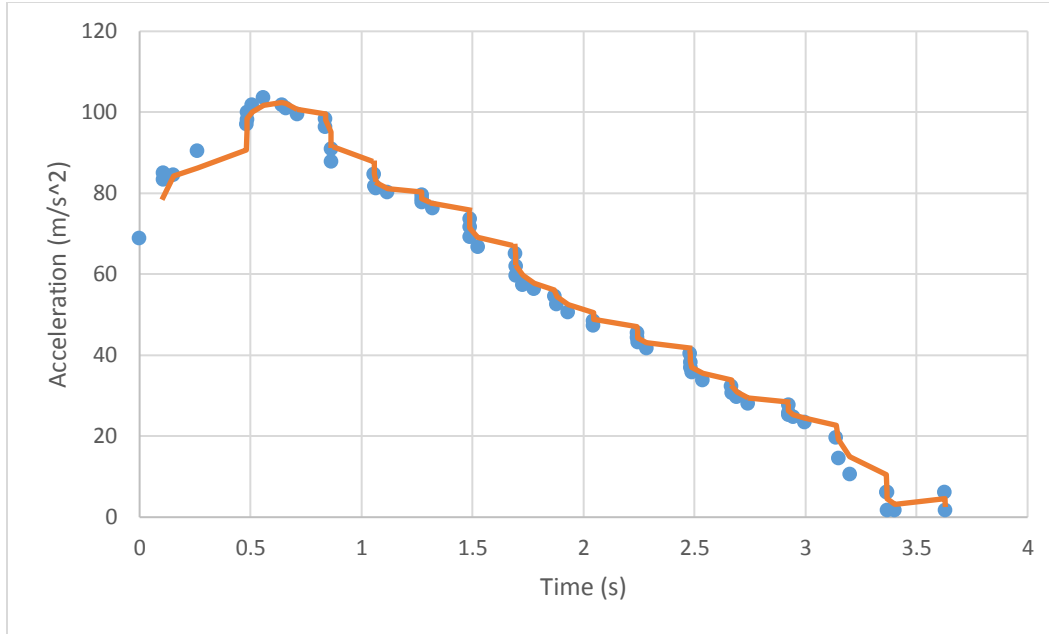
Figure 9: Acceleration vs. Time - Flight 1

The measured maximum acceleration of 103.63 m/s^2 was significantly greater than Stratologger measurement of 62.73 m/s^2 . While motor performance variations may have partially contributed to the outcome, it is unlikely that performance variations of 65% occurred. Sensor errors are likely, therefore, to be the greatest source of error. During extensive testing in the weeks leading up to launch, the team found that accelerometers returned approximately $1/8^{\text{th}}$ of the expected acceleration. A hard-coded fix was applied to scale up measurements from the accelerometer. While errors were scaled up also, they still deviated less than 0.2 m/s^2 , as demonstrated by the previously mentioned acceleration measurements on the launch pad. Non-linear scaling could explain the large deviation, meaning at greater accelerations the measured value might be greater than $1/8^{\text{th}}$ of the actual value. It is also possible that the accelerometers become significantly less accurate at higher acceleration values, although they were rated up to $16g$'s.

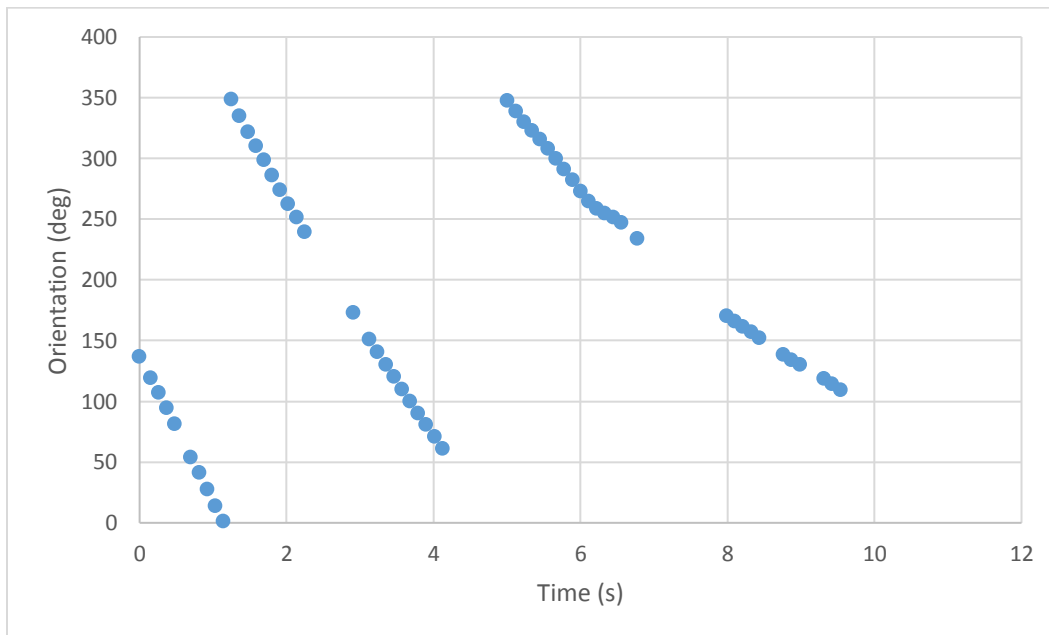
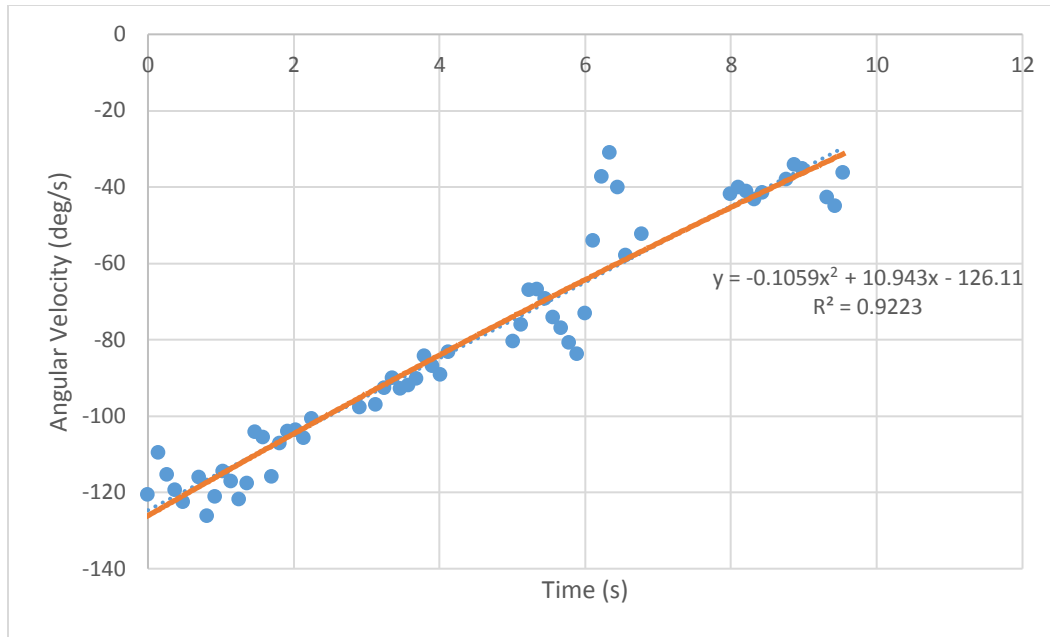
Figure 10: Vehicle Orientation Over Time - Flight 1

Figure 11: Angular Velocity Over Time, Flight 1

Downlink data indicated that upon motor burnout the vehicle immediately detected apogee by sensing an over 90-degree tilt around the x-axis. This is incorrect since the rocket did fly nominally, and the root issue was traced to faulty integration methods used in the code for while the rocket was standing by on the launchpad.

Premature apogee detection also resulted in the vehicle failing to calibrate its control flaps, which was a planned step that would happen after the 3-second idle time post-burnout. The purpose of this step was to identify the true "neutral position" for control fins where no net torque was induced, such that the controller would give more accurate outputs. The lack of such calibration caused the flaps to have an incorrect neutral position that induced a small torque along the negative z-axis, causing the vehicle to rotate clockwise, as seen in the video.

The graphs shown are orientation data and angular velocity plotted over time. The vehicle exhibited a smooth clockwise rolling motion (clockwise defined as negative rotation by the right-hand rule) that gradually slowed down. This is due to the deceleration of the vehicle, thereby decreasing velocity such that control flaps exhibited less authority over the roll of the vehicle.

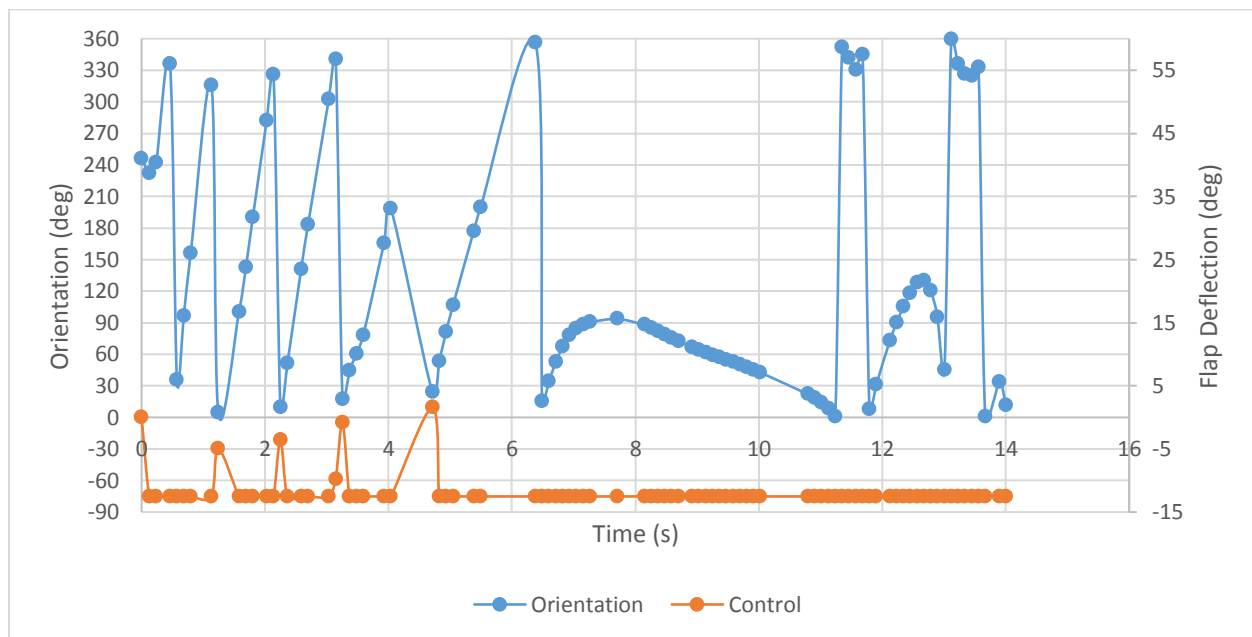
Figure 13: Vehicle Orientation and Control Over Time – Flight 2

As noted in 3.1.2.2, the data shown for Flight 2 was wrapped around when they exceeded the 0-360 degree limit. A critical disagreement between camera footage and XBEE data was noted – while the downlink data indicated that the vehicle was rolling counterclockwise, camera footage showed the vehicle rotating clockwise at the beginning of launch. The same code was used to integrate angular velocity for both Flights 1 and 2, yet only Flight 2 had the issue. The team has yet been able to identify the cause of negation.

The negation of orientation mostly likely cause the controller to apply force in the opposite of the intended direction, thus accelerating the vehicle's roll instead of regulating it. It may be seen, however, that the vehicle's roll was reduced when approaching alignment with "North," the first command. Nevertheless a stable and correct orientation was not achieved, and thus the controller never moved past the first command.

Apogee was not detected. The team had used a timer to forcibly prevent apogee triggers before 10 seconds of flight as extra precaution, but as previously mentioned, the timer issue that most likely caused LED and idling failures recurred and prevented the apogee trigger. The vehicle descended with controls locked to maximum counterclockwise.
