MEMORANDUM

From: Bulldog Rocketry

Subject: Bulldog Rocketry 5-2-15 Test Launch Summary

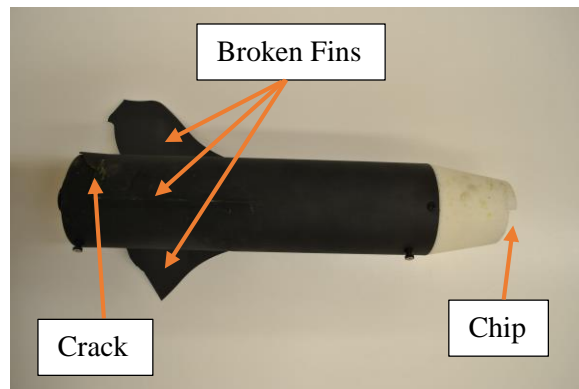
Figure 1: Post-flight booster with broken fins/reducer

brought about speculation of an insufficiently stiff fin. The thickness of the PA 802-CF fin material used (1/16") was less than needed and all the fins could be easily deformed by hand. The atypical shape of the fin design did not help this but it can be seen in Figure 2 that the dart fins of the same design survived impact well. The minimal thickness and exaggerated booster fin size resulted in an unstable flight path as each fin flexed in the crosswinds, creating unpredictable pressure differentials rather than stabilizing the rocket.

The booster chute came undone from the booster body upon deployment due to a faulty knot. The booster then fell from an estimated 670 feet before impacting the ground. It fell on its side with considerable force shattering the booster and reducer upon impact.

The booster is going to be redesigned and built using the Blue Tube. Redesign will require accommodations needed in order to keep the rocket stable since Blue Tube has a greater mass per unit length than the PA 802-FC. Additionally, since the booster will increase in mass and change the center of gravity (CG) location, the fins will be required to increase in size in order to move the CP and make the rocket stable. For this reason, the booster fins are going to be a traditional fin design, since it will be possible to get a greater surface area with slightly smaller fins than those of the bulldog legs. This will also assist in keeping the fins rigid and thus reduce any chances of fin flutter.

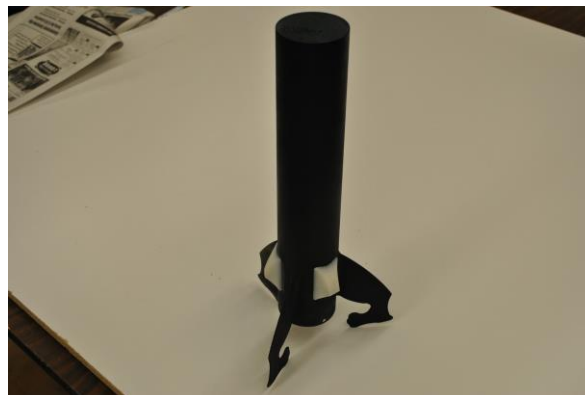
Figure 2: Intact dart Post Flight

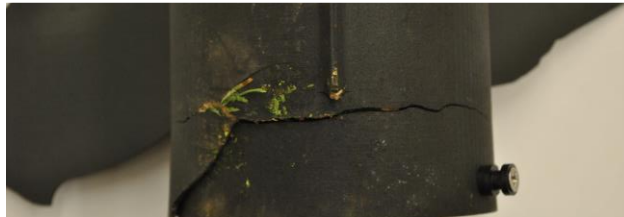
Figure 4: Detail View of Booster Body (PA-802-CF) fracture due to impact

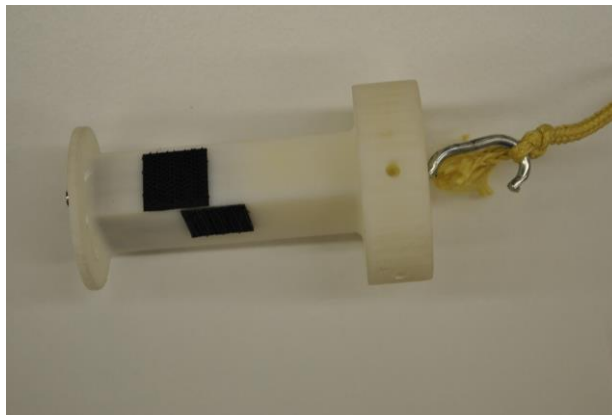
The dart separated as planned but both shock cords for the parachute and dart body were tied in the wrong configuration, putting more stress on the I-bolt located in the nose cone than intended. Figure 5 below shows the deformed I-bolt with the chute cord for the nose cone still attached.

Figure 5: Deformed I-bolt holding nose cone to dart/parachute

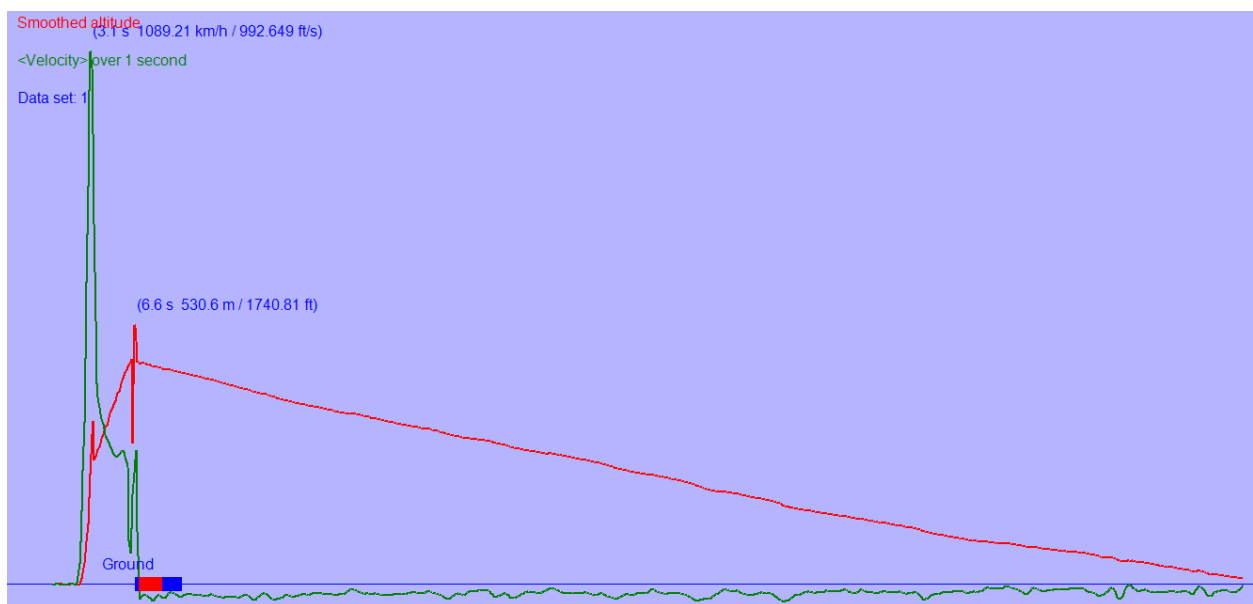
explain why the Altimeter Two in the dart reported a lower altitude of 1,555 feet than that of the AIM USB 3.0, which was 1,740.8 feet. The AIM USB 3.0 is capable of much higher g-forces than the Altimeter Two's. Additional support that there was something happening to the Altimeter Two's is that the booster's parachute was deployed at 53 feet and the dart's at 29 feet, which was visually confirmed during the launch to not be correct. It is also confirmed looking at the graph from the AIM USB 3.0 (Figure 6), which shows the nose cone coasting down at a steady descent rate. The AIM USB 3.0 only indicates the maximum flight velocity and altitude in terms of actual data points, the remaining information is represented by a graph.

Figure 6: Dart velocity profile (green line) & altitude profile (red line)
