inVenTs High-Power Rocketry

Virginia Polytechnic Institute
and State University

Wednesday, May 30, 2018

Flight Anomalies Analysis

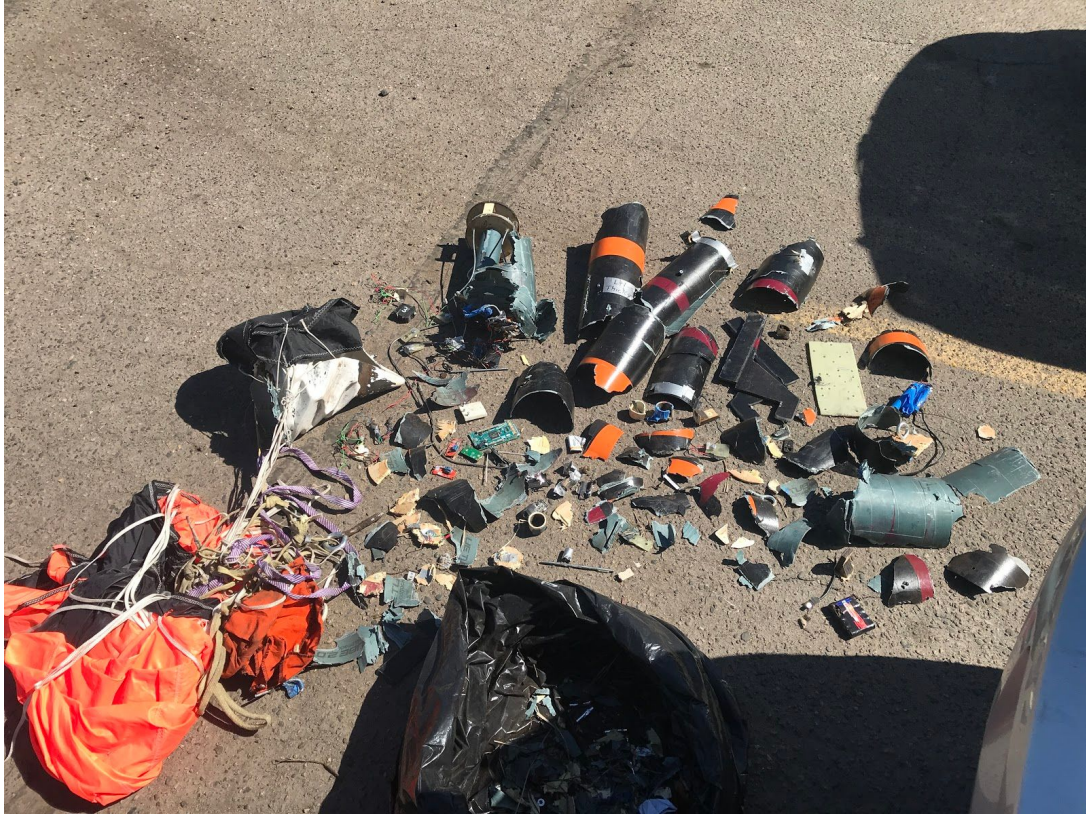
Unfortunately, during the competition launch on May 20, the inVenTs High-Power Rocketry Team was unable to successfully recover the rocket. Although the rocket launched beautifully, and more than likely performed the required functions properly, the parachute failed to deploy causing the rocket to slam into the ground and shatter into a thousand pieces. Figure 1 shows the remains of the rocket.

Although there is no way to tell for certain, the parachute deployment failure was likely caused by a wiring issue between the stratologger and the ejection charge or the stratologger itself. As a result of the safety inspections on Saturday night, the ejection charges had to be rewired to the stratologgers through the outside of the rocket body. Previously, the ejection charge was wired directly to the stratologger without a key switch or alternative way to arm it on the launch pad. By wiring it through the outside of the body tube, it was possible to arm it on the launch pad thus making it considerably safer. This is likely where the error began.

On Sunday morning at the launch, it was discovered that only one of our stratologgers was working. Ordinarily, the team would not have launched with one stratologger as it is a large risk, however, there wasn't an alternative option. Permission was received from the RSO's to launch with one stratologger and the pre-launch procedure was continued. The correct amount, 5 g, of black powder was placed in the ejection charge cap and properly sealed. After the rocket was set-up on the launch pad, the stratologger beeping sequence was checked and the rocket was ready for launch.

Figure 1. The rocket remains after launch.

As previously stated, although there is no way to tell for certain where things went exactly wrong, everyone on the team learned an important lesson in preparing better prior to launch. Had our ejection charge/stratologger arming system been set up properly to begin with, we would have had more time to make the appropriate changes and check to ensure both stratologgers were working in advance. In the future, this team will be much more prepared to handle unexpected setbacks.
