Submitted 5/12/2014

## UMD Flying Bulldogs: Post Flight Report

# Failure Analysis

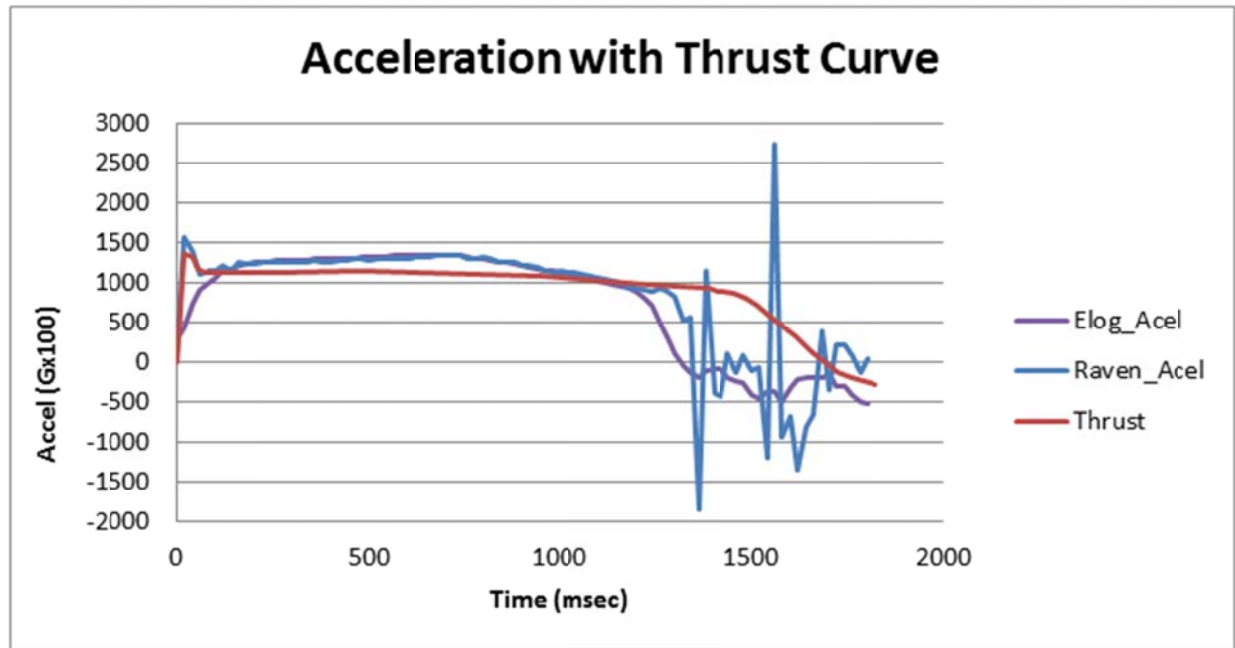
As the rocket ascended up the launch rail another whole fin was detached completely from the lower section. Once off the rail and in the air, a combination of wind, instability from losing fins, and loss of upward acceleration caused the flight path to abruptly change directions in the air. Figure 1 shows the acceleration as measured by the Raven III and the eLogger accelerometer. A spike in acceleration can be seen at the time of the abrupt change in direction from the Raven III, eLogger, and Stratologger altimeters. The change in direction caused the shear pins to shear, and allowed the bottom section of the rocket to detach, which was the catastrophic failure. Upon separation, the drogue chute caught the air at a high speed and was torn from the parachute cords. The separation caused the instrumentation to misread the altitude,

**Figure 1:** Predicted vs. Measured Acceleration

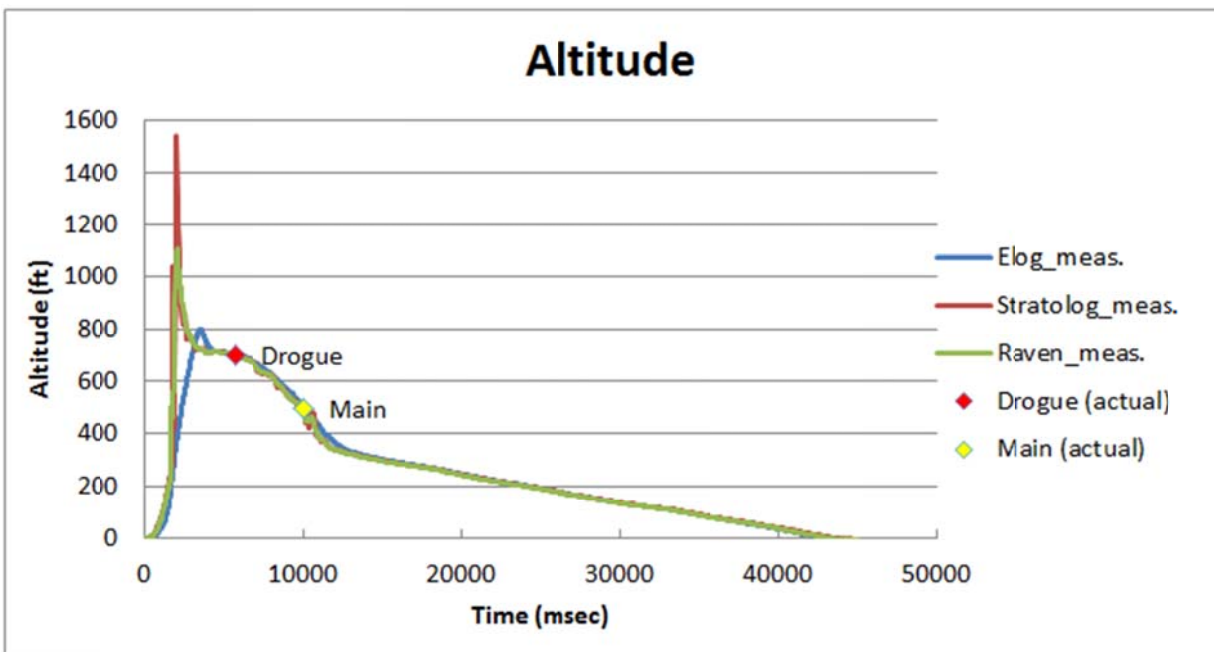
which resulted in a spike in the data. This spike can be seen in Figure 2, which shows the altitude data from the Raven III, eLogger, and Stratologger altimeters. It can also be seen that all three instruments were in agreement with the overall flight path. Note that the predicted altitude was removed from Figure 2 so that the measured data could be seen more clearly. Due to the failures throughout the flight, the predicted and measured altitudes were not in agreement.

**Figure 2:** Measured Altitude

The official apogee altitude for the Flying Bulldog was recorded as 1,100 ft, however, it is believed that the actual altitude was approximately 800 ft based upon the data collected from the teams' instrumentation. It is believed that even with the instability, the rocket should have reached a higher altitude. When comparing the predicted thrust to the measured acceleration, it can be seen that the motor burned out earlier than expected (see Figure 1). As soon as the acceleration decreased, the flight saw the large abrupt change in direction as mentioned above. The predicted maximum velocity was 500 ft/s, and the Raven III measured a maximum of 470 ft/s. The Pitot - static tube connected to the eLogger only read a maximum velocity of 100 ft/s, which was believed to be an error resulting from dampening integrated into the eLogger data system.

Although the flight was not successful, the instrumentation worked properly, and provided important data for analyzing the flight. Once the eLogger data was compared with the Raven III, it was observed that the general profiles of data would match, but the eLogger did not read the large spikes in data at key points. It is believed that this is due to over dampening within the data measurement system of the eLogger. If the eLogger is used again, action must be taken to lower the dampening characteristic of the component prior to use.

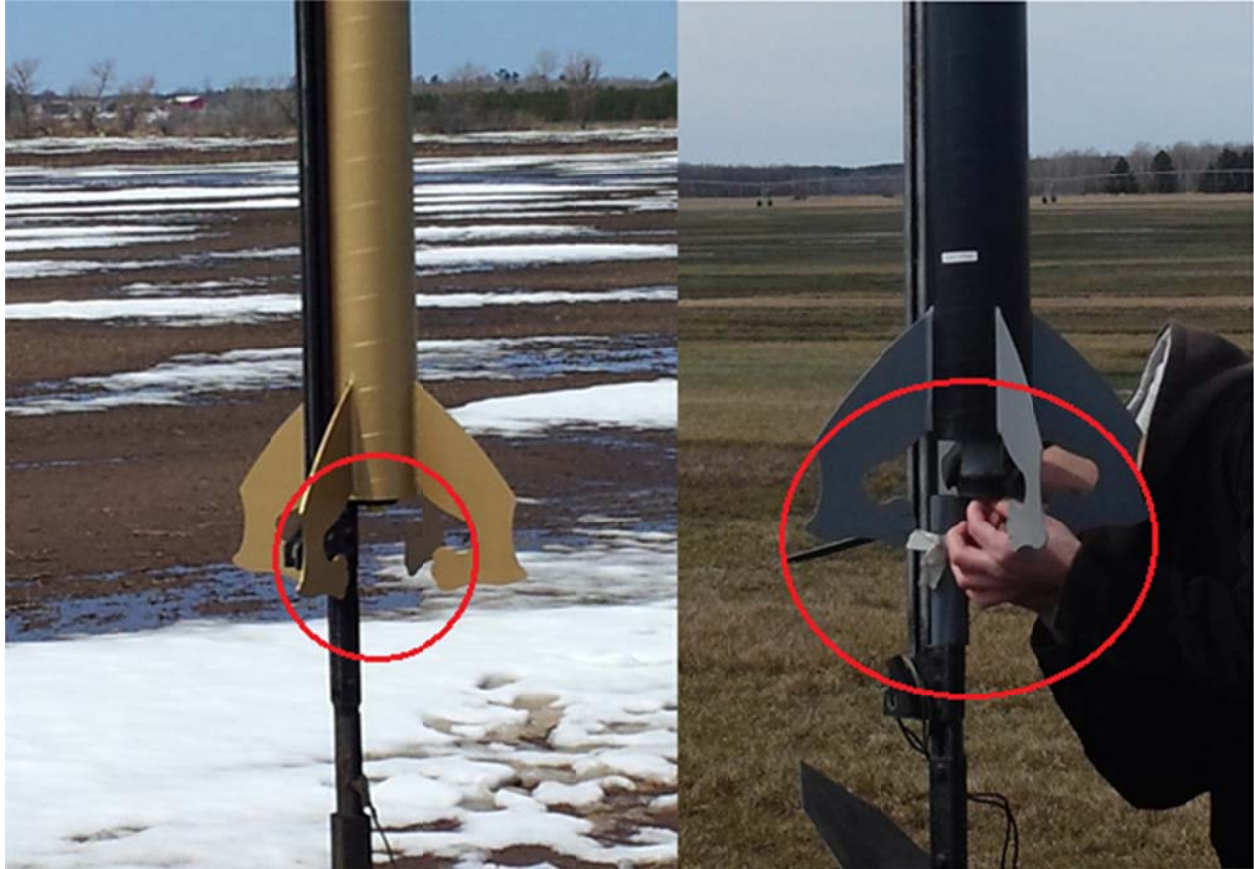
High speed video footage from a GoPro Hero 3, positioned just off the launch pad, revealed that an entire fin plus a piece of another fin was lost as the rocket traveled up the launch rail. Shown in Figure 1 is a side-by-side launch pad configuration between the test launch and the competition launch. A gray PVC “spacer” can be seen in the competition launch configuration, which is not present in the test launch configuration.

**Figure 1:** Launch Pad Configurations of Test Launch (Left) and Competition Launch (Right)

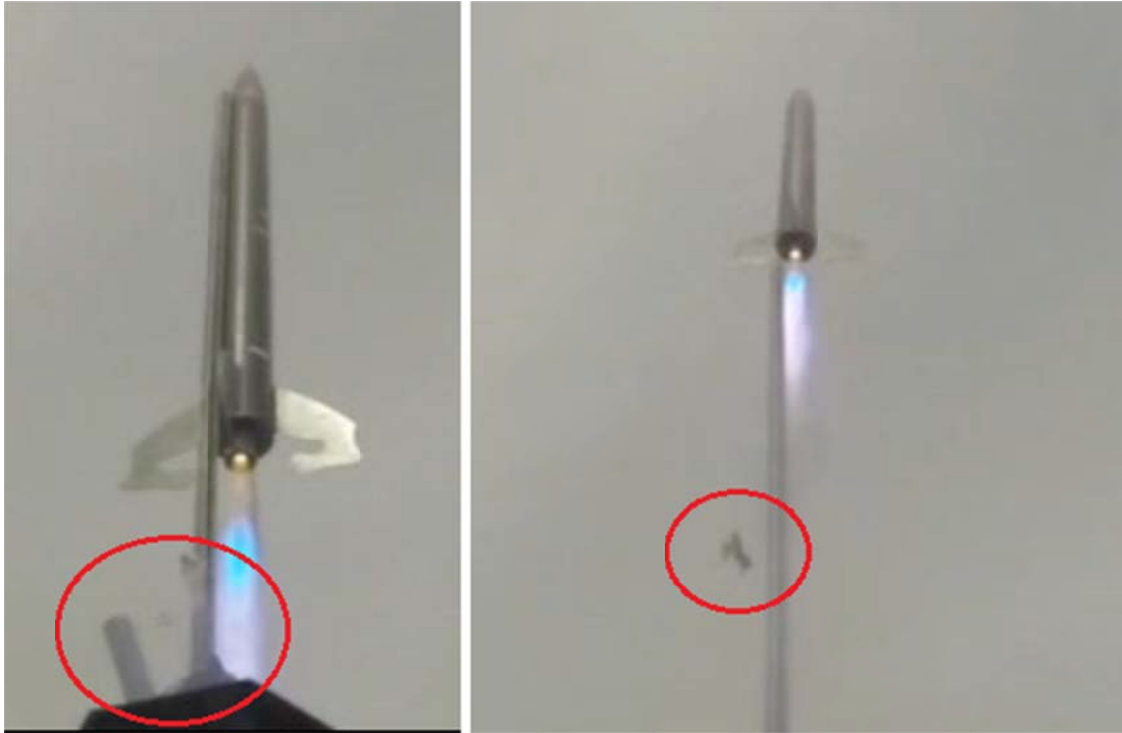
Once the Flying Bulldog was launched, it had a brief flight which ended in catastrophic failure. Almost instantly after ignition of the motor, a gray PVC "spacer" was detached from the side of the launch rail and hurled into a fin. The detachment of the spacer initiated the sequence of events resulting in catastrophic failure.

Figure 2 shows the spacer being thrown from the launch rail, next to a sheared off piece of a fin, along with another full fin that detached farther up the rail. This can also be observed in the slowed down high speed footage captured by the GoPro [1].

**Figure 2:** Separation of PVC Spacer & Part of Fin (Left) and an Entire Fin (Right)

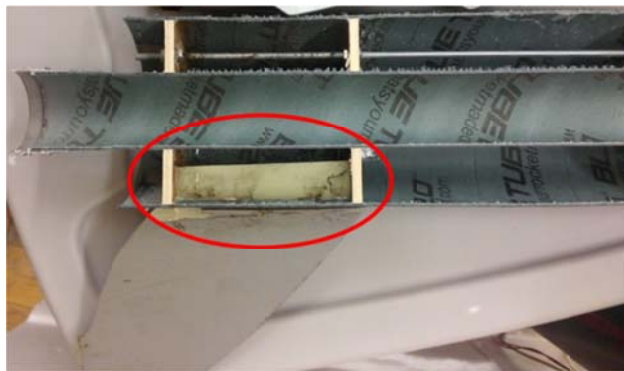
Shortly after the rocket left the launch rail, the instability was clearly noticed. The rocket first did an abrupt side-to-side motion, followed by premature separation. Upon separation of the body sections, the drogue was deployed, which caused an extremely large jerk on the body sections. As a result, two more full fins separated from the body tube, leaving only one partial fin attached to the lower body section.

The lower section of the body tube was rebuilt between the test launch and competition. Upon further investigation, it was found that an old revision of the fin design with a smaller tang was used to water jet cut the new fins. Because of this, the contact area for the epoxy attachment was reduced by nearly 45% as shown in Figure 3. The lack of contact between the fins, motor mount tube, and the centering rings allowed for easier separation of the fins during flight.

**Figure 3:** Cutaway of Lower Airframe Showing Wrong Size Tang

Based upon the analysis, there was multiple failure modes found. Although the failures were initiated by something out of our control, we could have taken better steps to prevent further failures, as the fin size should have been inspected more thoroughly prior to reconstruction.
