Pioneer Rocketry

University of Wisconsin - Platteville

## Post-Flight Performance Report

Midwest High-Power Rocket Competition

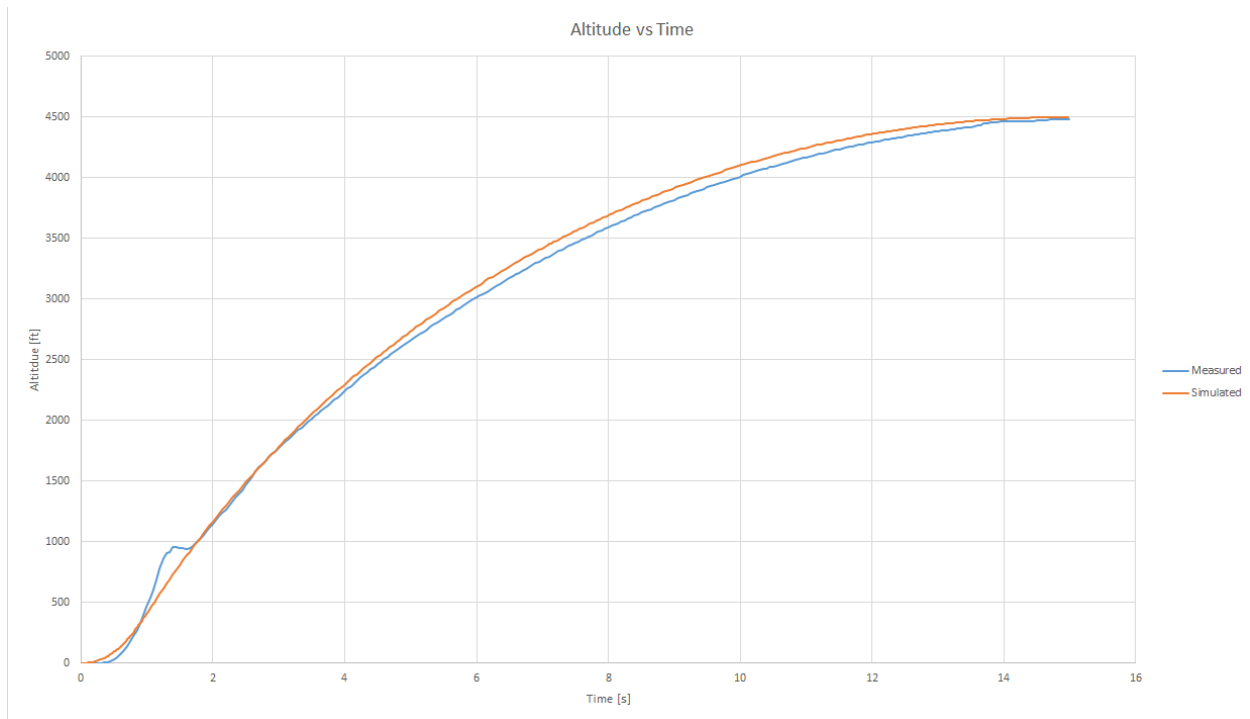
**FIGURE 1: PREDICTED AND MEASURED DART ALTITUDE VS TIME.**

The motor performed exactly as expected. This was determined retroactively, by simulating an OpenRocket launch in which the two rocket stages did not separate. It can be seen in Figure 1 that the simulation of a no-separation launch aligns well with the data collected. Table 1 shows key data corresponding to Figure 1.

Altitude data from the barometer matched very closely to what was measured during flight with the predicted apogee differing from simulation by only 6ft. The velocity data gathered from the accelerometer seemed to be less in magnitude and lag behind the simulated values. By differentiating the altitude data from the barometer a different source for velocity data can be found. While noisy this barometer data matches the simulation better than the

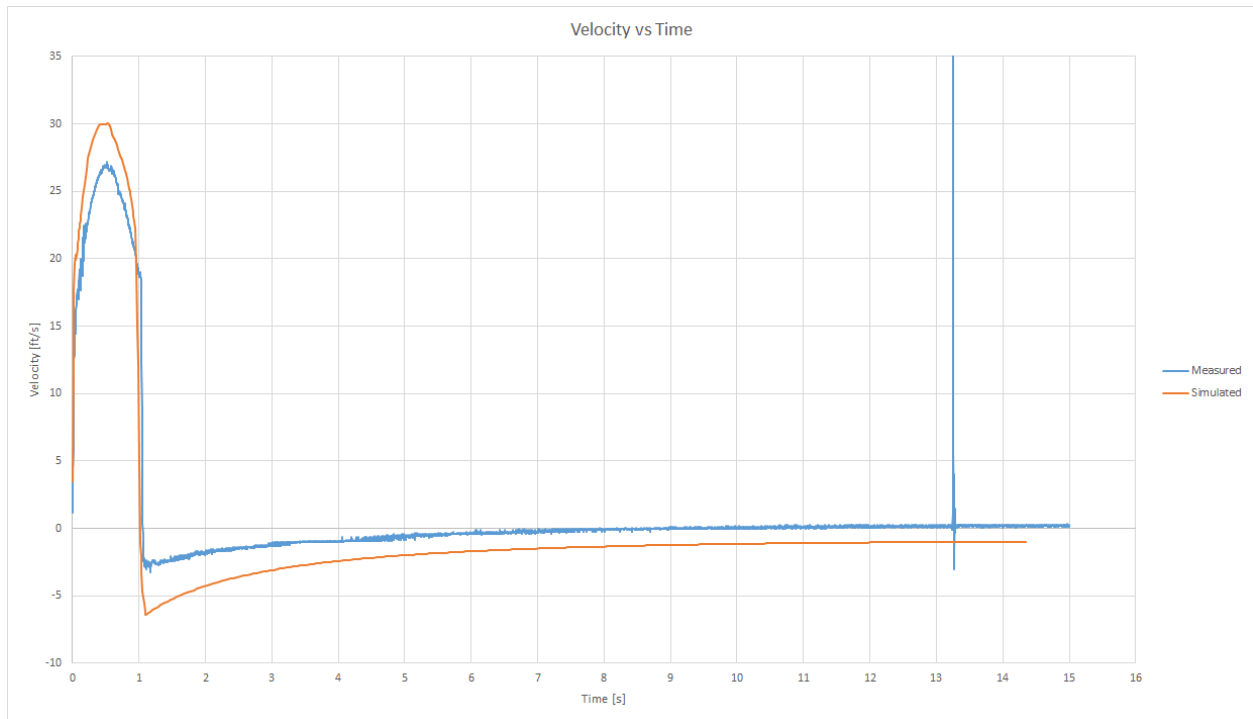
FIGURE 3: PREDICTED AND MEASURED DART ACCELERATION VS TIME.

accelerometer data. The acceleration data closely matches the simulation in shape but the magnitudes are quite a bit different.
