Post-Flight Performance Report

Wichita State University

Team RISE

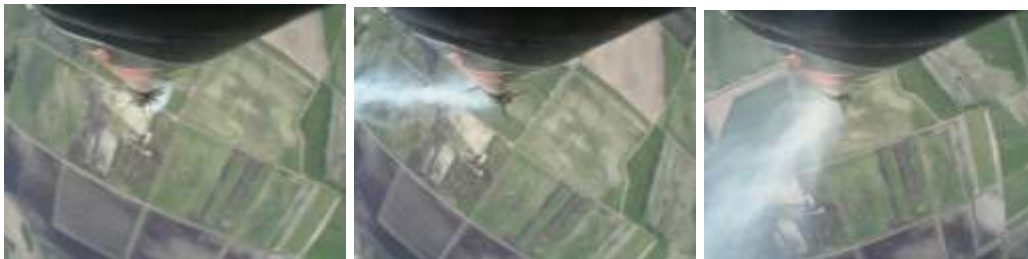
After assessing the damage and rebuilding the necessary parts, we were able to launch a second time. During this second flight, a fixed transition piece was used instead of the drag chute due to time constraints to rebuild and install the drag chute system. Although a safe flight and successful recovery were achieved, the dart failed to separate, as seen in Figure 1, since the transition got stuck under the lip structure that would normally secure the drag chute closed.

Figure 1. *Booster stuck under dart's lip structure during several flight instances.*

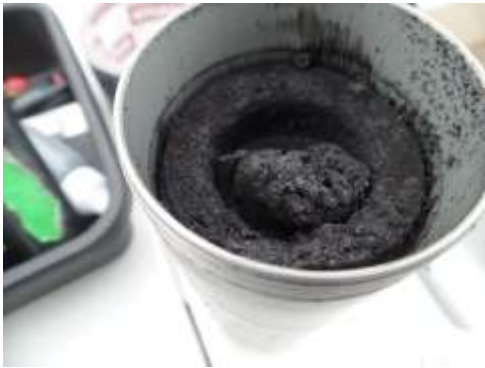
During the first flight, the motor came out of the booster during flight, resulting in a peak acceleration of 31.1 g's registered for the booster. Furthermore, when the motor case was inspected, extra debris, which included some Mylar material clumped within the motor, was observed as seen in Figure 2. Similar damage was observed during the last test flight before competition.

Figure 2. Debris and Mylar clump after first launch.

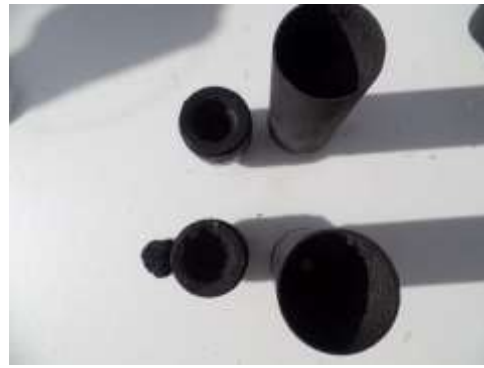
During the second flight, the motor performed close to expected generating a peak acceleration of 29.4 G's for the booster. When the motor case was inspected, no abnormal debris was found, as seen in Figure 3.

Figure 3. Motor after second launch (top) and after first launch (bottom)

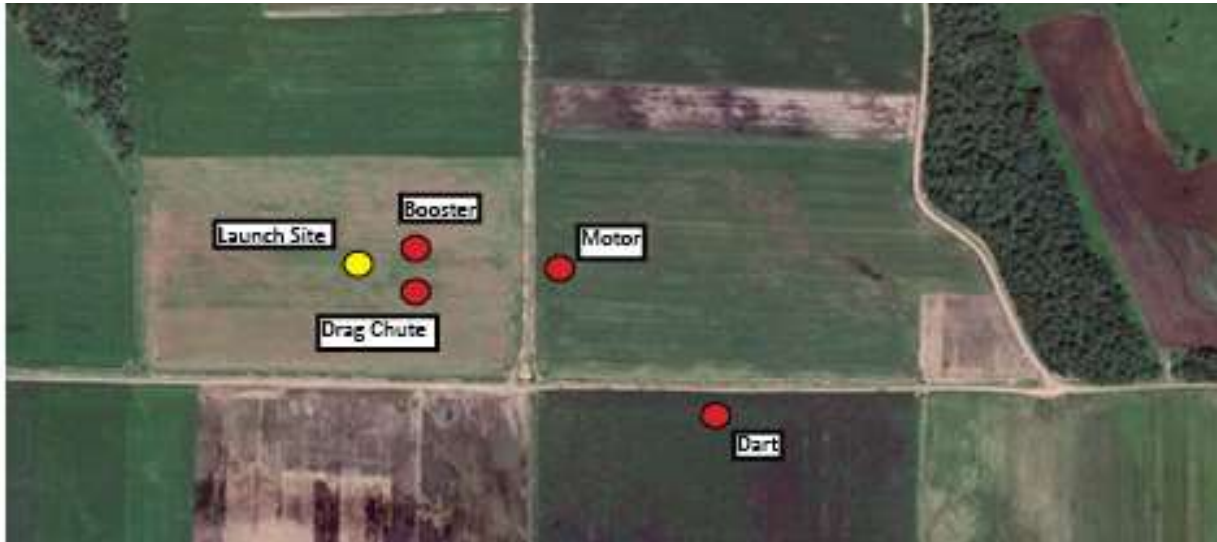
Location for the booster, drag chute, dart and motor after the first launch can be seen in Figure 4. The dart did not suffer any structural damage, and the electronics were fully functional as well. The booster and drag chute suffered severe structural damage which is explained in detail on Table 2.

Figure 4. *Location of recovered parts after first launch.*

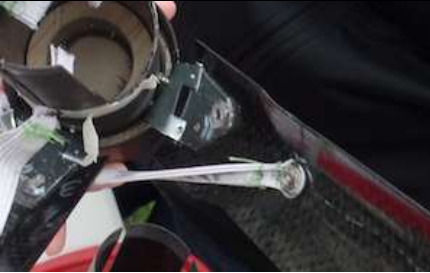
Damage	Possible Cause	Picture
Shock Cord	Stitching ripped apart	Tug force on shock cord after motor fell out of booster and parachute released out aft end.	
Coupler	Zipped along length and sheared in half	Shock chord zippered coupler first weakening structure then sheared in half at joint due to the hyperstability of booster.	
Petal Hinges	Hinges bent causing structural damage to the carbon fiber booster body tube section	Unexpected high loads were imparted on to the drag chute system.

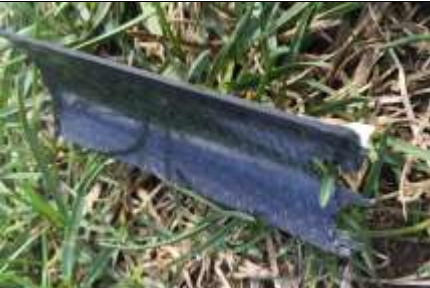
Cup	One of the sections where the boattail normally rests sheared off	Broke during impact on the ground.

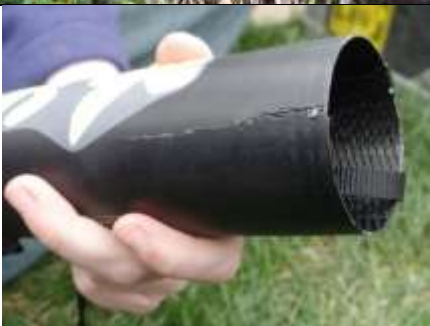
Booster Body Tube	Crack along length	Zipper effect on body tube due to tug force from shock chord.

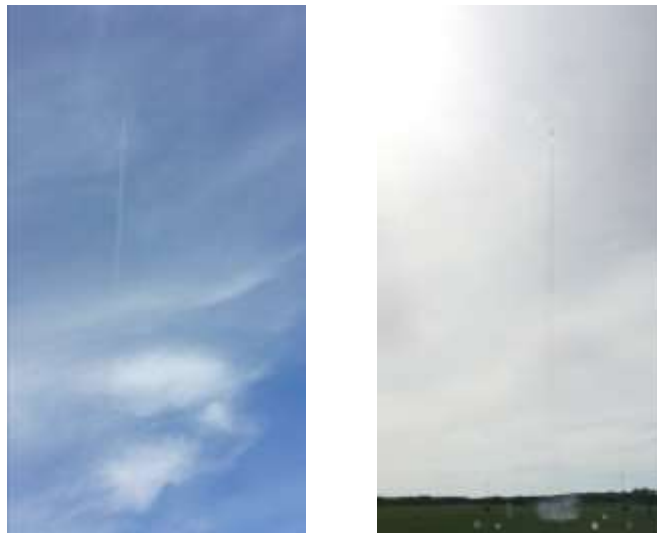
Both flight paths during ascent were consistent and straight as seen in Figure 6. During descent, flight path for the first flight is inconsistent due to the motor friction fit issues. Nevertheless, for the second flight, the recovery locations for both the dart and booster were consistent with the wind direction.

Figure 6. *Flight paths during ascent for first (left) and second (right) flights.*

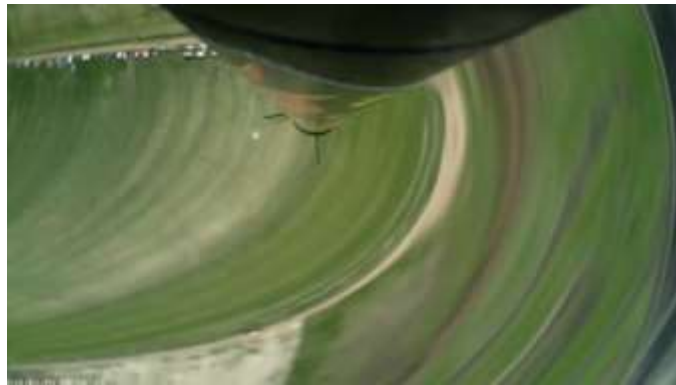
On-board video was successfully recorded during both launches with a direct downward view using the 808 Keychain Camera with a lens mounted externally to the dart using an extender cable. This camera records HD footage at 30 frames per second. The launch pad is visible during the entire ascent. Separation and dart parachute ejection could also be easily viewed in the footage. Figure 7 is an example screenshot from the on-board footage. For part of the flight where rotation was significantly higher (approx. >5rps) the video became warped and curved as seen in Figure 8.

Figure 8. *Distorted footage from high rotation rate.*
