INCIDENT REPORT

Planned Mission

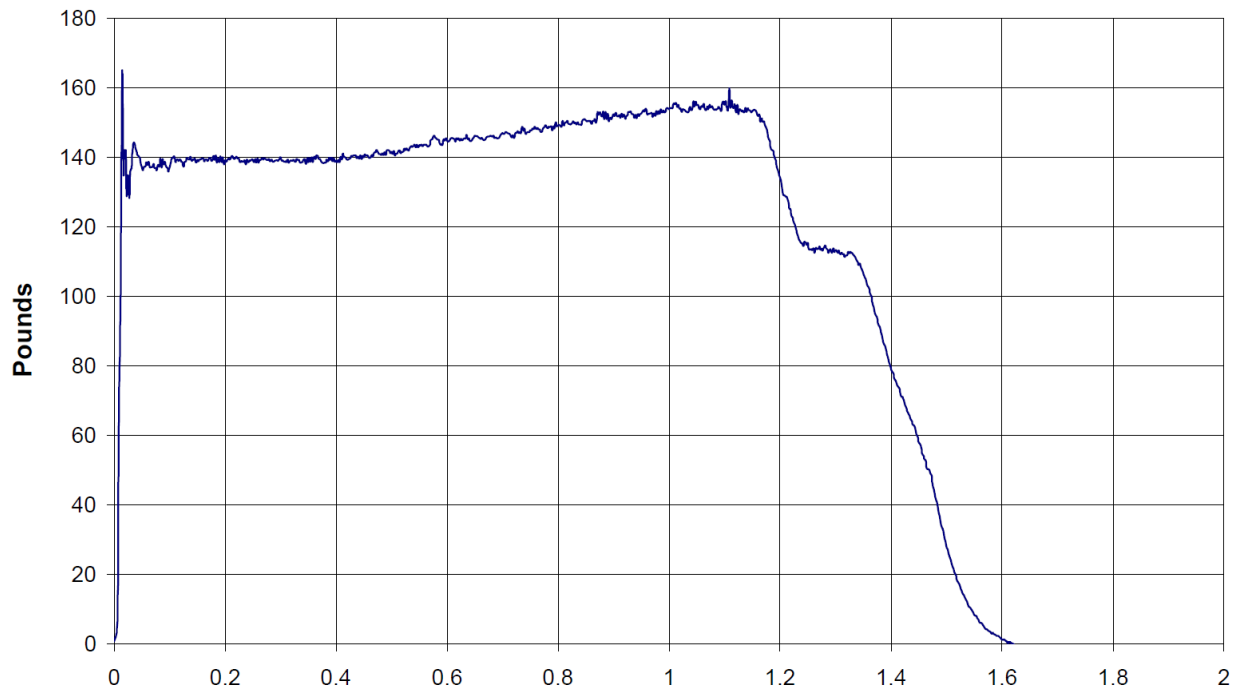
- The rocket lifted off as expected. The burnout time recorded was 1.3 seconds which we assume to imply a 1.6 second burnout time as suggested by the manufacturer in figure 1.

Figure 1: Cesaroni J580 Thrust vs. Time graph. Note the drop in thrust around 1.3 seconds that is often read as the burnout time by the altimeter.

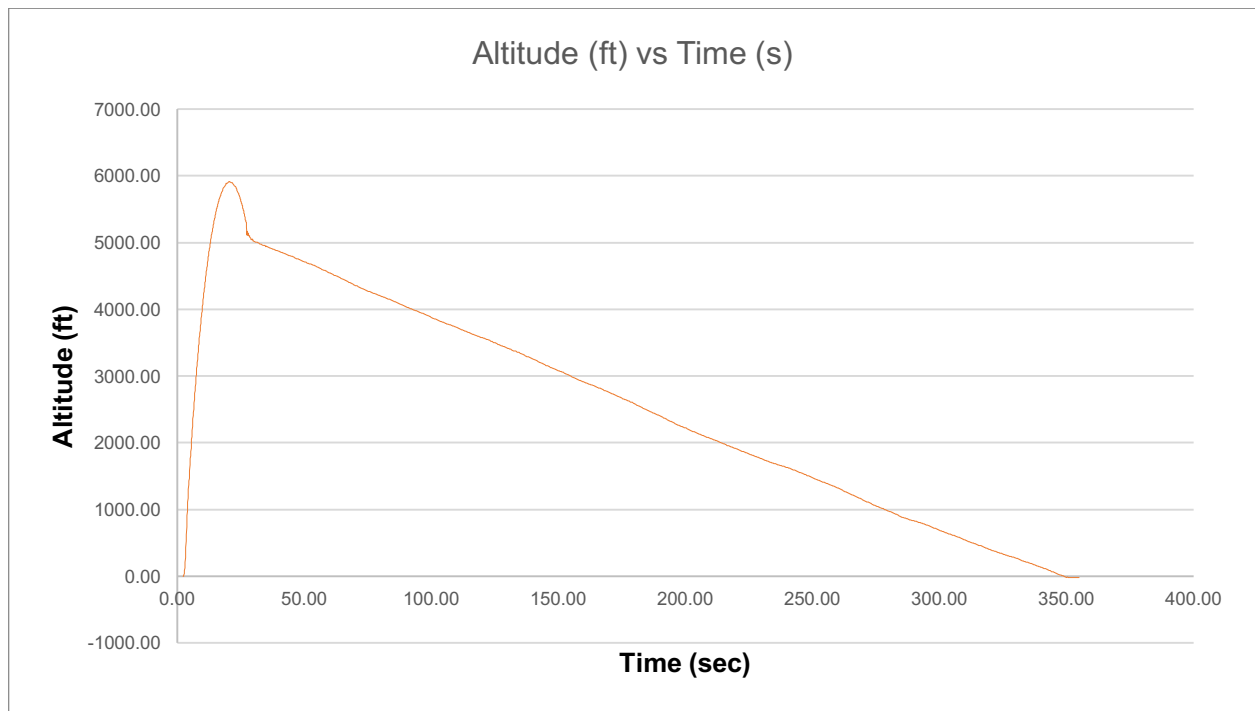
- The rocket achieved an apogee of 5913 feet (figure 2). While significantly higher than 4900 feet, the python code the team used predicted that the rocket could achieve 5980 feet if the rocket motor provided 10% extra thrust. Cesaroni, the rocket motor manufacturer, labels the J580 motor used with an accuracy of $\pm 10\%$.

Figure 2: The rocket achieved an altitude of 5913 feet above the launch site. The data was measured using an Adafruit Altimeter, and was confirmed by the Entacore altimeter and the Altimeter 2 on board that reported very similar values.

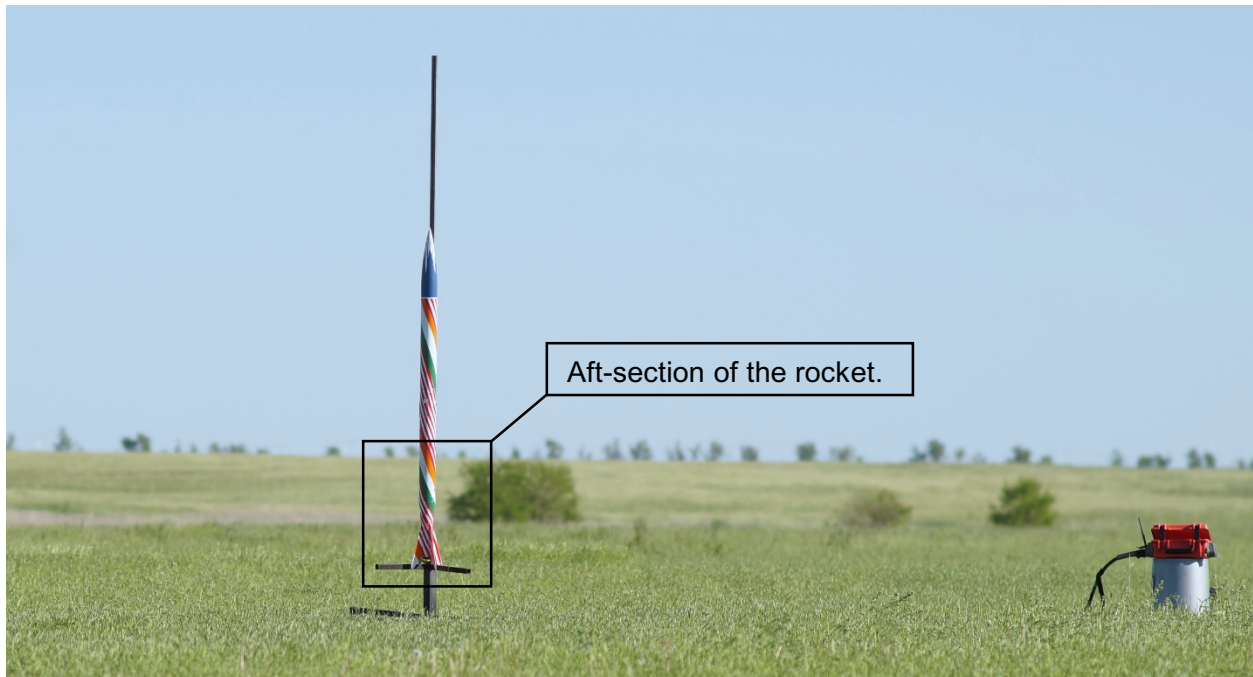
- When the motor ejection charge went off, the shock cord connecting the aft section (figure 3) of the rocket to the flap section of the rocket disconnected. The failure occurred at the bonding site on the aft section. When the rocket was recovered, the adhesive was found to have peeled off cleanly. The adhesive was also found to be soft to the touch. The team concludes with certainty that the adhesive did not cure properly and did not have enough hardener in it to result in a strong bond.

Figure 3: Rocket-Men's rocket on the launch site near Argonia, KS on May 4, 2016 moments before the unsuccessful mission. The aft-section that went unrecovered is highlighted.

-
- The shock-cord will be attached to the foremost centering ring on the aft section via 2 eye bolts. The original bonding technique did not account for peeling forces, which led to a failure in the mission. The use of eye bolts will handle the applied loads better.

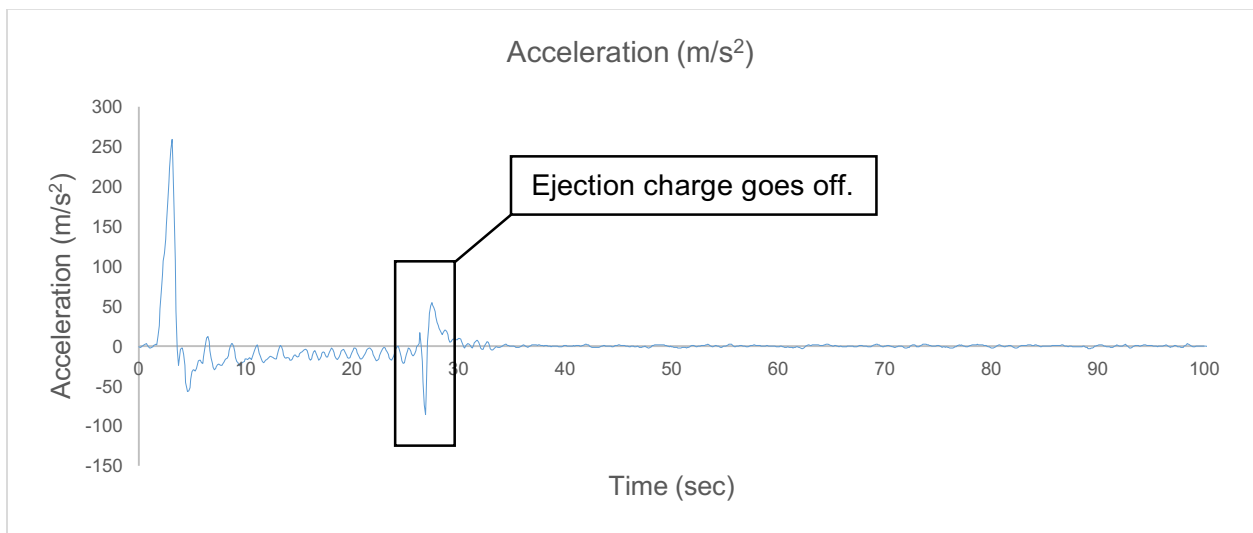
- The team therefore looked at the acceleration data and found peaks in the acceleration curve at the time of ejection of -86.3 and 50.9 m/s^2 . The team will keep these values in mind while designing a failsafe method to ensure that shock-cord detachment shall not be a cause for mission failure in the future.

- One of the flaps was found attached to the rocket body merely by aluminum tape; the aluminum tape was used to provide a smooth transition from the rocket body to the flap surface and was not intended to be a structural member. The flap was adhered to a carbon fiber stiffener using an epoxy-based adhesive prior to launch. The flap was found to have peeled-off the adhesive bond on the stiffener. This could only have occurred due to a direct impact. The team rules out an impact on landing as the flap section's approach to the ground was controlled. The only other instance when the flap section may have suffered an impact would have been when the aft section was detached. The aft section must, therefore, have struck the flap section during its free fall. (Figure 4)

Figure 4: After achieving apogee, the rocket was inverted with the nose pointed towards the ground. The highlighted section's negative spike implies a downward movement in the payload section caused by the ejection charge going off. As a result, the aft section would have moved upwards initially; it would have then proceeded to hurtle to the ground ballistically.

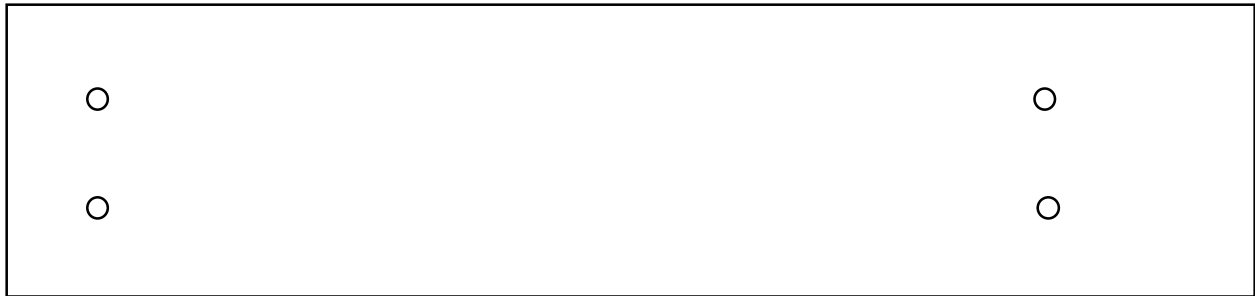
The flaps are currently bonded to the stiffener via an epoxy-based adhesive. While this holds up excellently in shearing and compressive loading situations, it holds up poorly if a peeling force is applied to it.

Figure 5: Holes to be drilled in the flaps. Steel safety wires will be used to strengthen the attachment of the flaps to the stiffeners.

- Holes will be drilled through the flaps and stiffener as pictured in figure 5.

- A steel safety wire will be passed through the holes in order to strengthen the bond, and address a situation such as the one encountered in the failed mission.
- The ultimate tensile strength of safety wire is 31200 psi. Using the equation $P=F/A$ we calculate a pressure of 326 psi that the safety wire will experience. The force was derived from the two sections of the rocket colliding in free fall like we assumed happened.
