February 5, 2025

Subject: Wifi Pole Drilled Shaft Repair Letter
SFCT Cargo Yard Densification Phase 2, Port Miami
Miami-Dade County, Florida

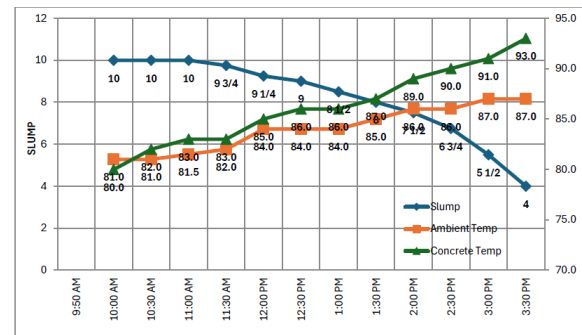
Figure 2: Slump Loss Chart

In regard to the second point of concern, the pour took 5.25 hours and the interpolated slump per the concrete supplier's slump test data indicates that initially placed concrete would have a slump of 4 3/4" at the conclusion of the pour (5" minimum at time of placement is required). This poses concerns of disturbing partially set concrete which could lead to compromised structural integrity of the concrete, cracks, or reductions in serviceability. However, the concrete with slump anticipated to be less than 5" was in the bottom of the drilled shaft and only outside of acceptable limits for the final 15 minutes of the pour. This concrete is well away from the limits of disturbance from the concrete placement. It is therefore our finding that concrete within areas disturbed by concrete placement satisfied 5" slump criteria for the duration of the pour. It is our finding that there are no reductions in strength or serviceability associated with the slumps of the concrete during placement.
