Inspection Report

Property Address:
98 Woodmere Road
West Hartford Ct 06119

Date of Inspection 6-20-2013

Premier Home Inspection, LLC

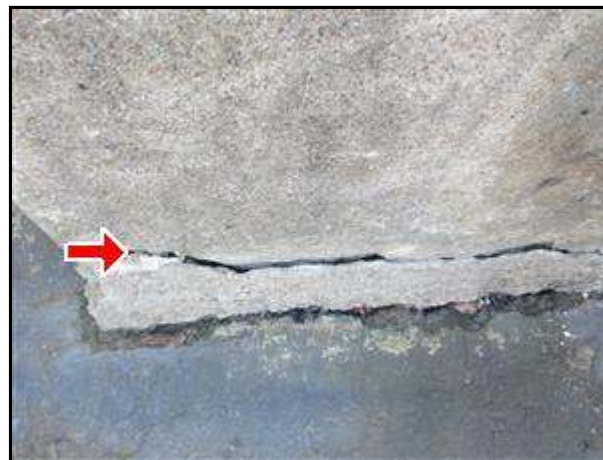
1.0 Picture 1 Damaged skim coat

Observation: The poured concrete foundation for its age appears in good condition. I observed cracks in the walls of the foundation. These cracks do not appear to have structural effect on the foundation. The foundation was even on either side of the cracks. The diameter of the cracks was less than the thickness of a quarter.

Observation: I did note that the foundation appears to have a skim coat of concrete. The skim coat has several sections of cracking and deterioration noted.

Recommendation: Consider filling these cracks and monitor for future movement. Recommend consultation with a contractor for further evaluation.

Recommendation: Recommend you have a contractor make repairs where necessary.

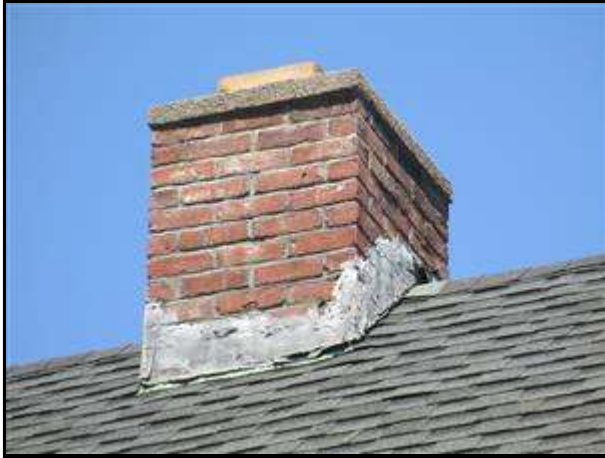
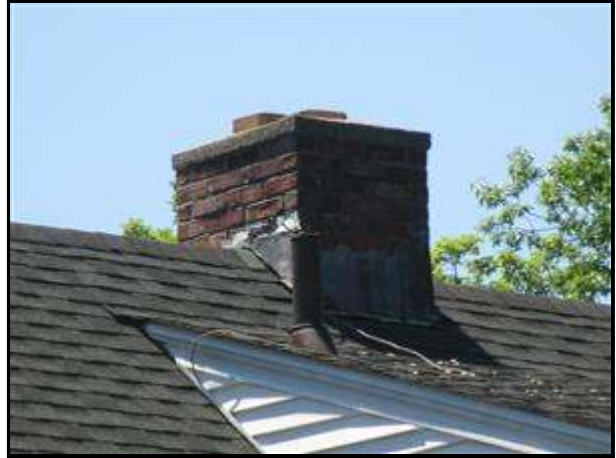
1.1 Picture 1 Chimney

1.1 Picture 2 Chimney

Observation: The chimney is located in the center of the house (when facing the front of the home). Condition of the chimney appears to be good. I did not note that any repointing is needed. The cement cap seems in good condition with no cracking noted. There appear to be two flues and they appear in good condition. The chimney is tight to the home and no major cracking was noted.

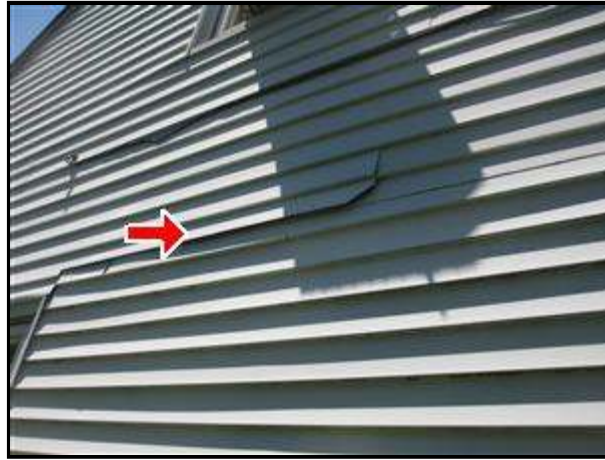
1.3 Picture 1 Detached siding

Observation: The siding appears to be vinyl. It is straight and tight up against the house. No significant deterioration was noted. I did note a section of siding on the right side of the home that seems to be pulling off the home.

Recommendation: Recommend you have repairs made as needed.

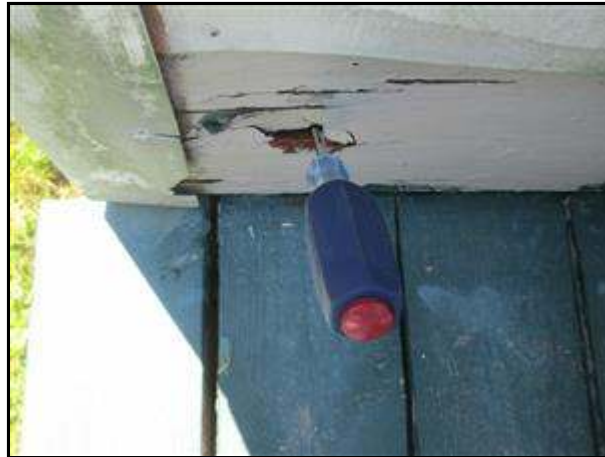
1.4 Picture 1 Trim rot (rear)

Observation: Trim appeared to be in good condition at the time of inspection. I did note a section of rot at the rear of the home.

Recommendation: I recommend you have this area evaluate and repairs made if necessary.

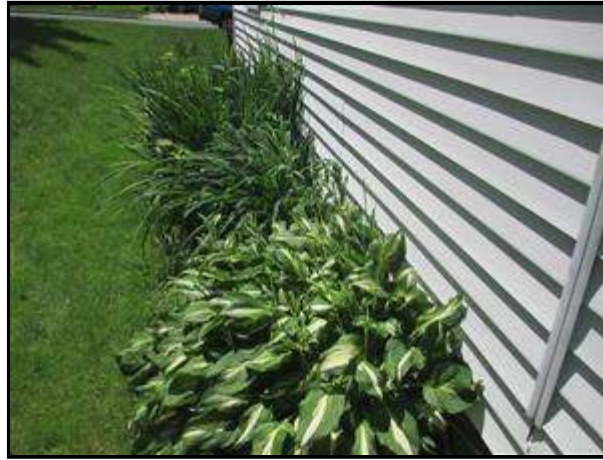
1.5 Picture 1 Vegetation Touching Home

Observation: There is vegetation very close to the home. Tree roots can cause significant structural damage to foundations.

Recommendation: Recommend you have any vegetation touching the house removed. All vegetation should be kept trimmed at least 6-12" inches away from the structure, to eliminate a common avenue for pest infestation.

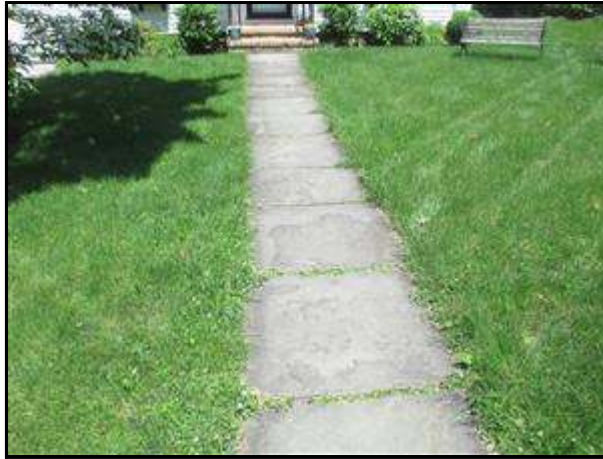
1.10 Picture 1 Front Walkway

Observation: The front walkway appears to be stone. It was even and in good condition.**1.11 DECKS, BALCONIES, STOOPS, STEPS, AREAWAYS, PORCHES AND APPLICABLE RAILINGS****Comments:** Inspected

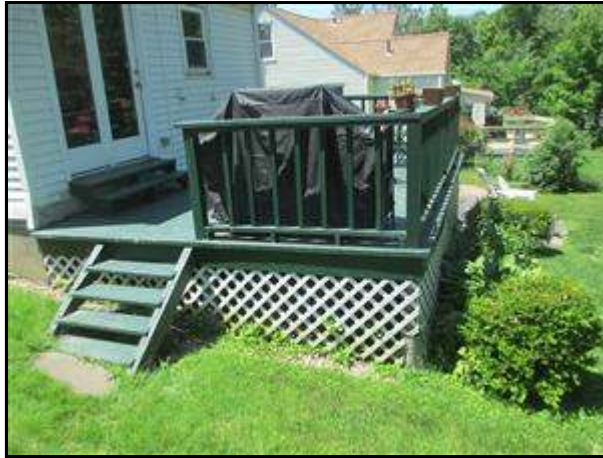
1.11 Picture 1 Deck

Observation: There is a wood deck on the back of the house. I probed the wood and it appeared to be solid and when I walked on the deck it was solid under foot. The deck was even and level on all sides and there appeared to be concrete support posts underneath. I did note that the deck is tight to the home. The balusters appear solid and in good condition. I also noted lag bolts and nails in the joist hangers. I did note the balusters do not appear to be spaced correctly. This can be a safety hazard.

Recommendation: Recommend you have a contractor come out and evaluate the balusters and at that time have them make recommendations.

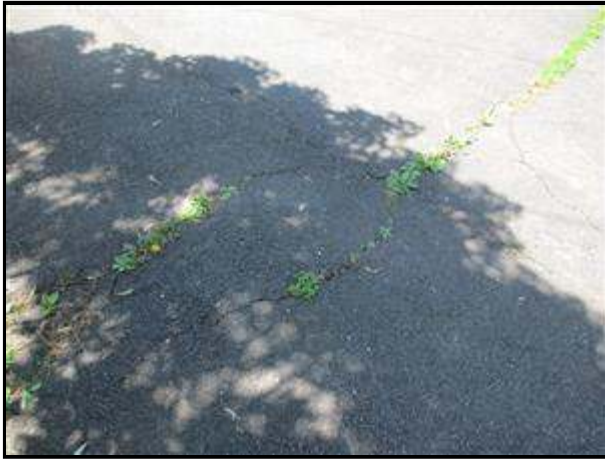
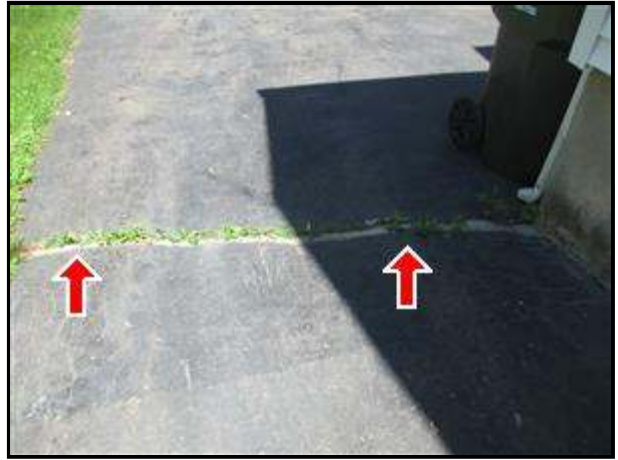
1.12 Picture 1 Driveway Cracking

1.12 Picture 2 Driveway Cracking

Observation: The asphalt driveway has moderate cracking on most of its surface. There are no major depressions or sections missing.

Recommendation: Recommend having a licensed paving contractor evaluate and make recommendations.

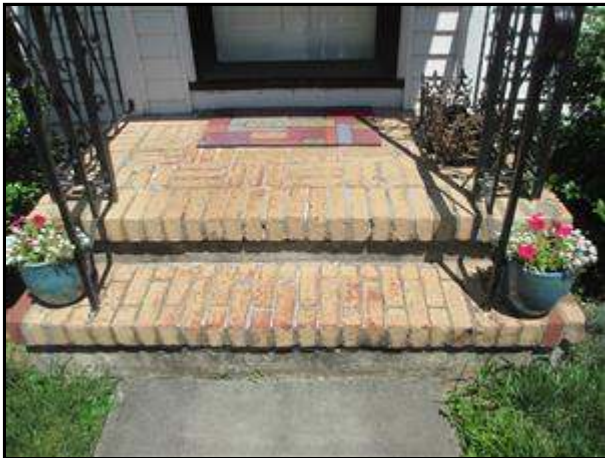
1.13 Picture 1 Front Steps

Observation: The brick step to the front of the home are in need of some minor repointing. The mortar is missing in some sections. I noted gaps where water will enter.

Recommendation: Recommend that you have a contractor evaluate the front steps and make recommendations.

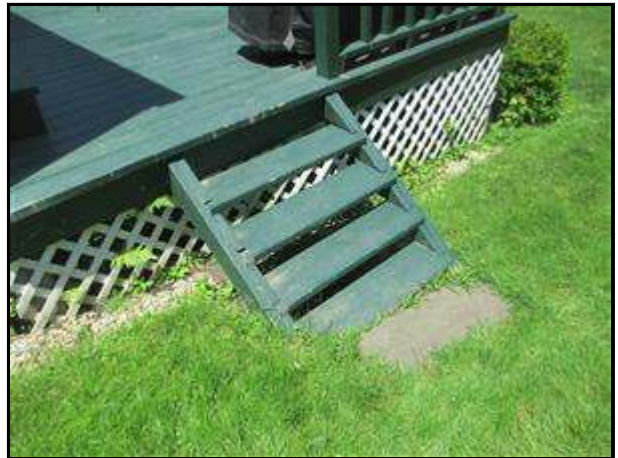
1.13 Picture 2 Rear Steps

Observation: There are wood steps on the rear of the building. They appear to be in good condition. They are solid under foot and at the time of the inspection show no significant signs of deterioration.

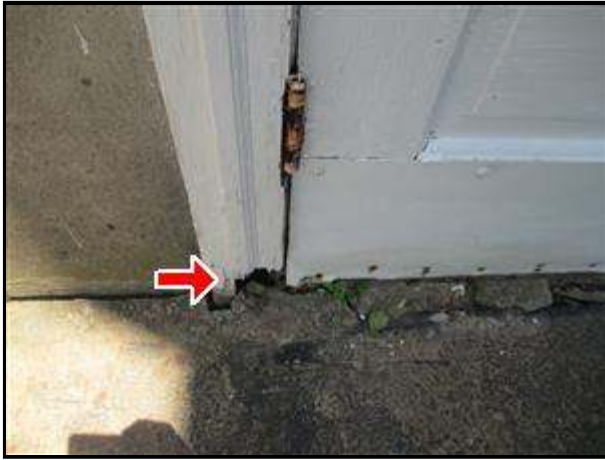
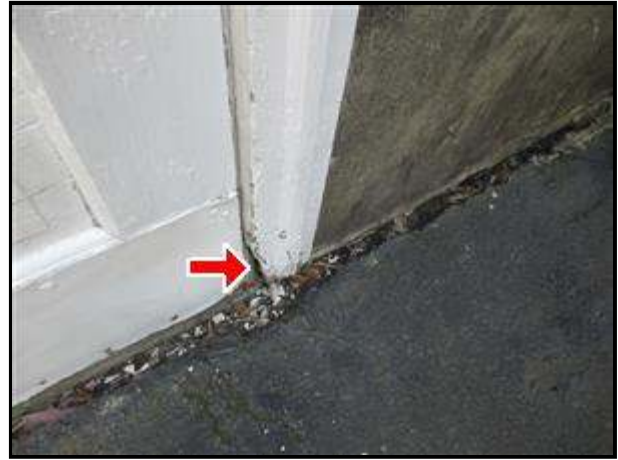
1.15 Picture 1 Trim Rot

1.15 Picture 2 Rot

Observation: I inspected the rear door and it both opened and closed properly. I did not note any rot around the door trim at the time of the inspection. I did note a rear door to a storage room that seems to have trim rot.

Recommendation: Recommend you have repairs made to the door trim.

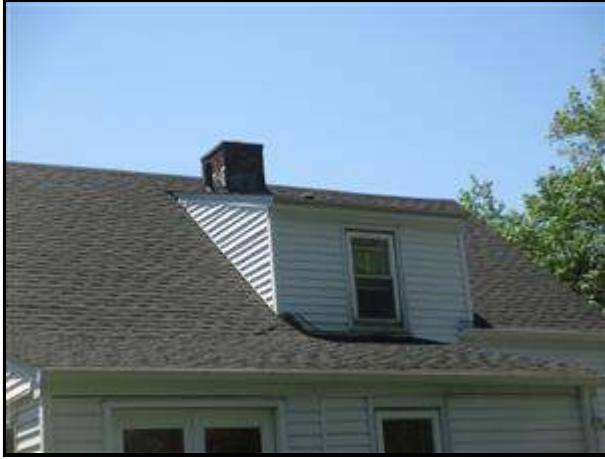
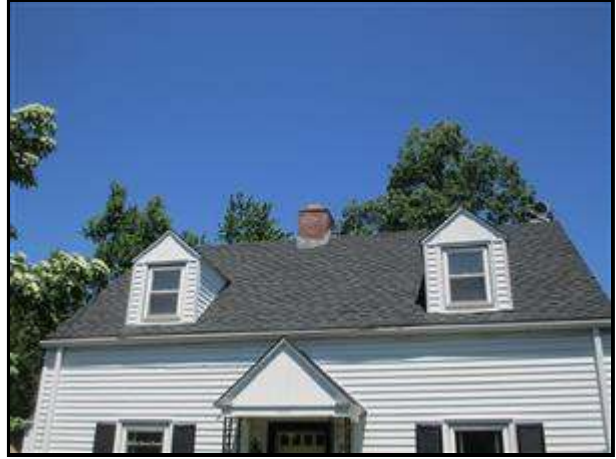
2.0 Picture 1 Roof

2.0 Picture 2 Roof

Observation: At the time of the inspection, the roof where visible and accessible seems to be performing its intended function of keeping out the rain and other related weather. The roof lines were straight and the shingles did not show any signs of lifting, thermal cracking or substantial particulate loss. This is an architectural shingle and as the house was built in 1909, this appears, most likely, to be a replacement roof. Most architectural style shingle have a life expectancy of 25 - 30 years. The roof looked to be in newer condition.

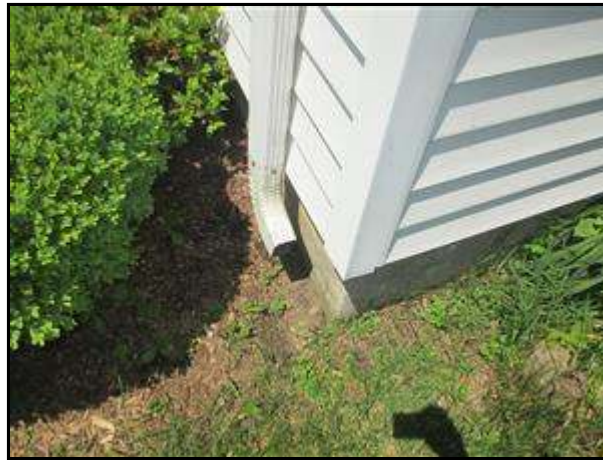
2.4 Picture 1 Missing Extension

Observation: I noticed several downspouts missing extensions.

Recommendation: Recommend you have any missing extensions installed.

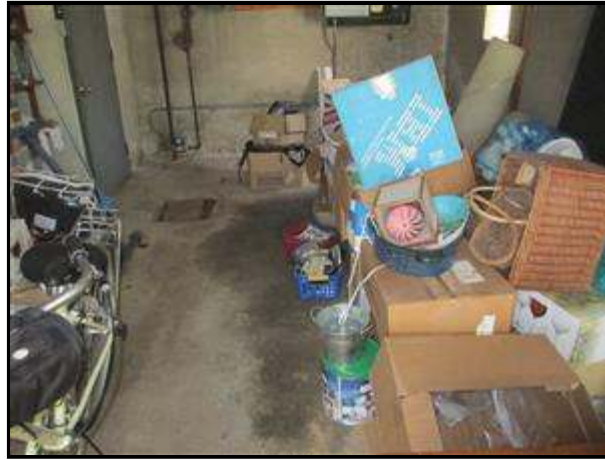
3.0 Picture 1 Garage Storage

Observation: The garage foundation appears to be poured concrete. No major cracking was noted.

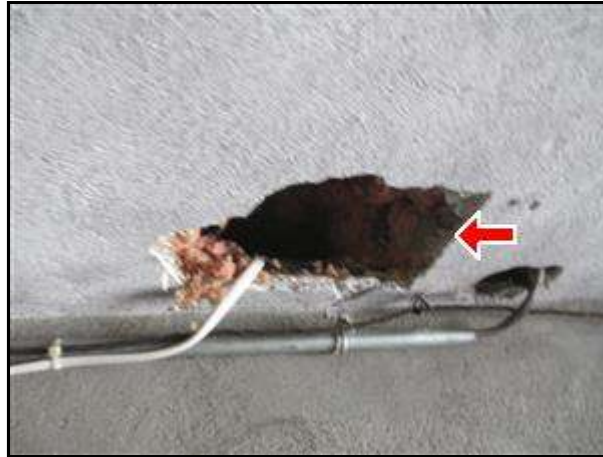
3.7 Picture 1 Hole in garage ceiling

Observation: I did note that the garage is under living space. The garage ceiling does have a hole. I strongly recommend that you do not park a car in the garage until the garage is properly enclosed.

Recommendation: Recommend you consult with a licensed contractor concerning this.

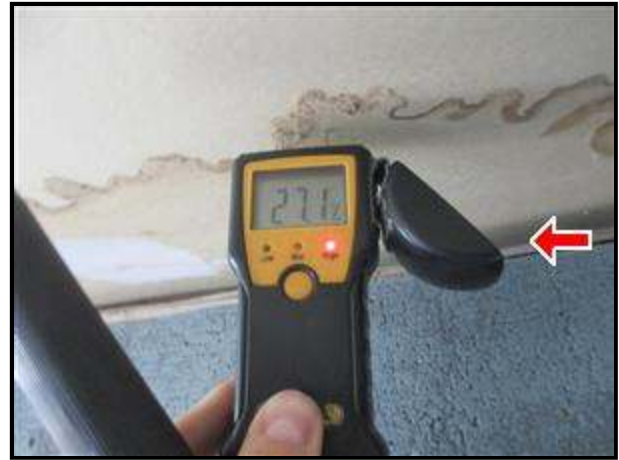
Observation: The basement is completely finished space. The walls, ceilings and flooring all appeared to be in good condition. I did not note any significant cracking or staining of the walls or ceilings. I noted active water penetration in the storage room off the garage.

Active water intrusion

Recommendation: Recommend you consult with a contractor to determine where this water intrusion is coming from.

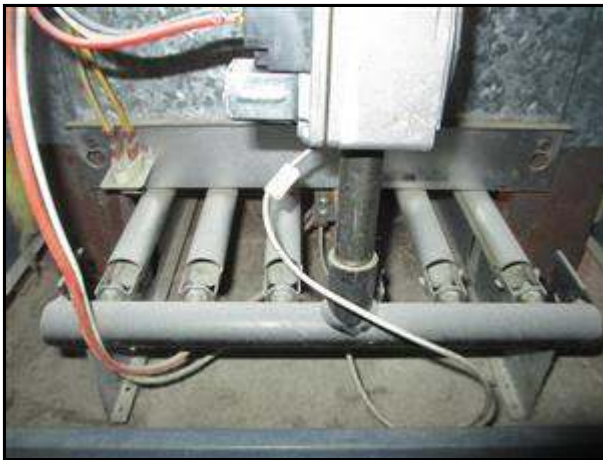
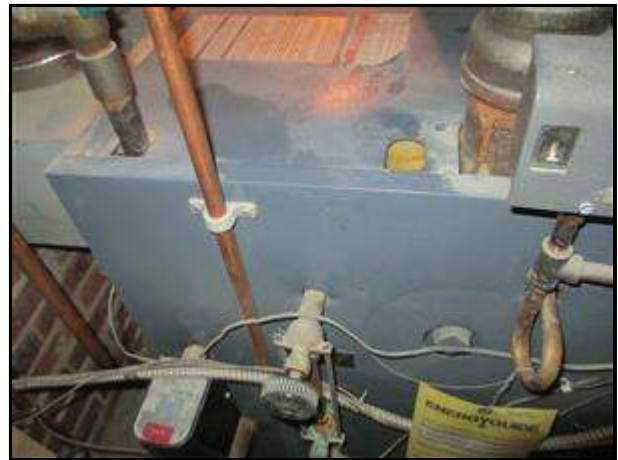
5.0 Picture 1 Heating System

5.0 Picture 2 Heating System

Observation: There appears to be a single zone gas fired steam boiler heating system in the house. I did fire the unit and the unit did not make any unusual noises or fumes. The unit did turn off when the emergency switch near the unit was turned off. At the time of my inspection no water leakage was noted. The life expectancy of this type of unit is anywhere from 25 - 30 years. Although the unit functioned normally at the time of the inspection, I would place this unit approaching the end of that time span. I noted a date of 1994 on the unit.

Recommendation: I recommend having a licensed heating contractor clean and service the unit if it has not been within the last year.

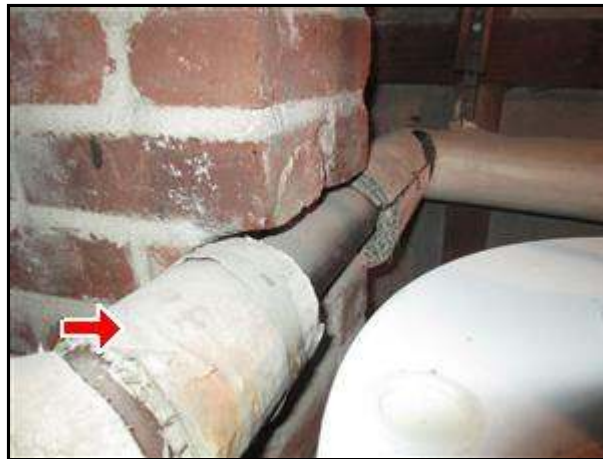
5.2 Picture 1 Possible asbestos

Observation: Although excluded from our contract insulation on the boiler and/or distribution piping is similar in appearance to materials known to contain asbestos. Although there is a very high probability the material is asbestos, it is simply not possible to visually determine if the material is asbestos with absolute certainty, laboratory analysis is necessary.

Recommendation: Consultation with a licensed asbestos contractor is recommended to determine the proper course of action and to obtain an opinion as to the necessity of air or bulk samples. Due to the age of construction, there may be other materials within the home that contain asbestos but are not identified by this inspection report. Asbestos fibers that get into the air represent a health hazard.

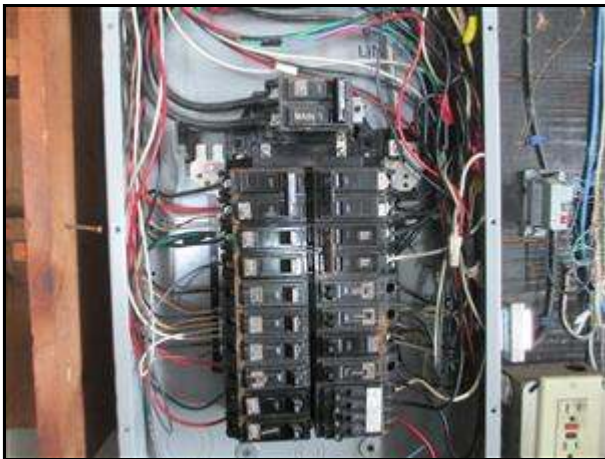
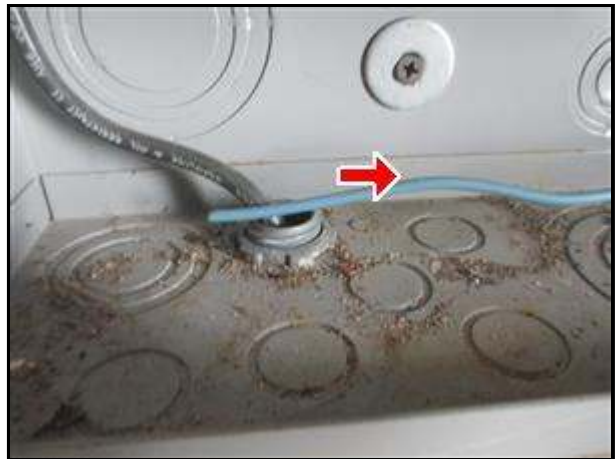
6.0 Picture 1 Electrical Panel

6.0 Picture 2 Loose wire

Observation: The main disconnect breaker read 100 amps. The interior of the box looked clean and free of rust or corrosion. I noted what looked like aluminum wiring coming into the home from the street. The branch wiring looked to be copper. The branch wires did look proportionally sized to their amperage. There was no corrosion noted on any of the wiring. There did appear to be double tapping. The box appears to be properly grounded. I noted a loose wire in the box.

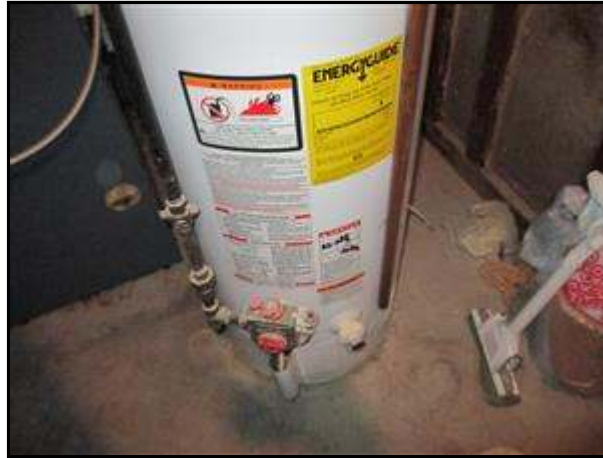
7.7 Picture 1 Water Heater

Observation: At the time of the inspection the water heater appears to be in good condition with no signs of leaks or physical damage. I did not note any rusting. The expected life cycle of this type of unit is approximately 12-15 years. I noted a date of 2007 on the unit.

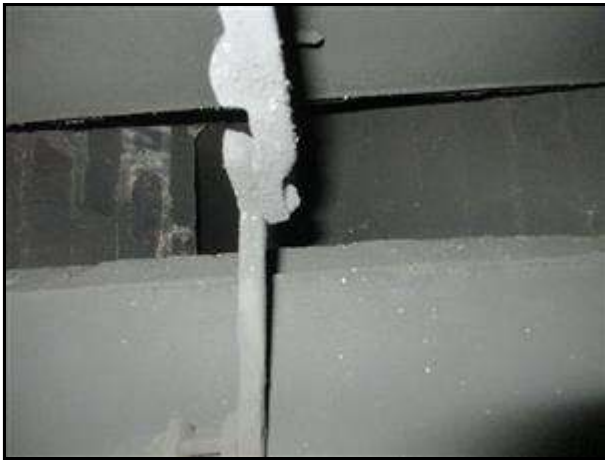
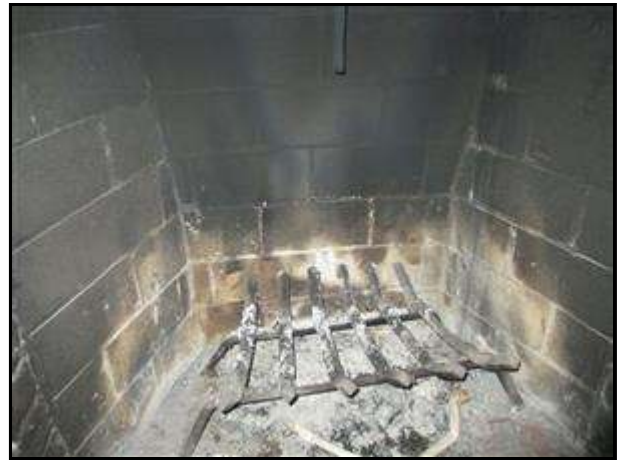
9.1 Picture 1 Flue

9.1 Picture 2 Firebox

Observation: The liner was only partially visible and appeared in good condition. The damper is present and functional. However, there is creosote dust that may conceal a hairline crack which can not be determined until cleaned and inspected by a licensed chimney sweep. The firebox appears in good condition with no significant cracking noted.

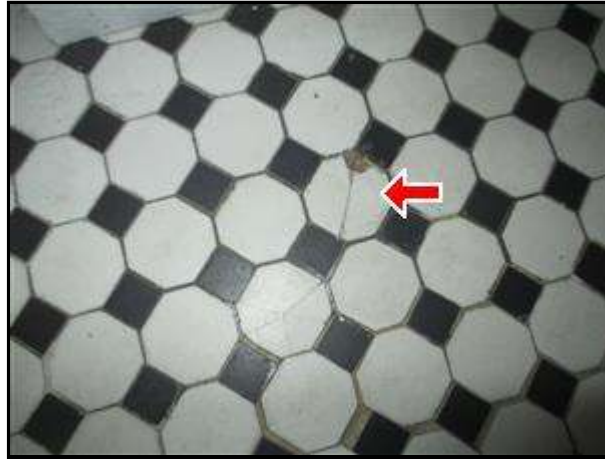
11.7 Picture 1 Cracked tiles

Observation: Floor appears to be ceramic tile, no major defects were noted at the time of the inspection. I did note cracked tiles.

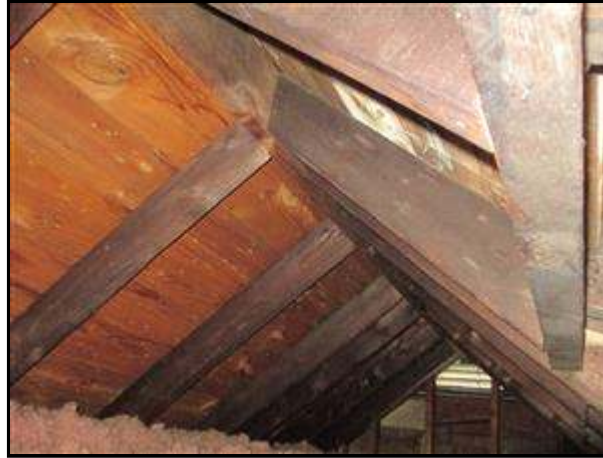
12.1 Picture 1 Attic

Observation: The structural supports in the attic appear to be tight up against the ridge beam, they appear to be even and are not showing signs of rot.**12.2 Roof Decking****Comments:** Inspected**Observation:** The roof backing is wood and where visible and accessible there is no visible signs of water leaking or damage. At the time of the inspection, I did not notice the visible presence of mildew or mold and there appeared to be no significant darkening of the roof decking.**12.3 Any Venting into Attic****Comments:** Inspected**Observation:** Where visible and accessible there are no visible systems venting directly into the attic.**12.4 Chimney****Comments:** Inspected

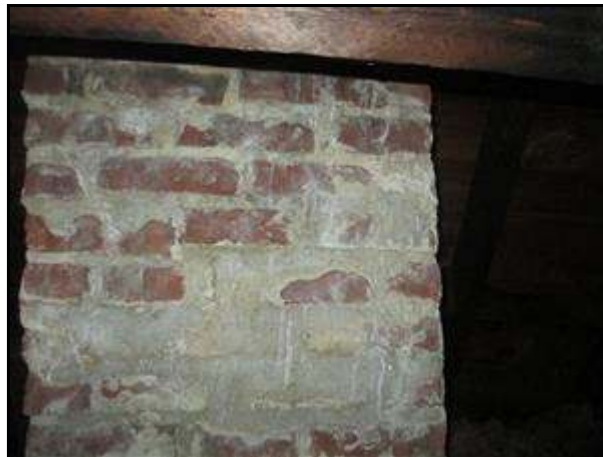
12.4 Picture 1 Chimney

Observation: The attic chimney looks to be straight and dry with no major missing sections of mortar. The section of the chimney in the attic appears to be made of brick.

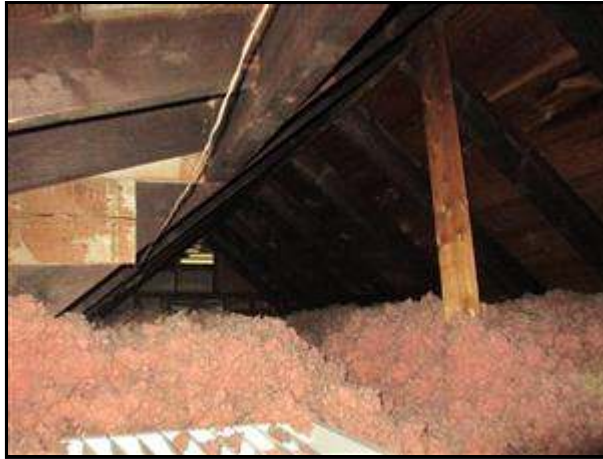
12.5 Picture 1 Insulation

Observation: The attic has approximately 16 to 18 inches of blown insulation.
