Client Name:
Windsor Essex Community Housing
Corporation (CHC)

Site Location:
Various Addresses , Windsor, Ontario
Bridgeview I (Various Addresses) – District #2

Project No.
16313-09

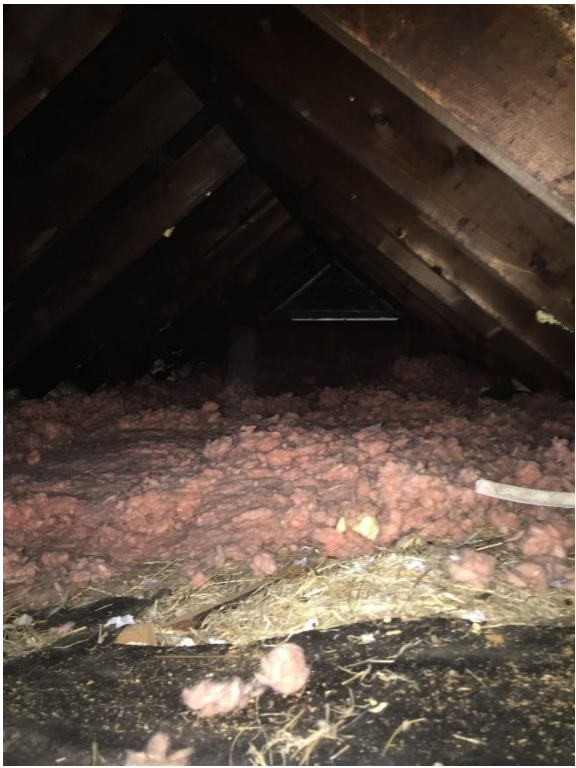
Photo No. 1.

Date: April 11, 2016	
Location: 1275 Rankin Attic (Loc. 09-1275-10)	
Description: Non-asbestos attic insulation

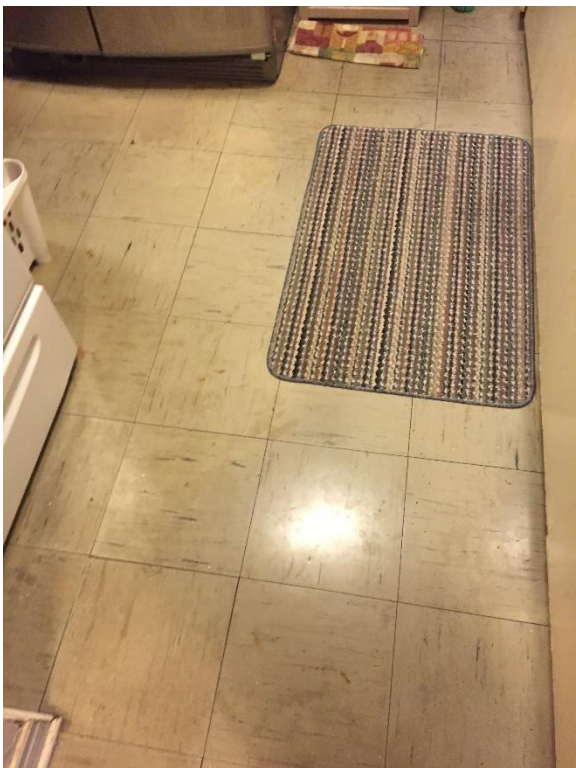
Photo No. 2.

Date: April 11, 2016	
Location: 1275 Rankin Kitchen (Loc. 09-1275-02)	
Description: Asbestos-containing Vinyl Floor Tile 1 (VFT1) – 12”x12” Beige with Black Veins.

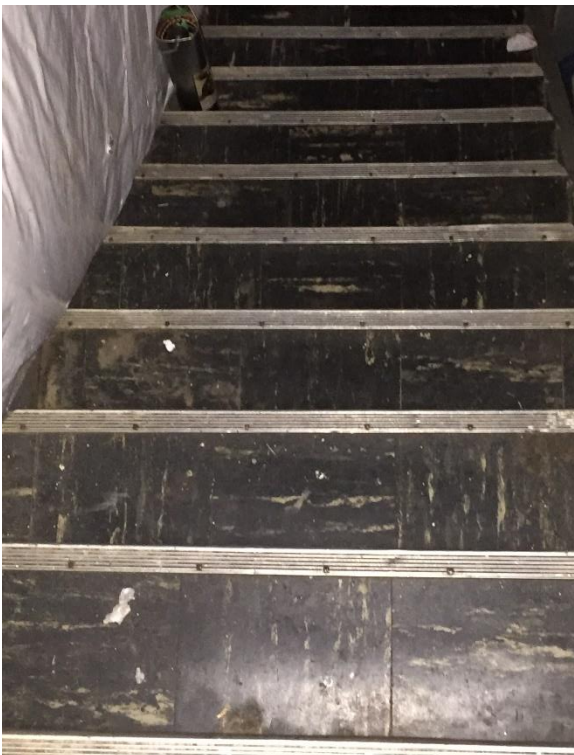
Photo No. 4.

Date: April 11, 2016	
Location: 1306 Rankin Basement (Loc. 09-1306-01)	
Description: Asbestos-containing Vinyl Floor Tile 3 (VFT3) – 9”x9” Black with Light Brown Streaks

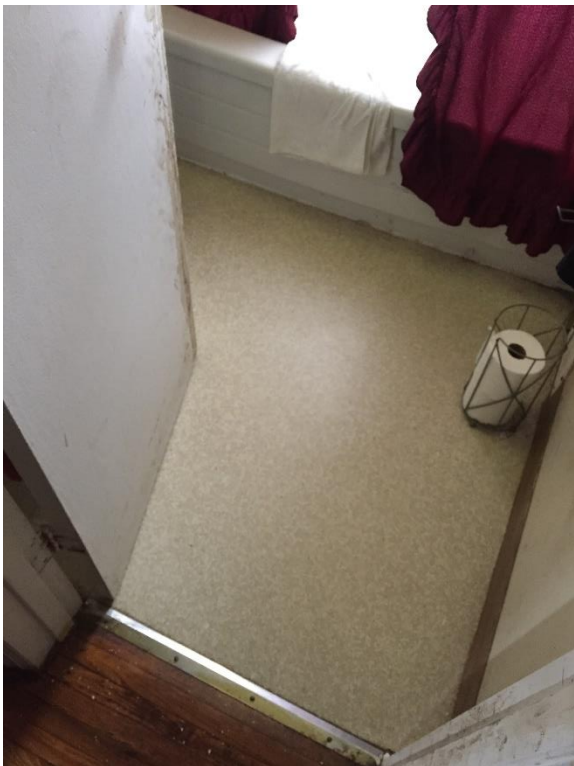
Photo No. 6.

Date: April 11, 2016	
Location: 1339 Rankin Washroom (Loc. 09-1339-03)	
Description: Non-asbestos Vinyl Sheet Floor 2 (VSF2) – Beige with Stoney Pattern

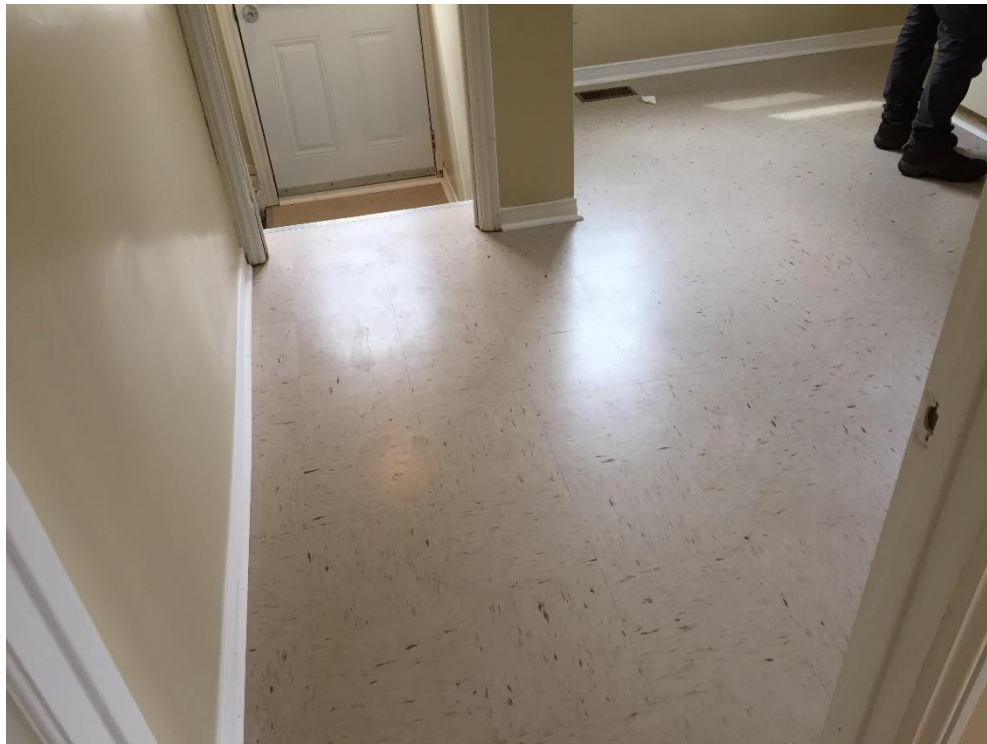
Photo No. 7.

Location:
1291 Rankin Hallway
(Loc. 09-1291-04)

Description:
Non-asbestos Vinyl Floor
Tile 4 (VFT4) – 12”x12”
Beige with Brown Marks

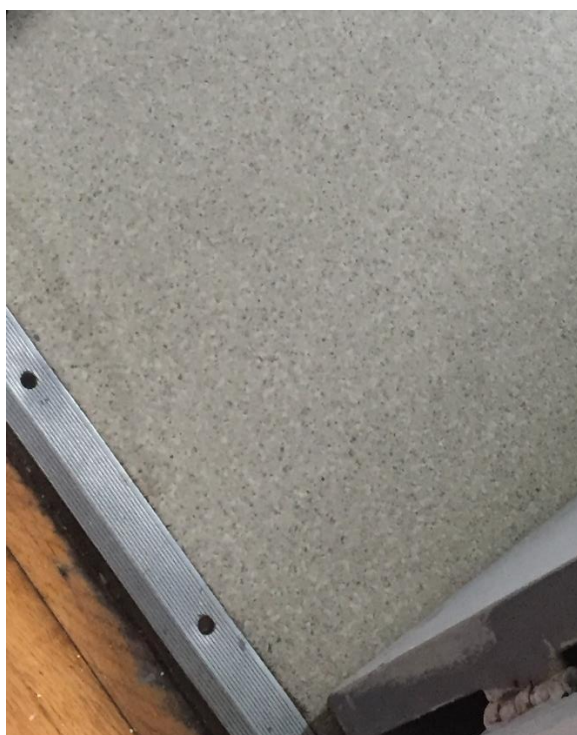
Photo No. 8.

Location:
1014 Rankin
(Loc. 09-1014-03)

Description:
Non-asbestos Vinyl
Sheet Floor 3 (VSF3) –
Grey

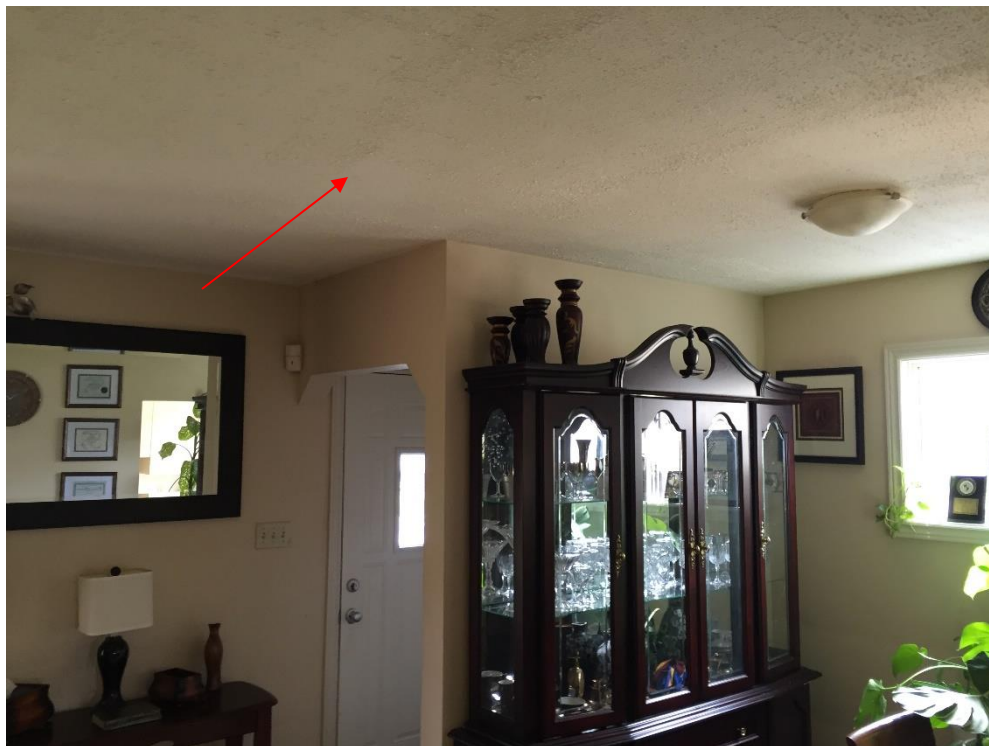
Photo No. 9.

Location:
1291 Rankin Living
Room
(Loc. 09-1291-05)

Description:
Non-asbestos texture
finish on plaster

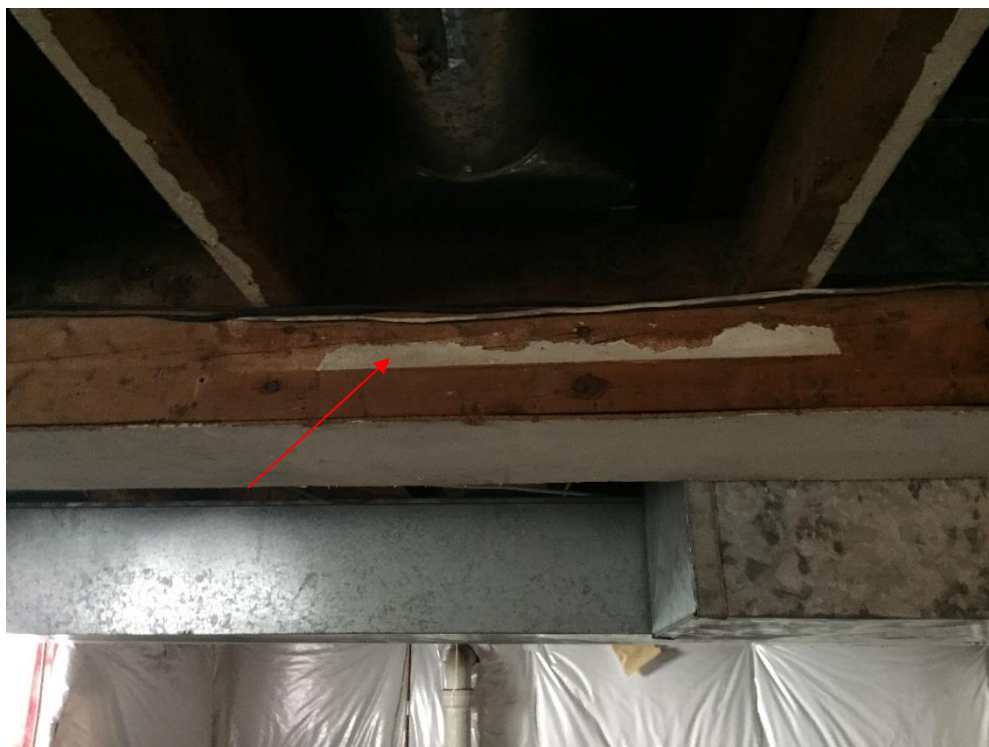
Photo No. 10.

Location:
1339 Rankin
Basement
(Loc. 09-1339-01)

Description:
Asbestos-containing
Heat Shield residue
observed in POOR
condition

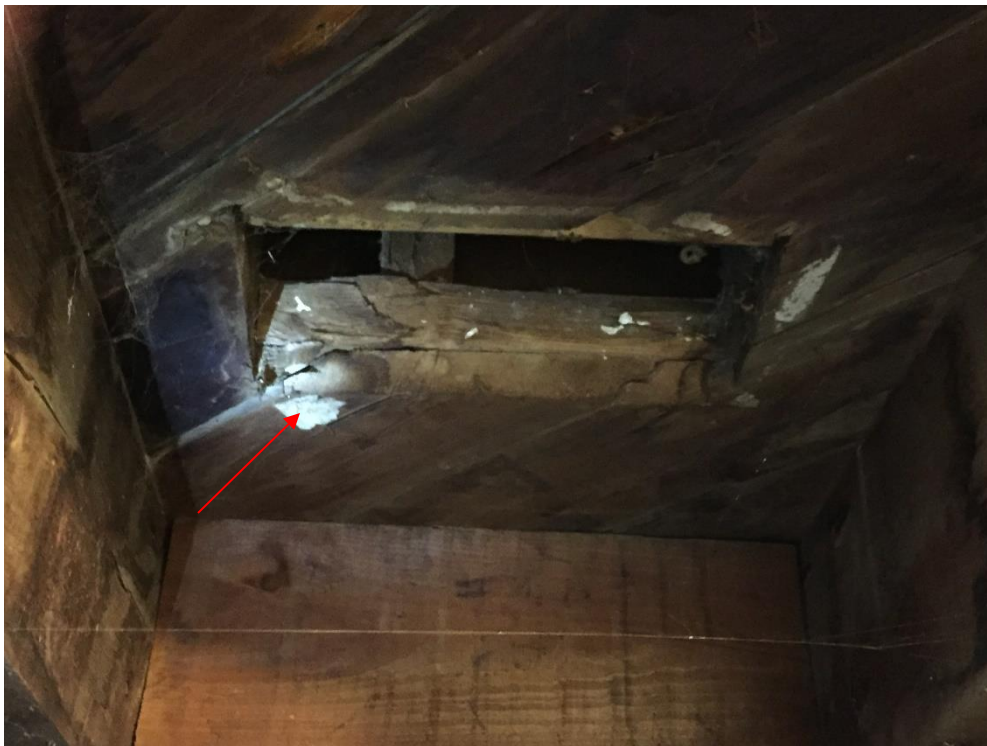
Photo No. 11.

Location:
1181 Askin Basement
(Loc. 09-1181-01)

Description:
Asbestos-containing
Heat Shield residue
observed in POOR
condition

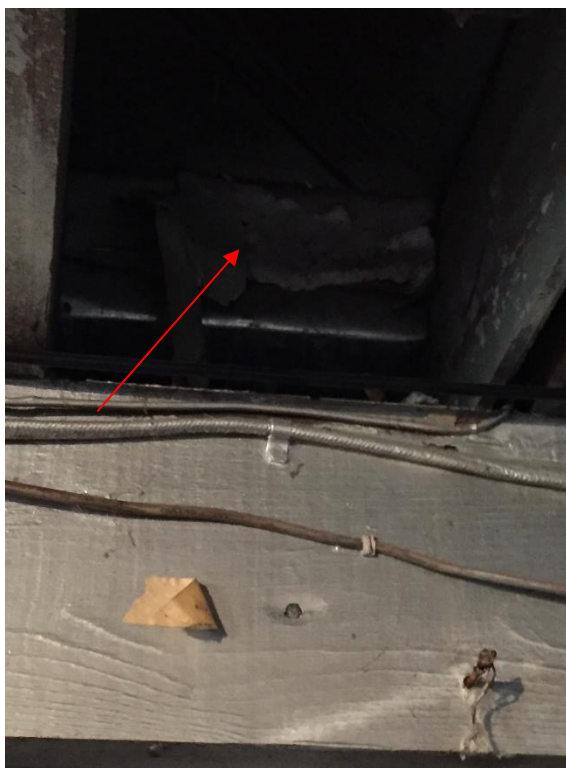
Photo No. 12.

Location:
2300 Girardot
Basement
(Loc. 09-2300-01)

Description:
Asbestos-containing
Heat Shield around
vents observed in
POOR condition
