**Client Name:**  
Windsor Essex Community Housing  
Corporation (CHC)

**Site Location:**  
140 Bridge Avenue, Windsor, Ontario  
Ashgrove Manor Apartment Building– District #5

**Project No.**  
16313-41

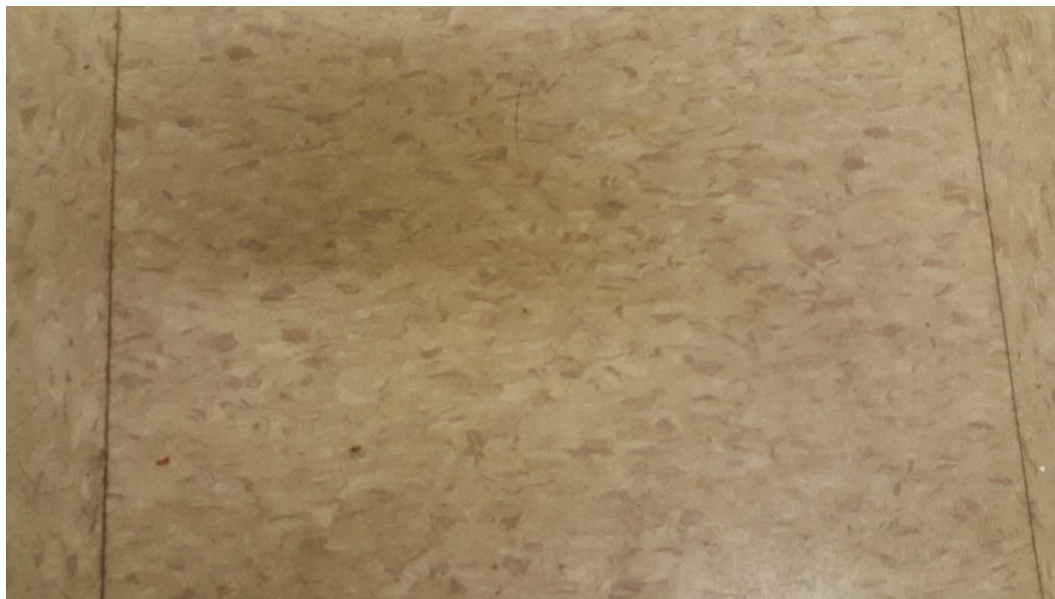
**Photo No. 1.**

**Location:**  
Basement Corridor  
(Loc. 41-001)

**Description:**  
Non-asbestos Vinyl  
Floor Tile 1 (VFT1) –  
12”x12” Beige with  
Light and Dark Beige  
Flecks. **Asbestos-**  
**containing** mastic  
may be present.

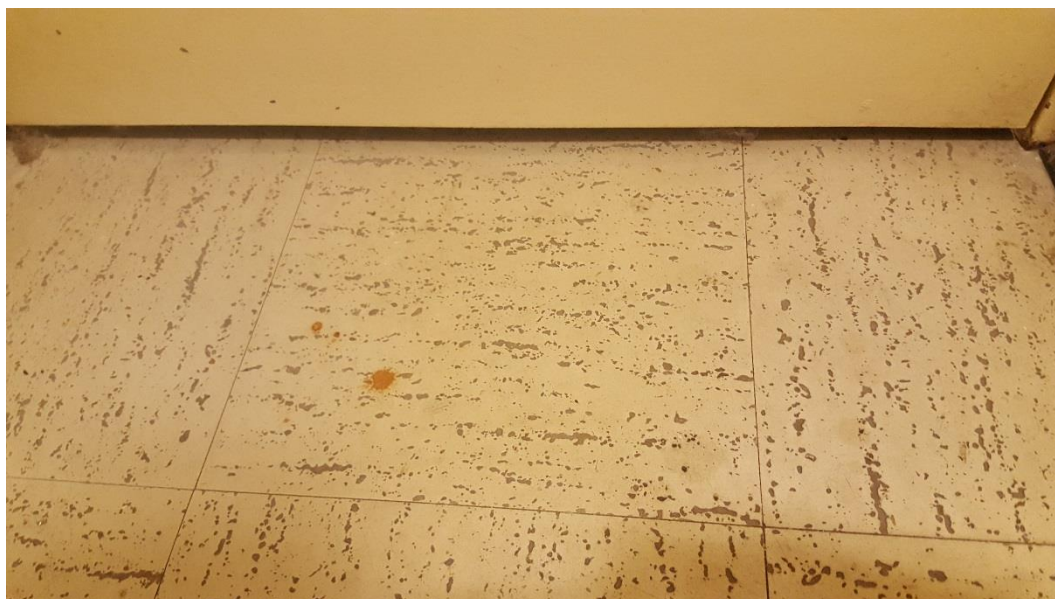
**Photo No. 2.**

**Location:**  
Unit 415  
(Loc. 41-415)

**Description:**  
**Asbestos-containing**  
Vinyl Floor Tile 2  
(VFT2) – 12”x12”  
Beige with Grey  
Indents (2%  
**Chrysotile**), with  
**asbestos-containing**  
mastic (2%  
**Chrysotile**)

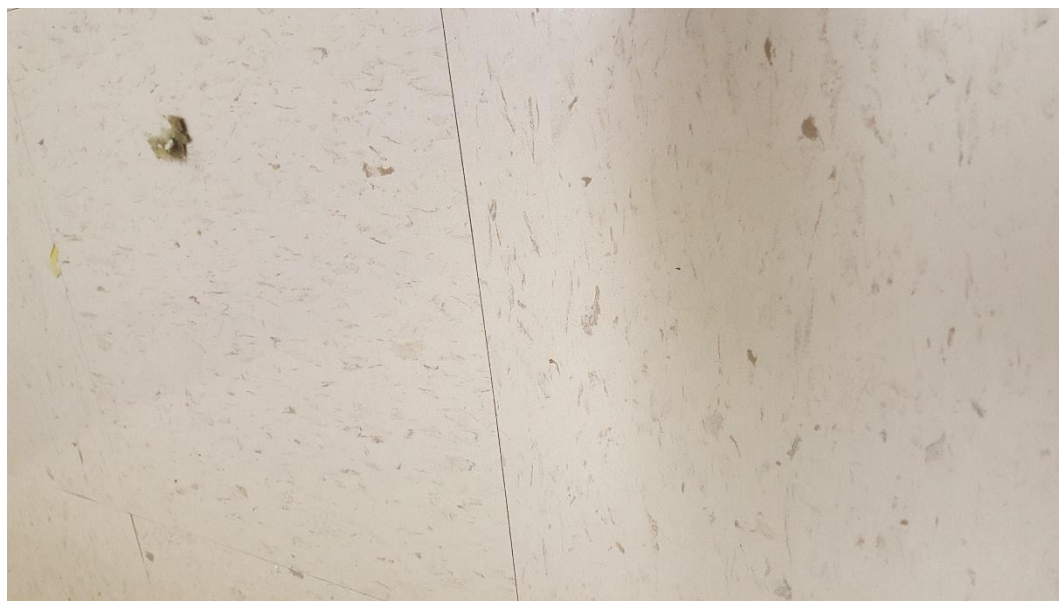
**Photo No. 3.**

**Location:**  
Washroom  
(Loc. 41-118)

**Description:**  
Non-asbestos Vinyl  
Floor Tile 3 (VFT3) –  
12”x12” Beige with  
Brown and Grey  
Flecks. **Asbestos-**  
**containing** mastic  
may be present.

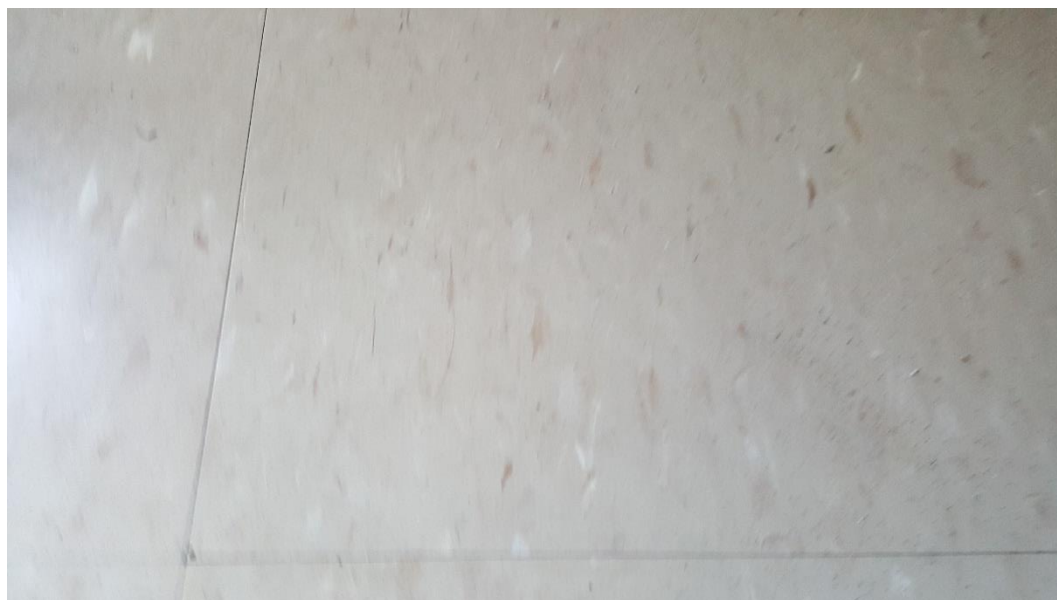
**Photo No. 5.**

**Location:**  
Unit 1110  
(Loc. 41-1110)

**Description:**  
Non-asbestos Vinyl  
Floor Tile 6 (VFT6) –  
12”x12” Beige with  
Sparse Tan and White  
Flecks. **Asbestos-**  
**containing** mastic  
may be present.

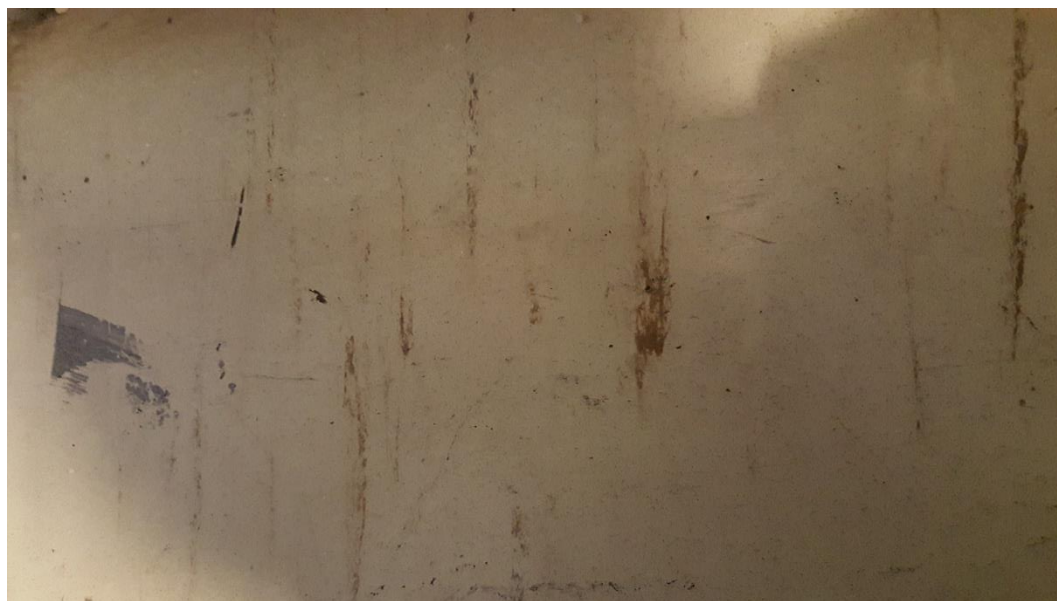
**Photo No. 6.**

**Location:**  
Craft Room  
(Loc. 41-115)

**Description:**  
**Asbestos-containing**  
Vinyl Floor Tile 7  
(VFT7) – 12”x12”  
Beige with Brown  
Streaks (**2%  
Chrysotile**).  
**Asbestos-containing**  
mastic may be  
present.

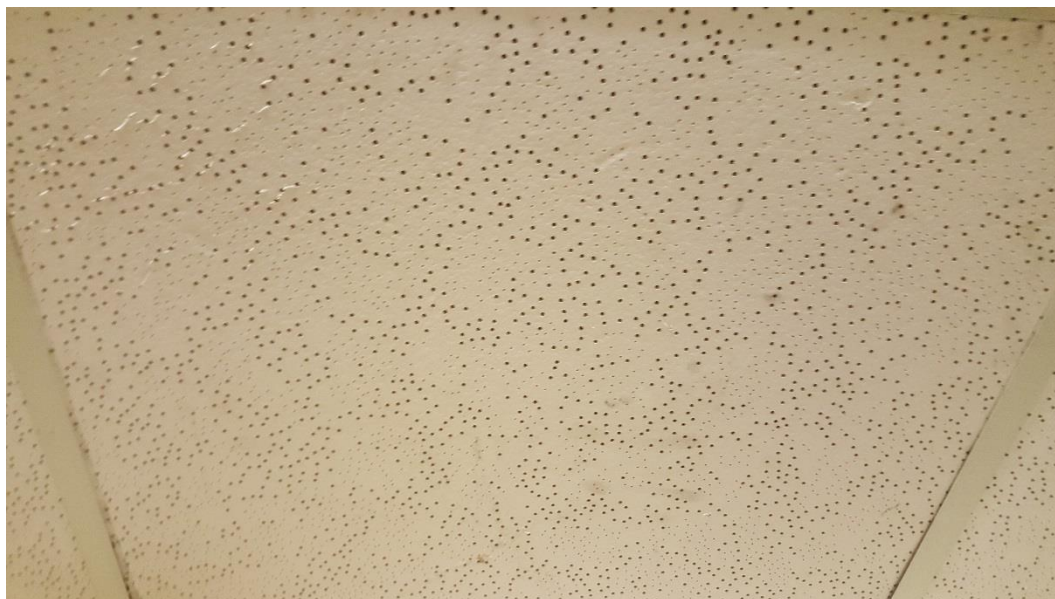
**Photo No. 7.**

**Location:**  
Office Area  
(Loc. 41-108)

**Description:**  
Non-asbestos Ceiling  
Tile 1 (CT1) – 2'x4'  
Small and Medium  
Random Pinholes

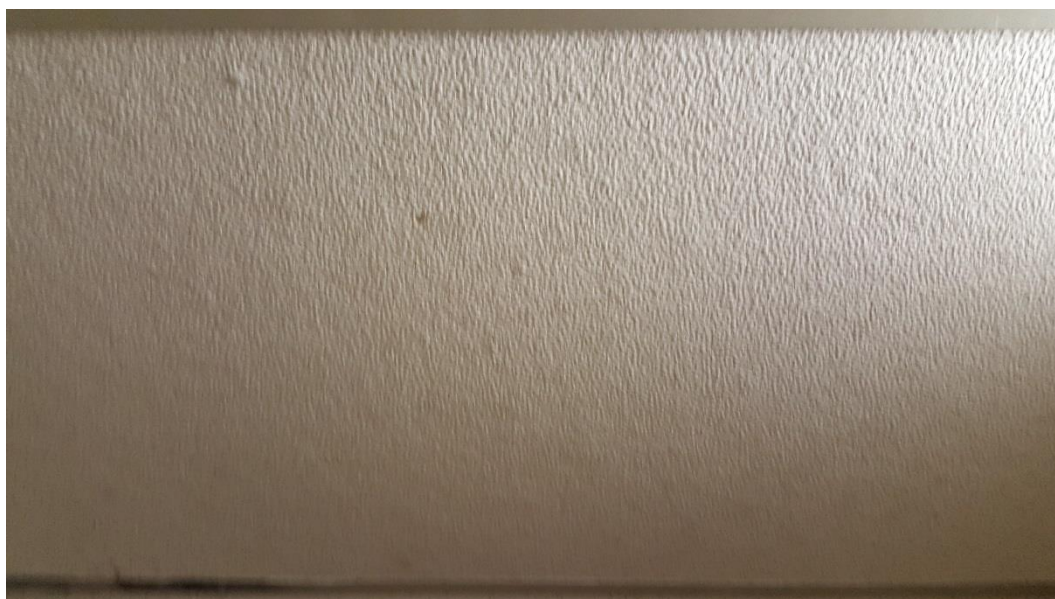
**Photo No. 8.**

**Location:**  
15<sup>th</sup> Floor Corridor  
(Loc. 41-1500)

**Description:**  
Non-asbestos Ceiling  
Tile 2 (CT2) – 2'x4'  
Textured

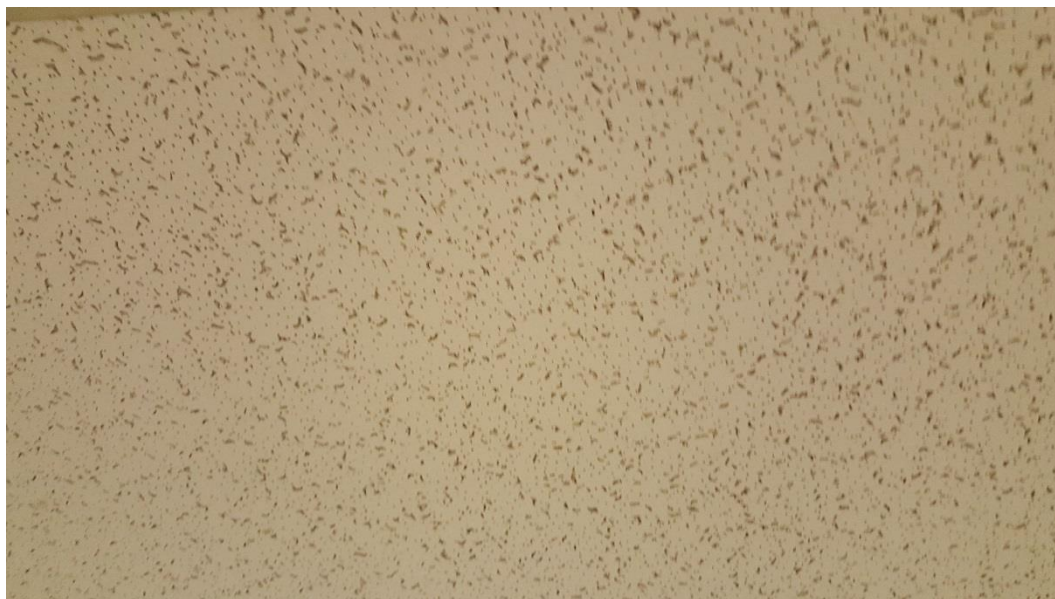
**Photo No. 9.**

**Location:**  
First Floor Corridor  
(Loc. 41-100)

**Description:**  
Non-asbestos Ceiling  
Tile 3 (CT3) – 2'x4'  
Short Hooked  
Random Fleck and  
Pinhole

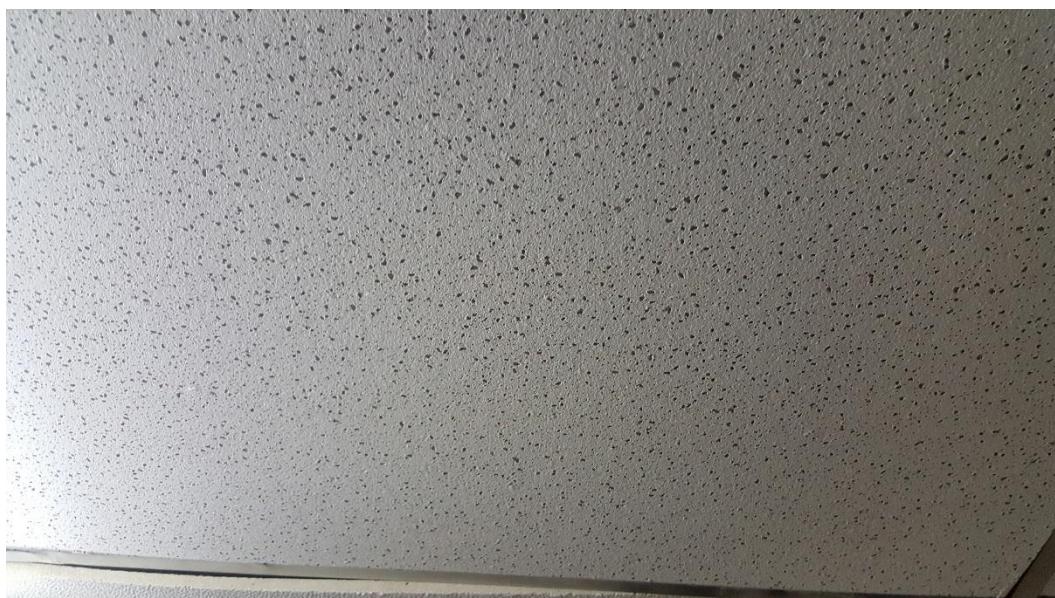
**Photo No. 10.**

**Location:**  
Office Area  
(Loc. 41-108)

**Description:**  
Non-asbestos Ceiling  
Tile 4 (CT4) – 2'x4'  
Small and Medium  
Dimple

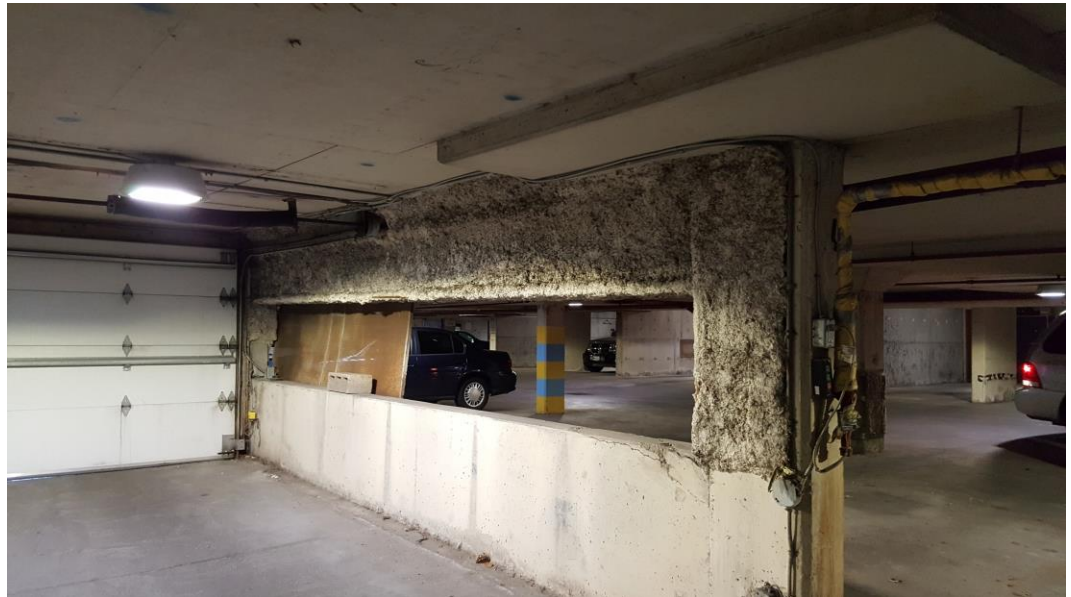
**Photo No. 11.**

**Location:**  
Parking Garage  
(Loc. 41-004)

**Description:**  
Non-asbestos sprayed  
fireproofing
