Sutton District High School

Ground Floor Plan

CLIENT: York Region District School Board

PROJECT NUMBER: 15785-35 DATE: September 2015 DRW BY: MM

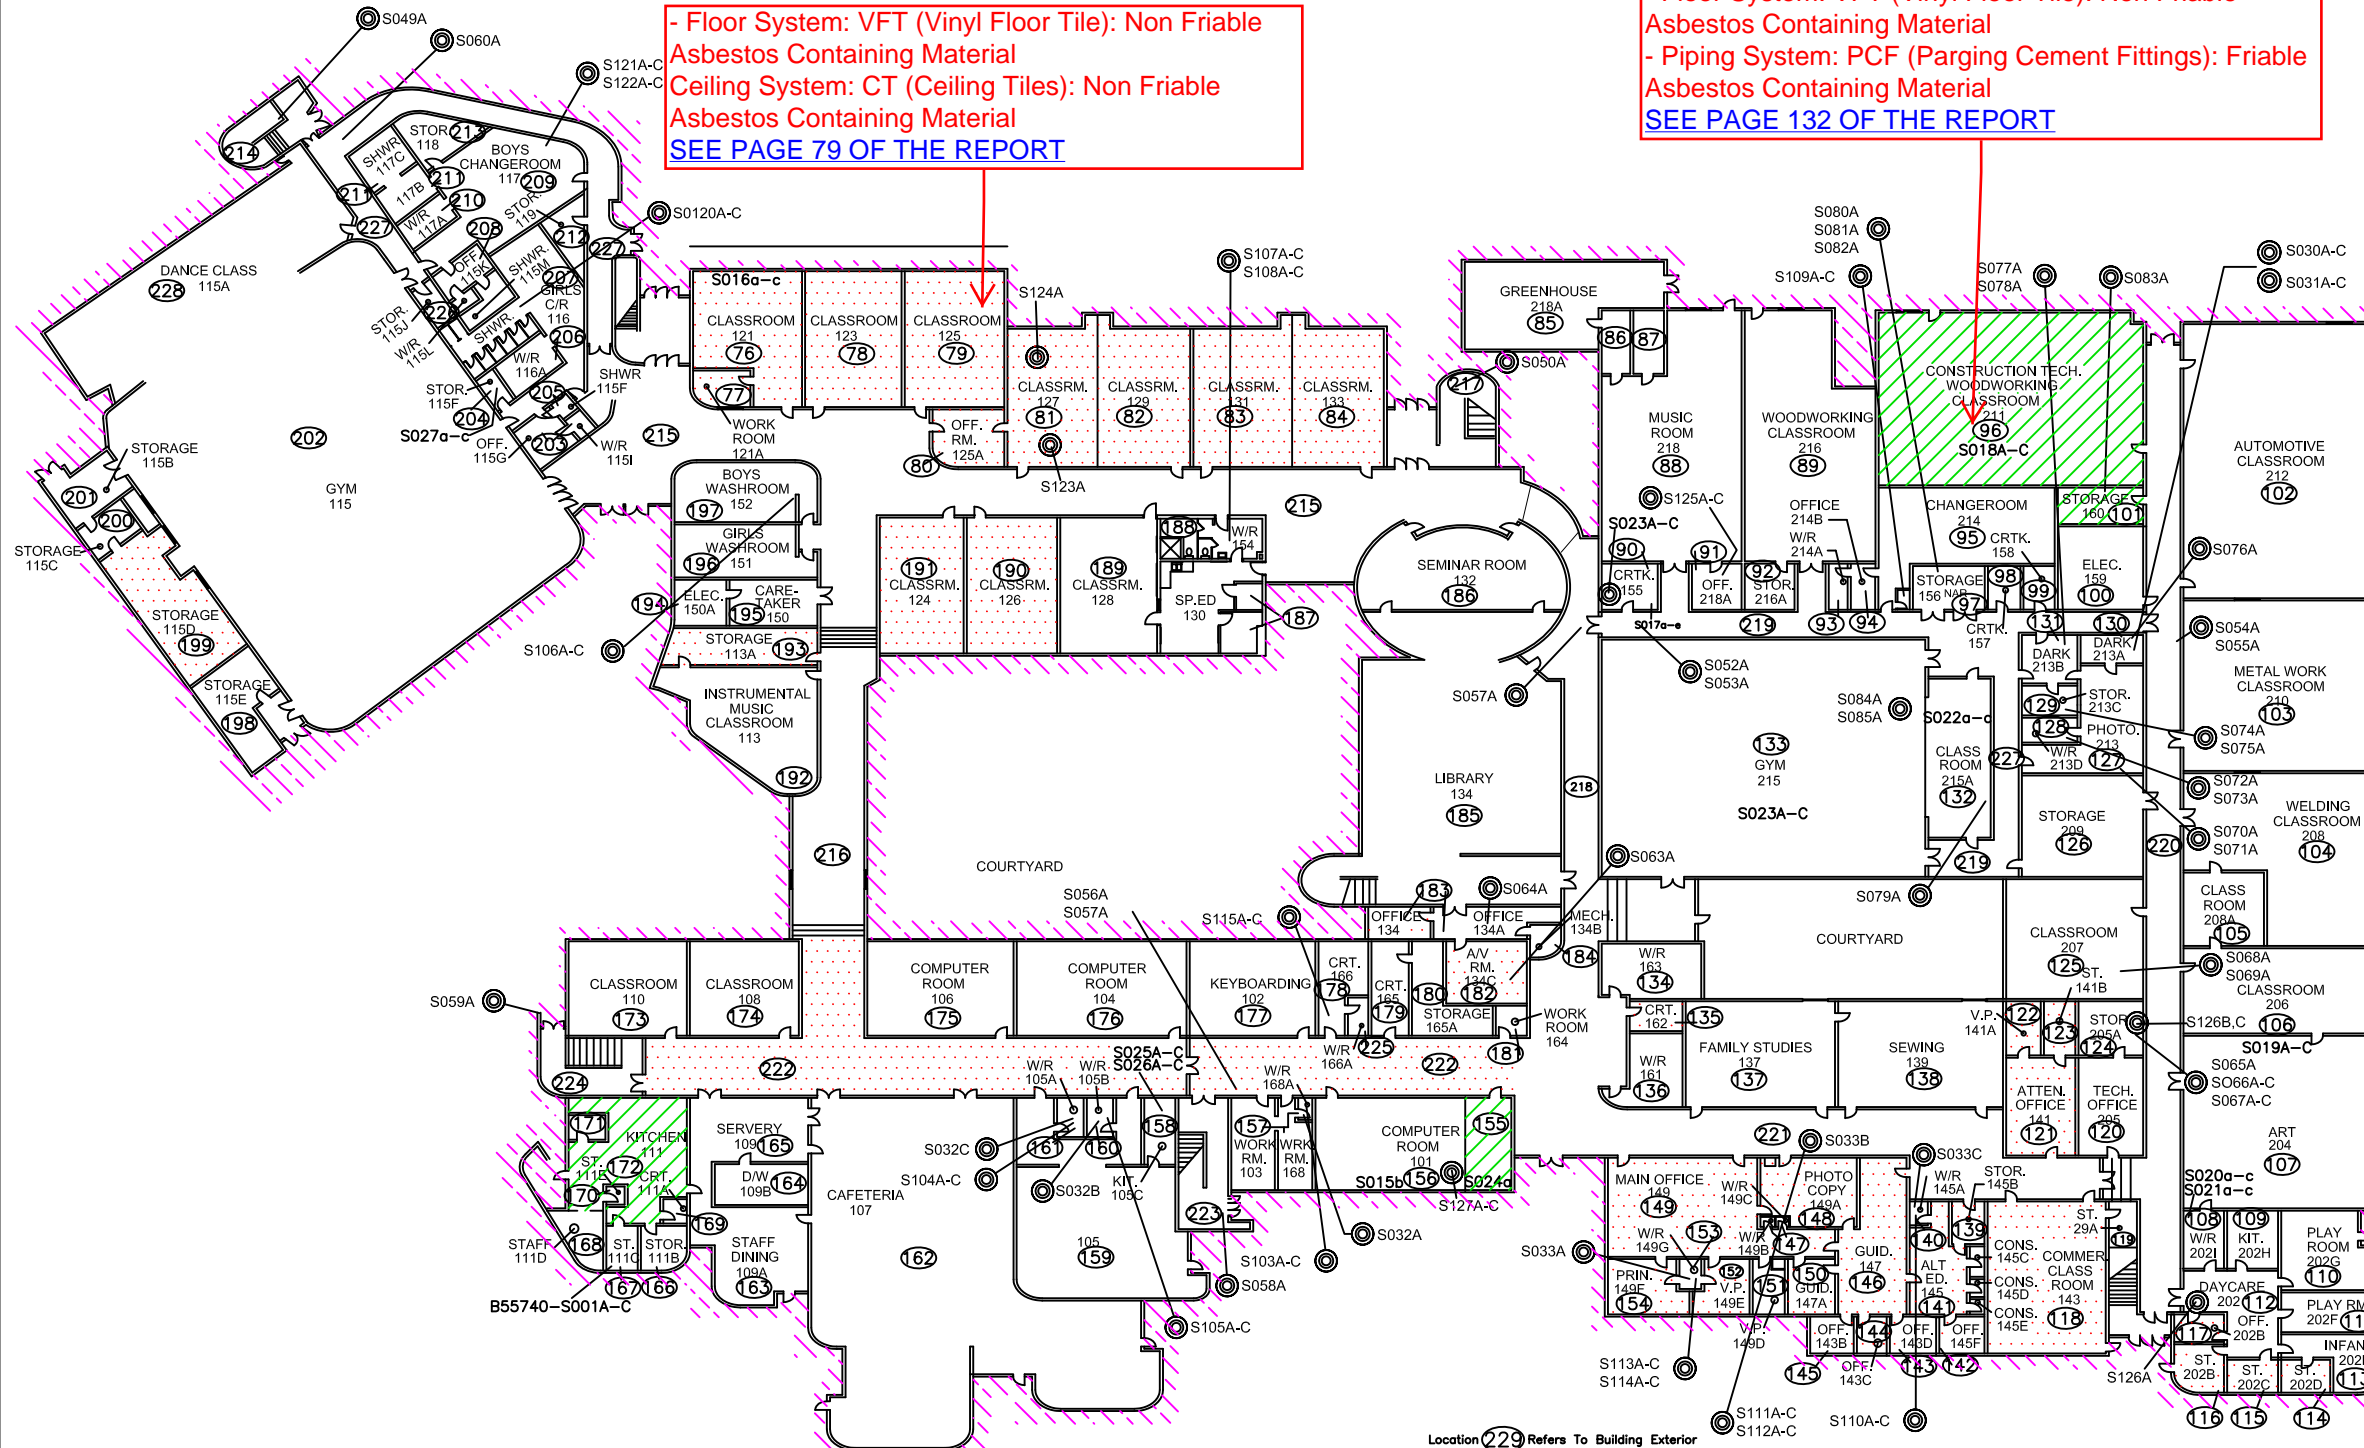
Figure 1

Please Note:
ASBESTOS CONTAINING Vermiculite is present within the exterior concrete block wall cavities throughout this facility.

Drywall Joint Compound (DJC) have been identified as ASBESTOS CONTAINING throughout the building.

- Floor System: VFT (Vinyl Floor Tile): Non Friable
Asbestos Containing Material
Ceiling System: CT (Ceiling Tiles): Non Friable
Asbestos Containing Material
SEE PAGE 79 OF THE REPORT

- Floor System: VFT (Vinyl Floor Tile): Non Friable
Asbestos Containing Material
- Piping System: PCF (Parging Cement Fittings): Friable
Asbestos Containing Material
SEE PAGE 132 OF THE REPORT

- Other System: Chalkboard: Presumed Non Friable
Asbestos Containing Material
- Ceiling System: CT (Ceiling Tiles): Non Friable
Asbestos Containing Materials
- Structure System: DJC (Drywall Joint Compound):
Non-Friable Asbestos Containing Material
[SEE PAGE 42 OF THE REPORT](#)

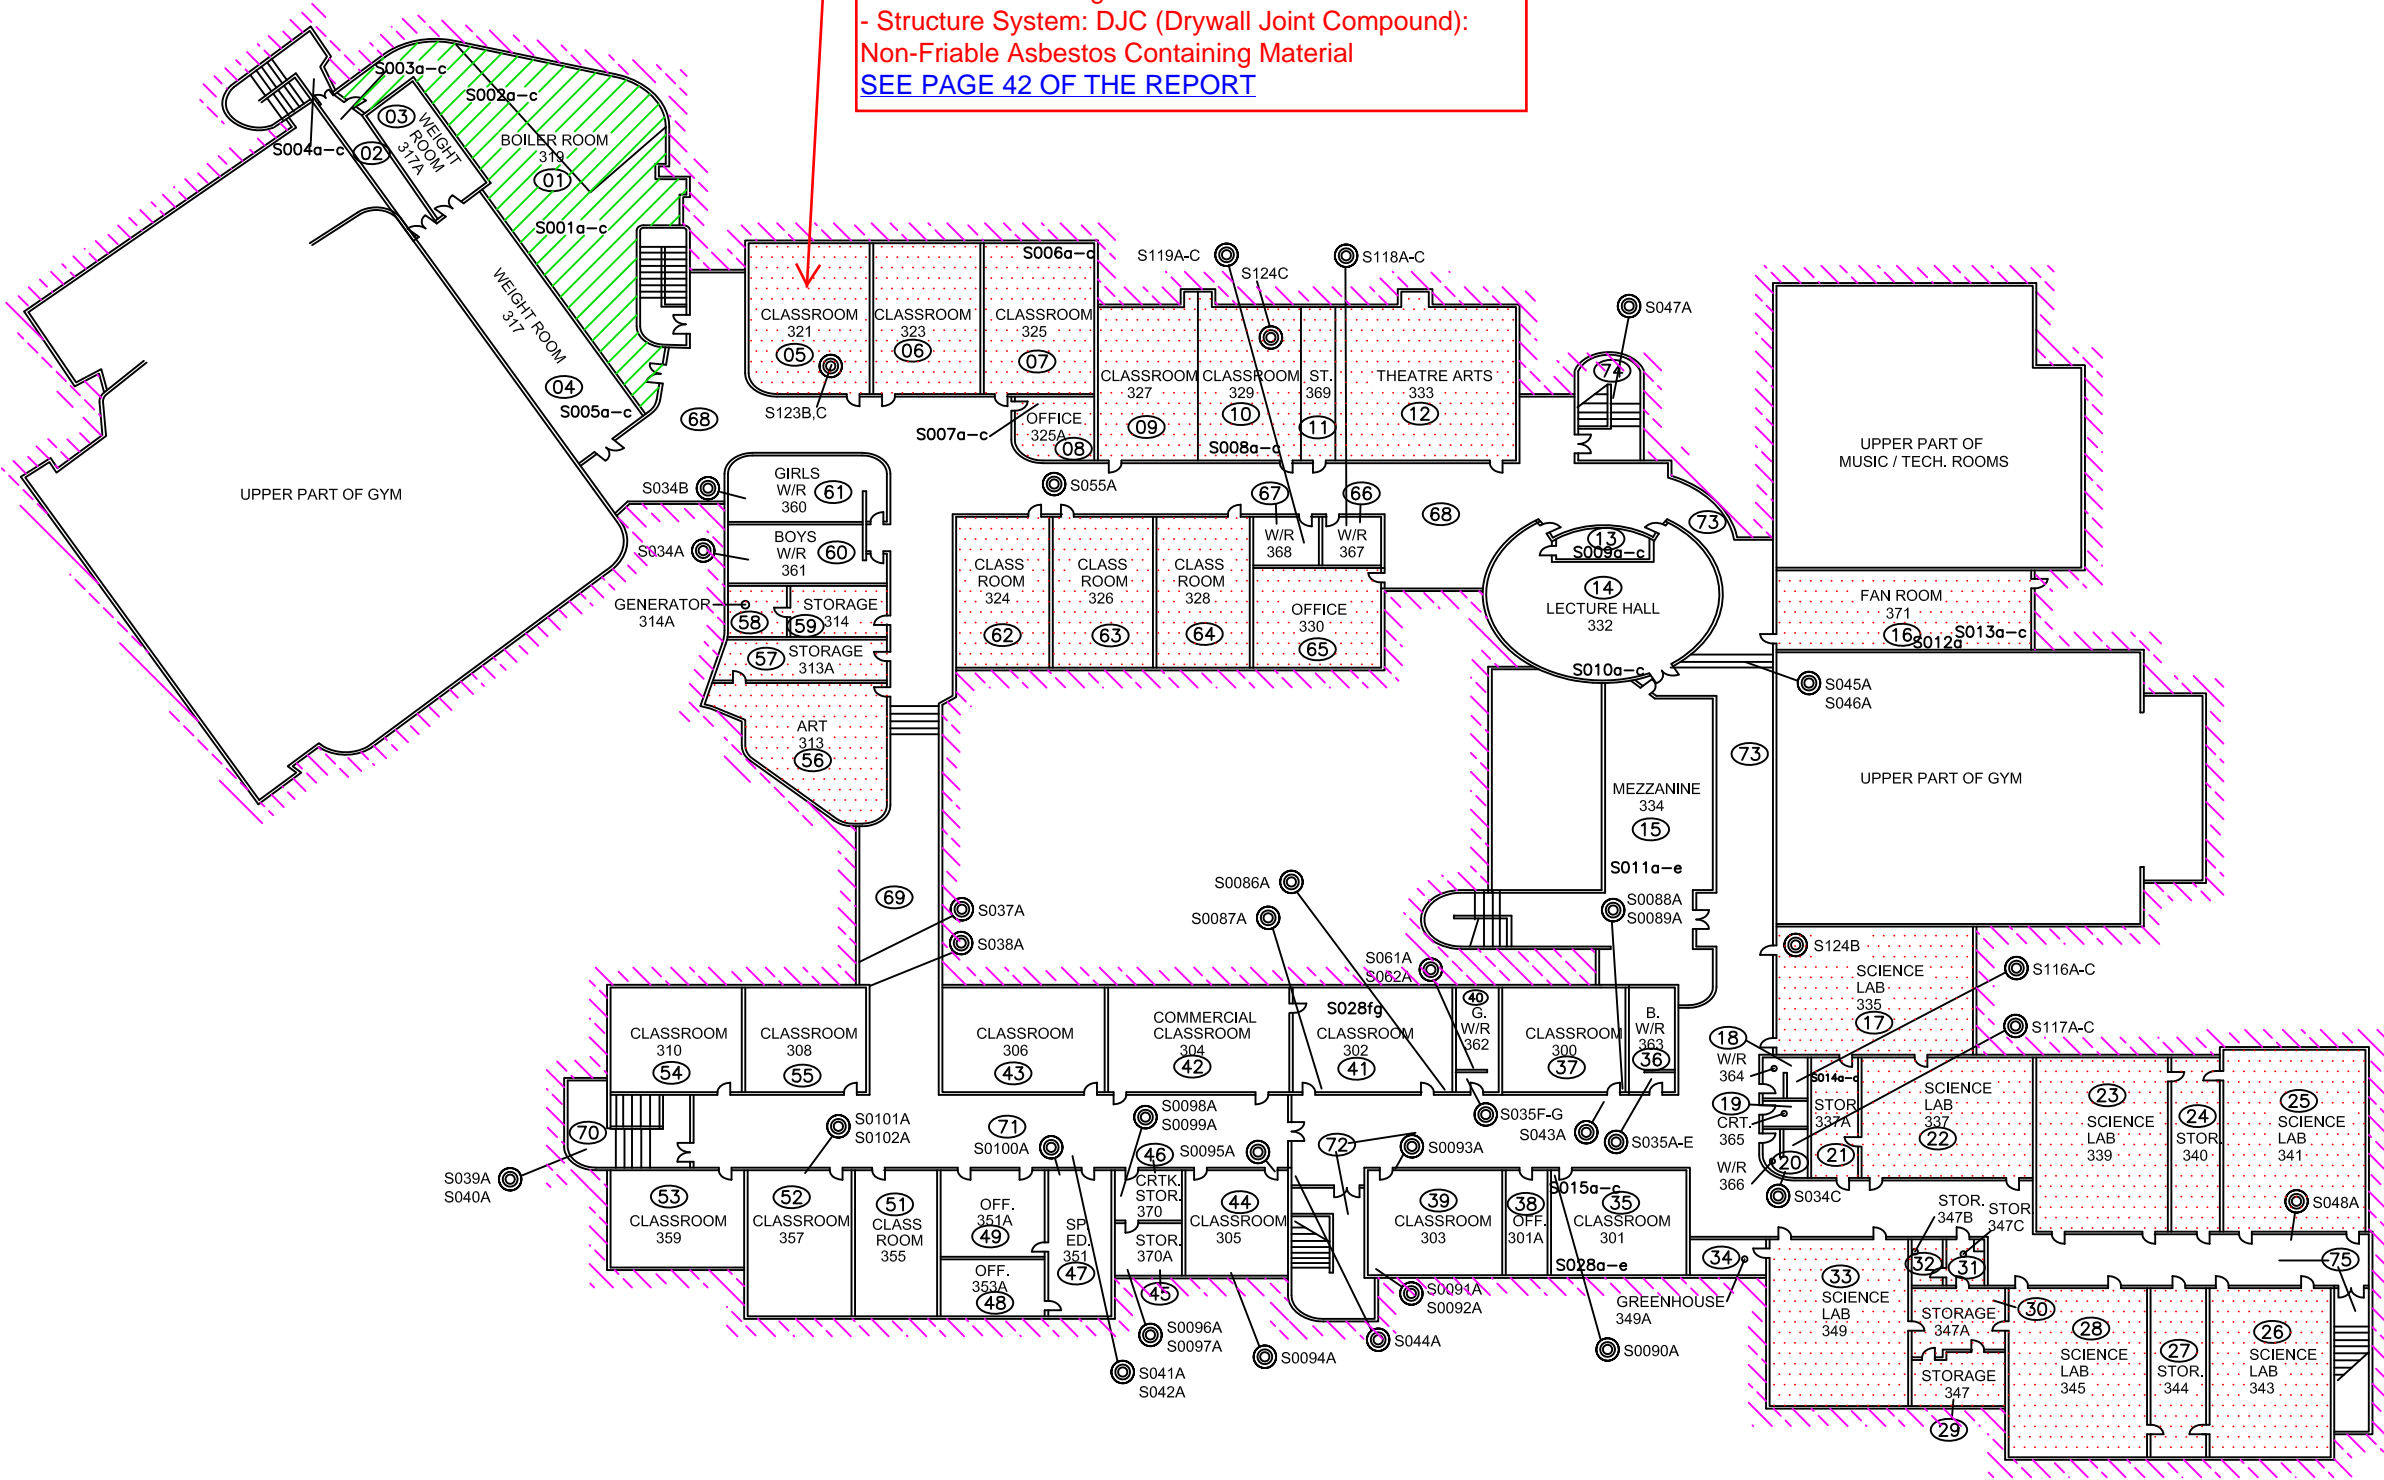
Figure 2

Please Note:
ASBESTOS CONTAINING Vermiculite is present within the exterior concrete block wall cavities throughout this facility.

Drywall Joint Compound (DJC) have been identified as ASBESTOS CONTAINING throughout the building.
