DESIGNATED SUBSTANCES ASSESSMENT

**Bridgeview I – District #2
Various Addresses
Windsor, Ontario**

**RFP No.: RFP 15-09
Building Code: 09
ECOH Project No.: 16313**

November 1, 2016

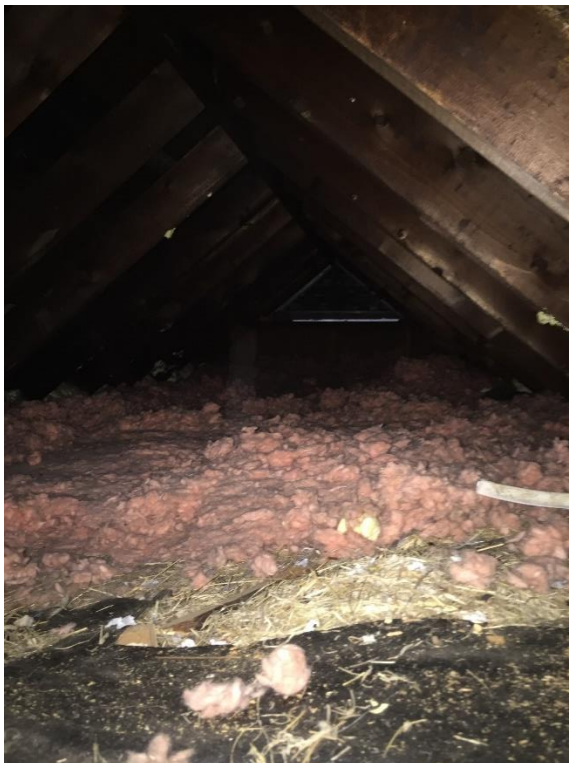
Location:
1275 Rankin Attic
(Loc. 09-1275-10)

Description:
Non-asbestos attic
insulation

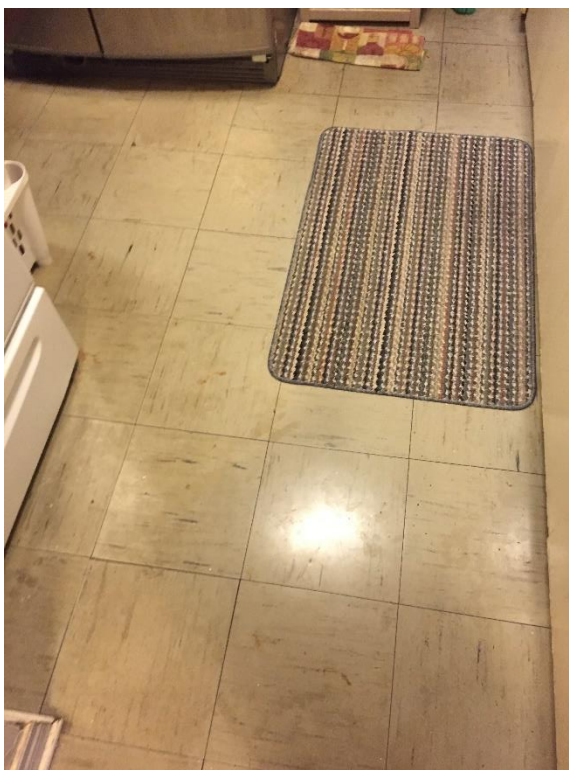
Photo No. 2.

Description:
Asbestos-containing Vinyl
Floor Tile 1 (VFT1) –
12”x12” Beige with Black
Veins.

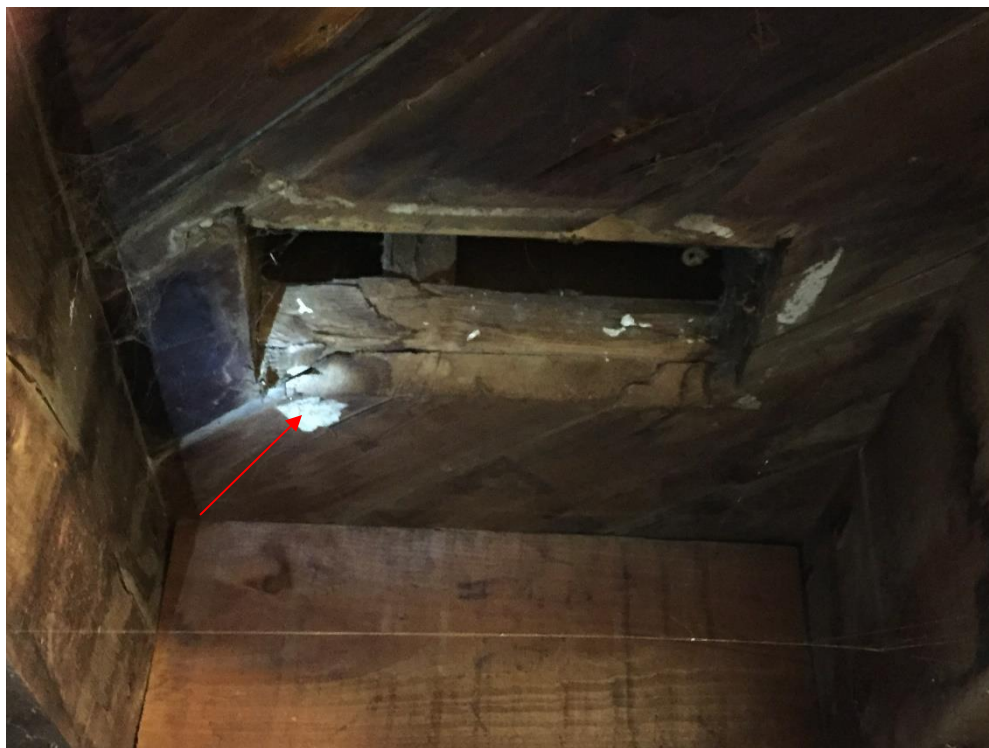
Location:
1181 Askin Basement
(Loc. 09-1181-01)

Description:
Asbestos-containing
Heat Shield residue
observed in POOR
condition
