N238PS — G1000 LOW VOLTS Troubleshooting Guide Aircraft: N238PS

(Diamond DA40NG, MAM40-858) Problem: G1000 NXi displays lower voltage than actual bus voltage, causing intermittent LOW VOLTS annunciations Date: February 2026 Prepared by: Aircraft Owner (Ingram Leedy)

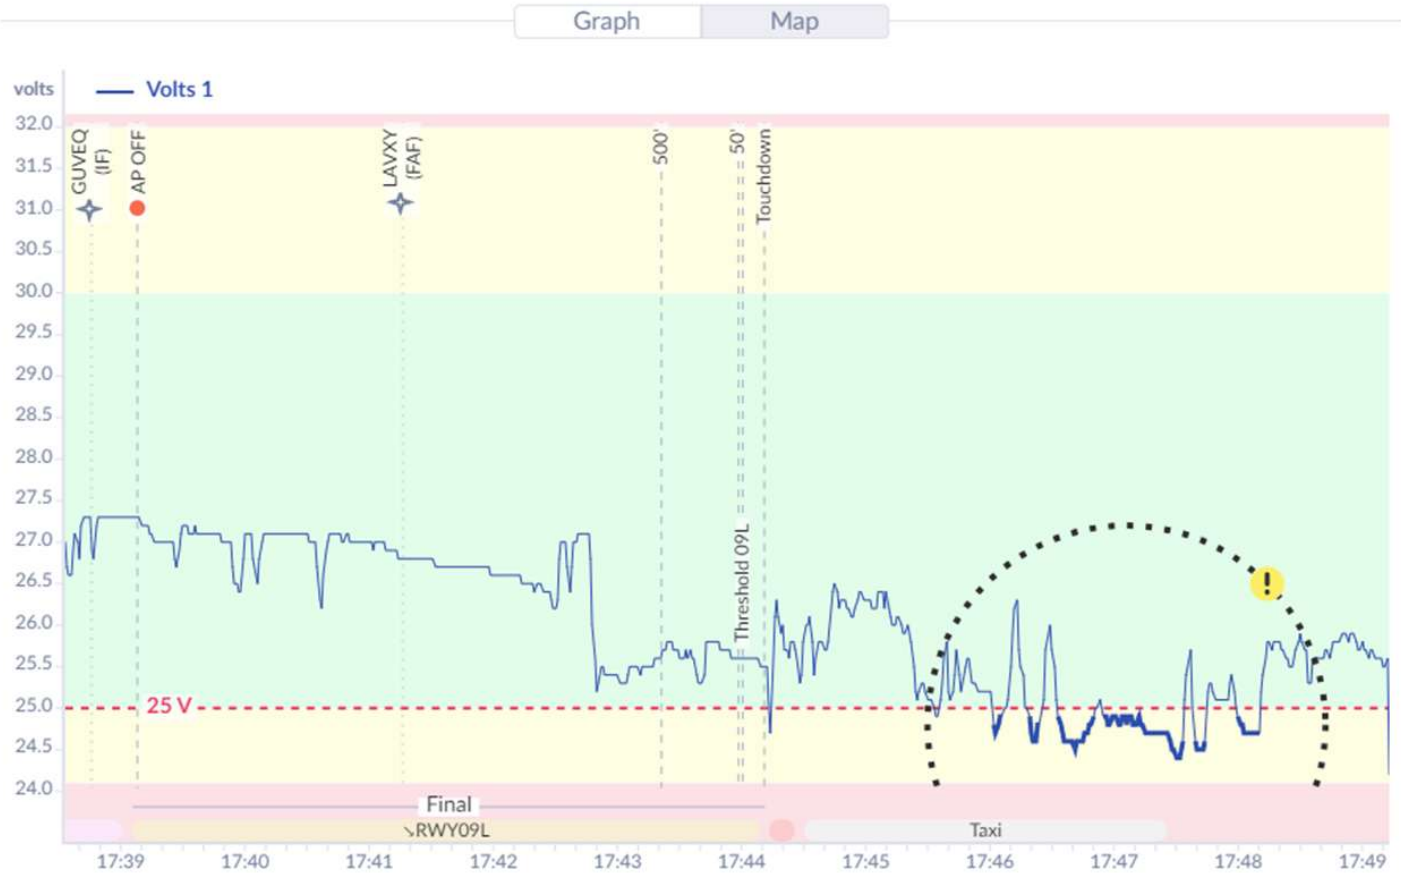
Volts < 25 V for 85 sec in total

The Problem The G1000 consistently reads 1–2 volts lower than actual bus voltage, with transient dips up to 5.6 volts low during high-current events. This causes false LOW VOLTS annunciations in flight even though the electrical system is charging normally. [FlySto LOW VOLTS Events \(In-Flight\)](#) These FlySto screenshots show actual LOW VOLTS events captured from G1000 flight logs. The voltage drops below the 25V threshold repeatedly during normal flight operations: 85 seconds below 25V — approach and taxi at KBOW, voltage swinging wildly between 24–27V:

dips are not real — the independent VDL48 logger shows the bus voltage is steady at ~28V during these same periods. The G1000 is the only instrument seeing these drops. **How We Know It's Real** Three independent
