# N238PS — G1000 LOW VOLTS Troubleshooting Guide Aircraft: N238PS

(Diamond DA40NG, MAM40-858) Problem: G1000 NXi displays lower voltage than actual bus voltage, causing intermittent LOW VOLTS annunciations Date: February 2026 Prepared by: Aircraft Owner (Ingram Leedy)

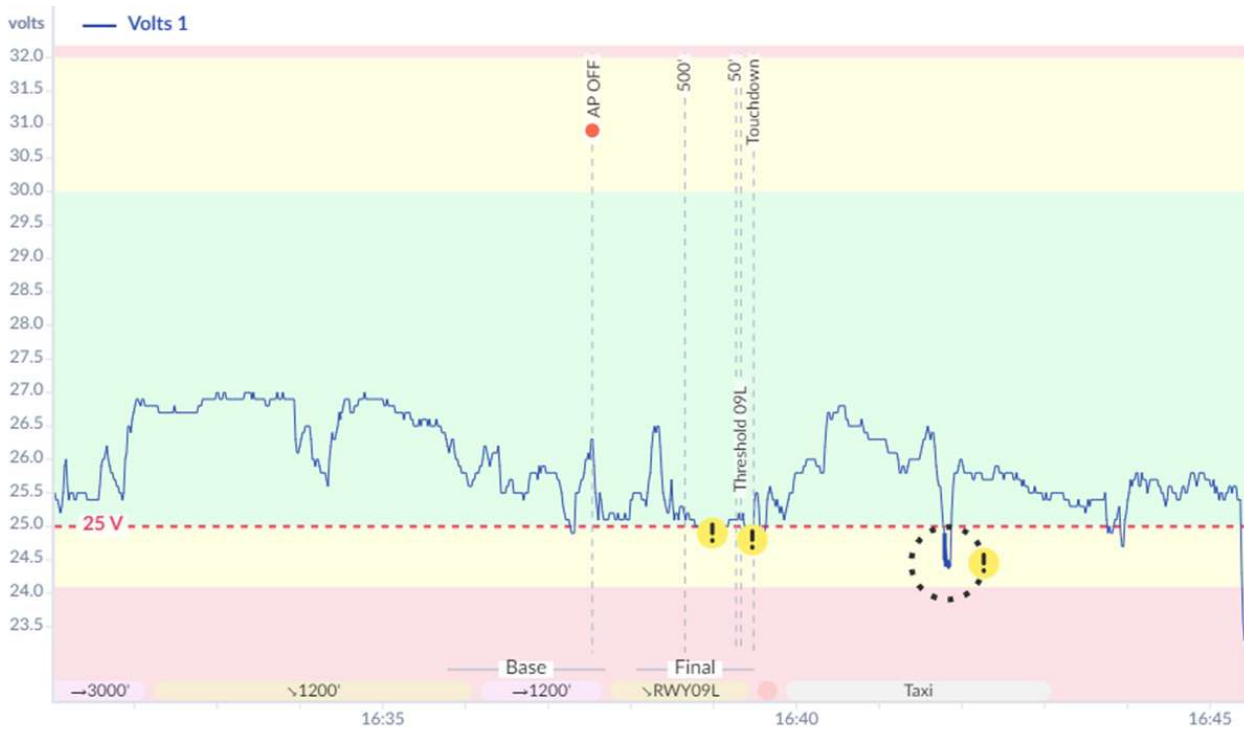
Volts < 25 V for 18 sec in total

18 seconds below 25V — during landing, and 5 seconds below 25V — at altitude during cruise:

dips are not real — the independent VDL48 logger shows the bus voltage is steady at ~28V during these same periods. The G1000 is the only instrument seeing these drops. **How We Know It's Real** Three independent

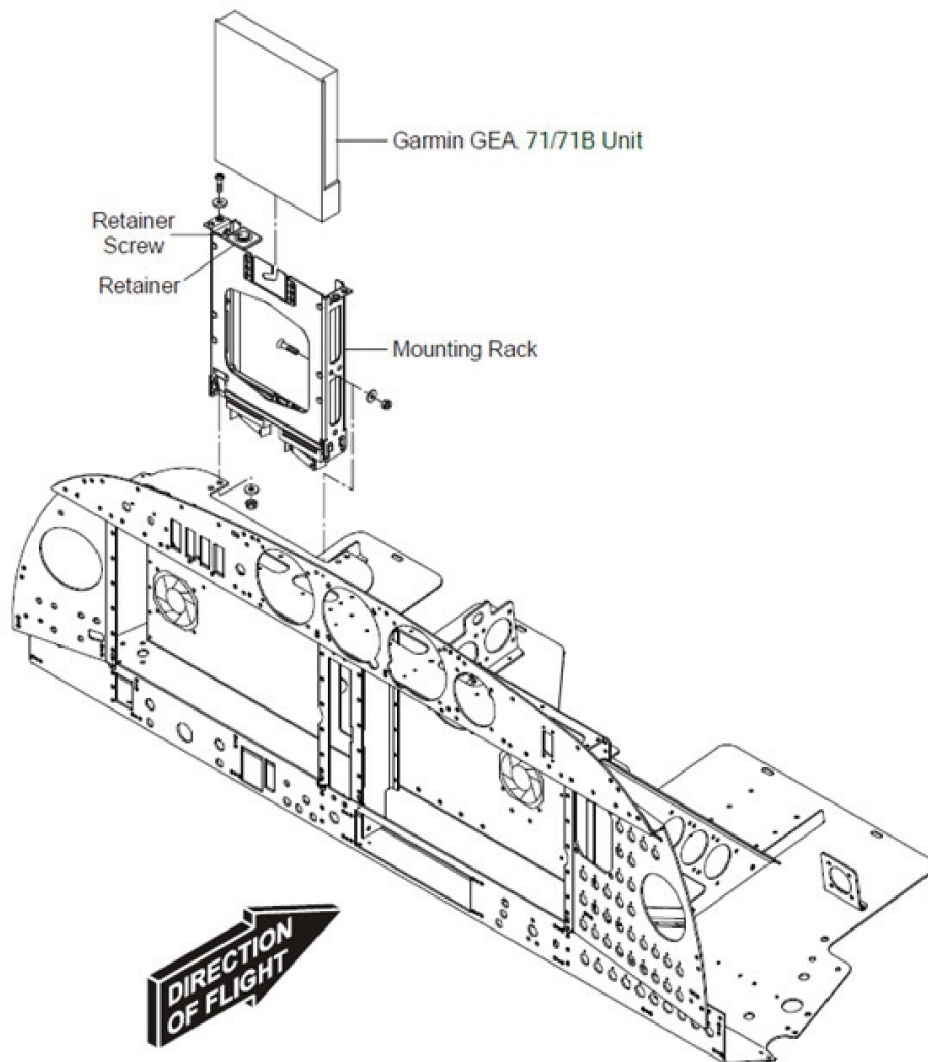
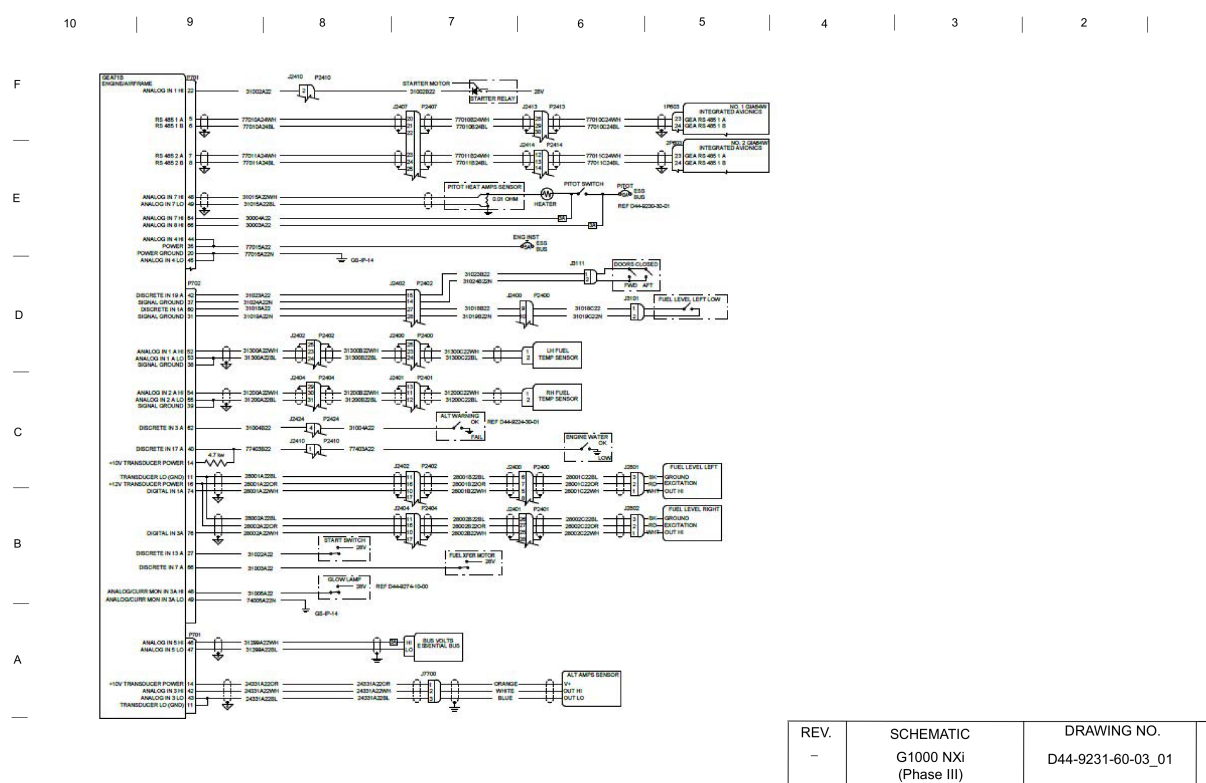
**Figure 6 : GEA 71 / 71B Processor Installation**

GEA 71S measures its own power supply voltage internally — there is no separate external sense wire Power input: Pin 35 (AIRCRAFT POWER) via wire 77015A22 from the Essential Bus through the 5A ENG INST breaker Ground reference: Pin 20 (POWER GROUND) via wire 77016A22N to ground stud GS-IP-14 The displayed voltage = what arrives at Pin 35 minus what's at Pin 20

Why Only the G1000 Reads Low The GEA 71S grounds through GS-IP-14, which routes through the instrument panel bus bar, IP frame, and fuselage structure to reach the battery negative terminal. Every joint in that chain adds potential resistance. The ECU (located under the pilot's seat) grounds through the GS-RP (Ground Stud — Relay Panel) studs, which use a separate ground path to battery negative. The ECU reads correctly — its ground path doesn't share the instrument panel's bus bar, frame bonds, or GS-IP studs. GEA 71S → GS-IP-14 → IP bus bar → IP frame → fuselage → battery negative (reads low) ECU → GS-RP studs → separate ground path → battery negative (reads correctly)

**Where to Look Instrument Panel** The GEA 71S — the unit that actually measures the voltage — is on the instrument panel shelf (AMM 31-40-00, p.985). Its connector P701 and ground stud GS-IP-14 are both in this area. Inspect: - GEA 71S connector P701 — is it fully seated with lock engaged? This is the voltage sensor unit. Check Pin 20 (power ground) and Pin 35 (aircraft power) specifically. - Ground stud GS-IP-14 — this is where the GEA 71S power ground wire (77016A22N) terminates. Check for loose nut, corrosion, or paint under the ring terminal. - All GS-IP ground studs on the IP bus bar (see table below) - Look for anything that appears disturbed, loose, or not fully reconnected **Ground Stud Locations (GS-IP Series)** All G1000 components ground to the GS-IP (Ground Stud — Instrument Panel) group. These are the specific studs and what's connected to each:
