# N238PS — G1000 LOW VOLTS Troubleshooting Guide

**Aircraft:** N238PS (Diamond DA40NG, MAM40-858) **Problem:** G1000 NXi displays lower voltage than actual bus voltage, causing intermittent LOW VOLTS annunciations **Date:** February 2026 **Prepared by:** Aircraft Owner (Ingram Leedy)

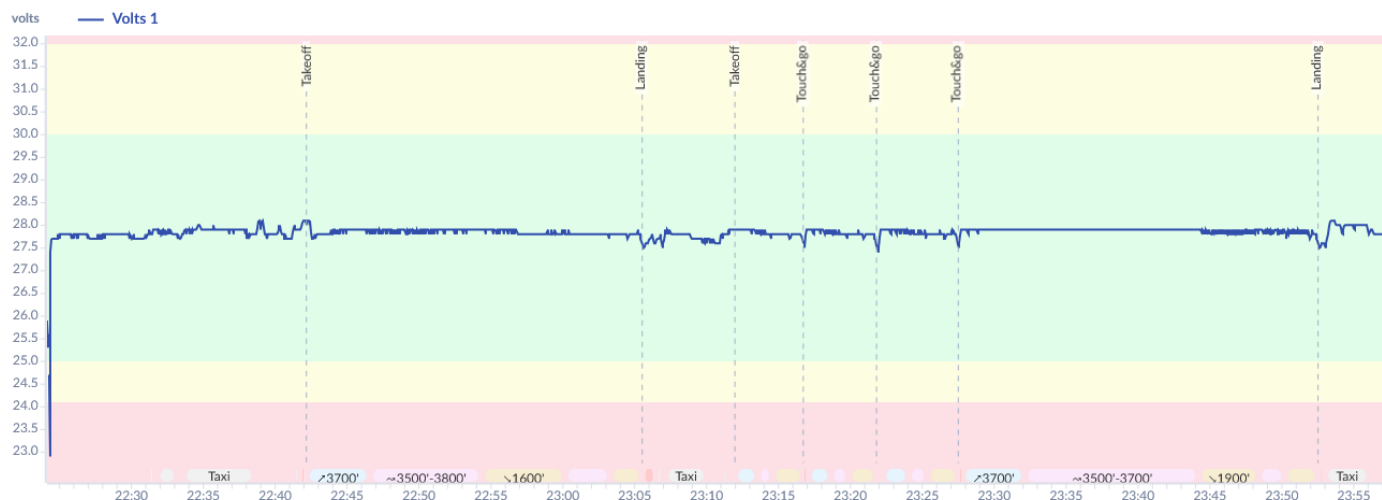
Comparing N238PS to another DA40NG (N541SA) shows something was never right — even from the delivery flight:

N541SA's G1000 reads rock-steady voltage at ~27.8V with barely any fluctuation. N238PS has **never** been this stable:

Even from delivery, N238PS was reading **0.25V low** and had **4–5x more voltage noise** than N541SA. This suggests a marginal ground connection has existed since the factory — the Feb 2024 shop visit then made it significantly worse.

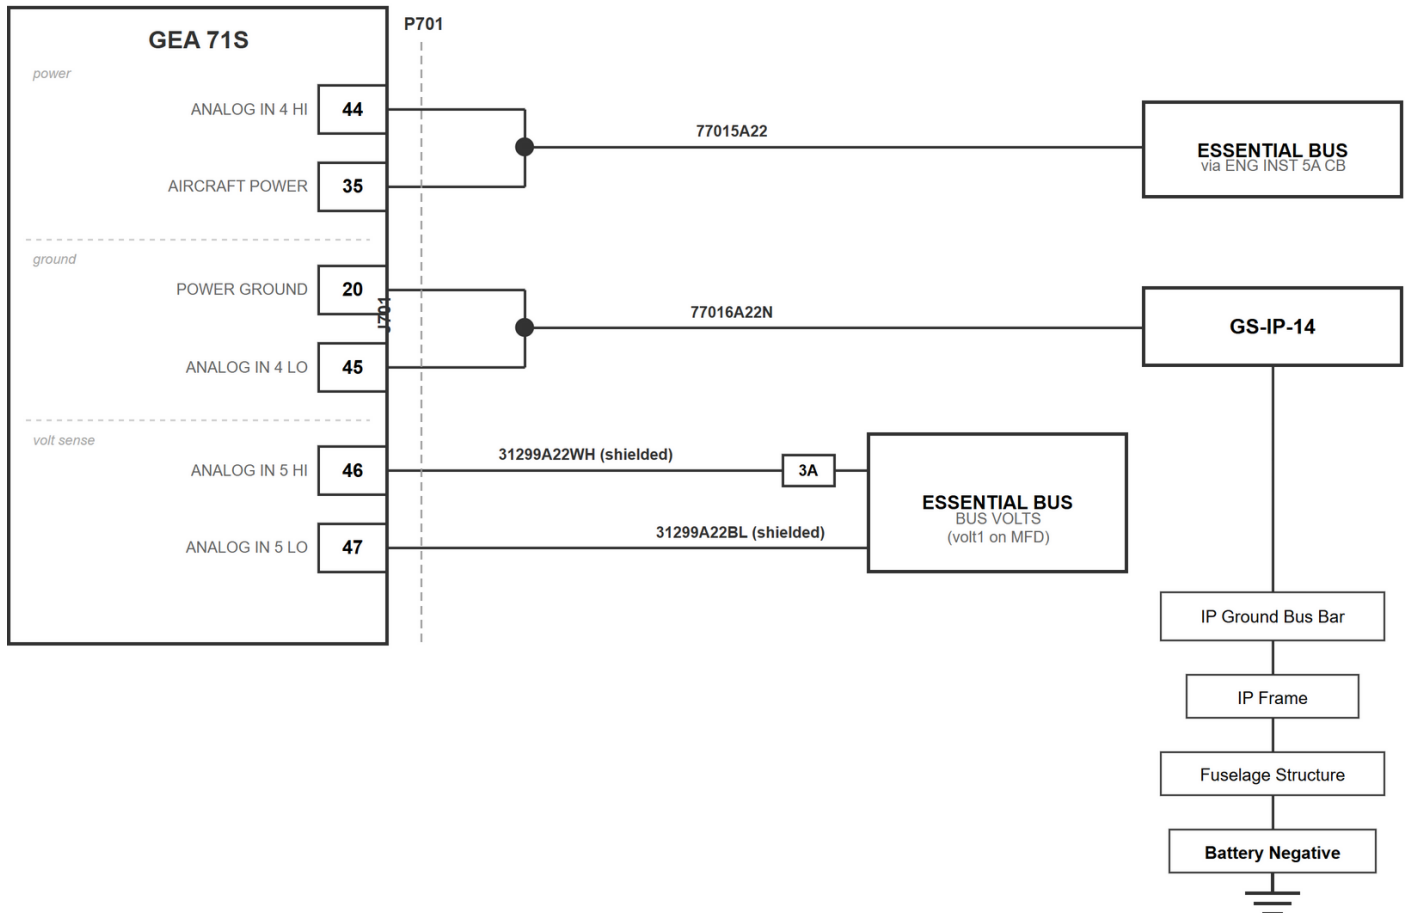
## GEA 71S — Voltage Measurement Path — N238PS (DA40 NG)

Both voltage channels share the same ground reference (Pin 20 (POWER GROUND) / Pin 45 (ANALOG IN 4 LO)) → wire 77016A22N → **GS-IP-14**). A high-resistance ground shifts **both** readings down equally.

The GEA 71S grounds through **GS-IP-14** (power ground Pin 20 (POWER GROUND) and Pin 45 (ANALOG IN 4 LO)), wire 77016A22N), which routes through the instrument panel bus bar, IP frame, and fuselage structure to reach the battery negative terminal. Every joint in that chain adds potential resistance.

**Inspect:** - **GEA 71S harness plug P701** — is it fully seated with lock engaged on the J701 receptacle? This connector carries all voltage measurement pins. Check Pin 20 (POWER GROUND), Pin 45 (ANALOG IN 4 LO), and Pin 35 (AIRCRAFT POWER) specifically. - **Ground stud GS-IP-14** — this is where the GEA 71S power ground wires (Pin 20 (POWER GROUND) and Pin 45 (ANALOG IN 4 LO), wire 77016A22N) terminate. Check for loose nut, corrosion, or paint under the ring terminals. - All GS-IP ground studs on the IP bus bar (see table below) - Look for anything that appears disturbed, loose, or not fully reconnected
