N238PS — G1000 LOW VOLTS Troubleshooting Guide

Aircraft: N238PS (Diamond DA40NG, MAM40-858) **Problem:** G1000 NXi displays lower voltage than actual bus voltage, causing intermittent LOW VOLTS annunciations **Date:** February 2026 **Prepared by:** Aircraft Owner (Ingram Leedy)

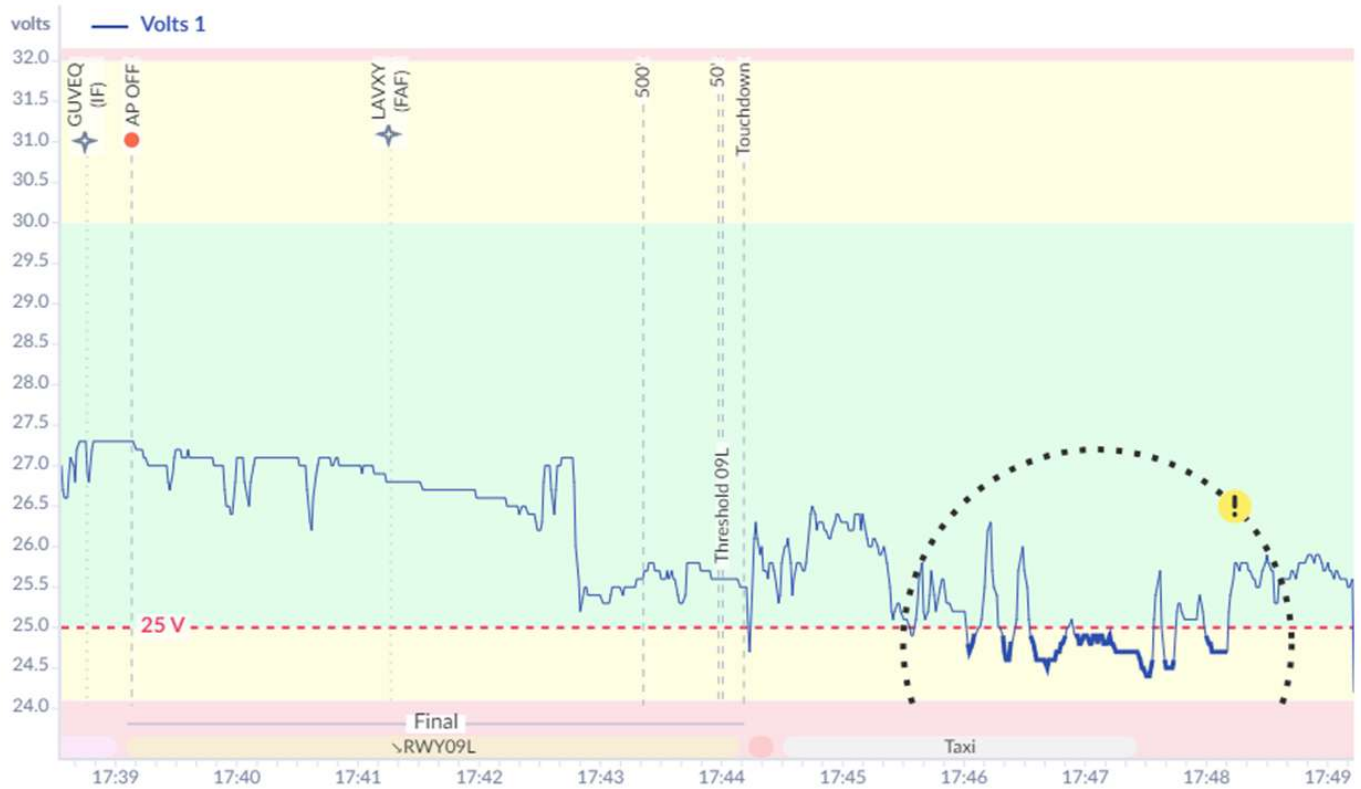
85 seconds below 25V — approach and taxi at KBOW, voltage swinging wildly between 24–27V:

These dips are **not real** — the independent VDL48 logger shows the bus voltage is steady at ~28V during these same periods. The G1000 is the only instrument seeing these drops.

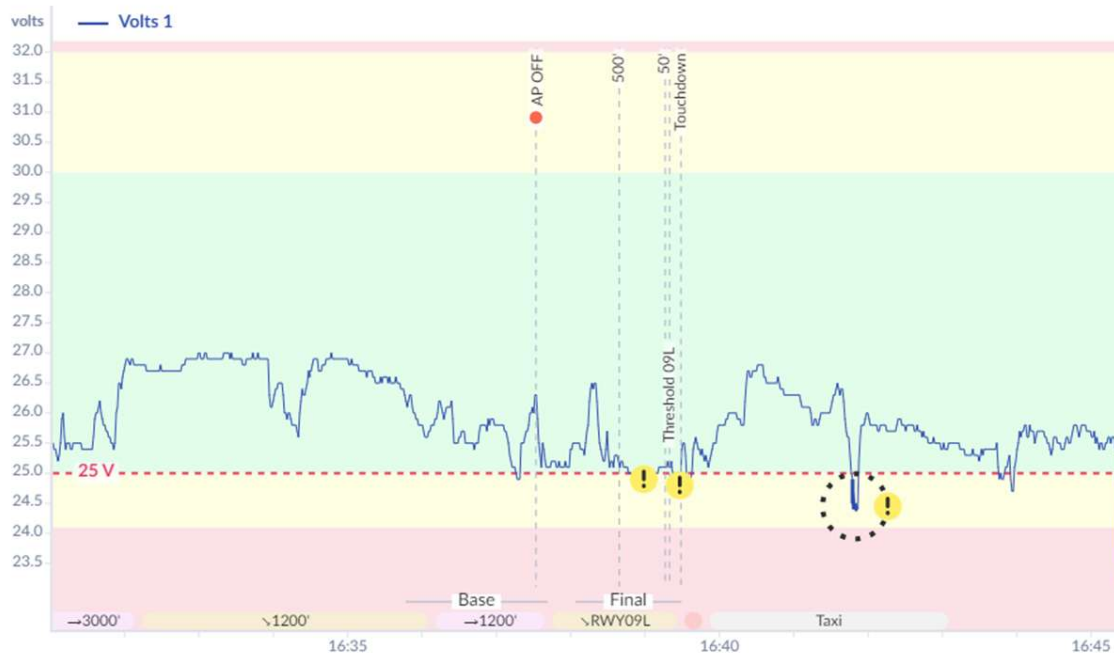
18 seconds below 25V — during landing, and **5 seconds below 25V** — at altitude during cruise:

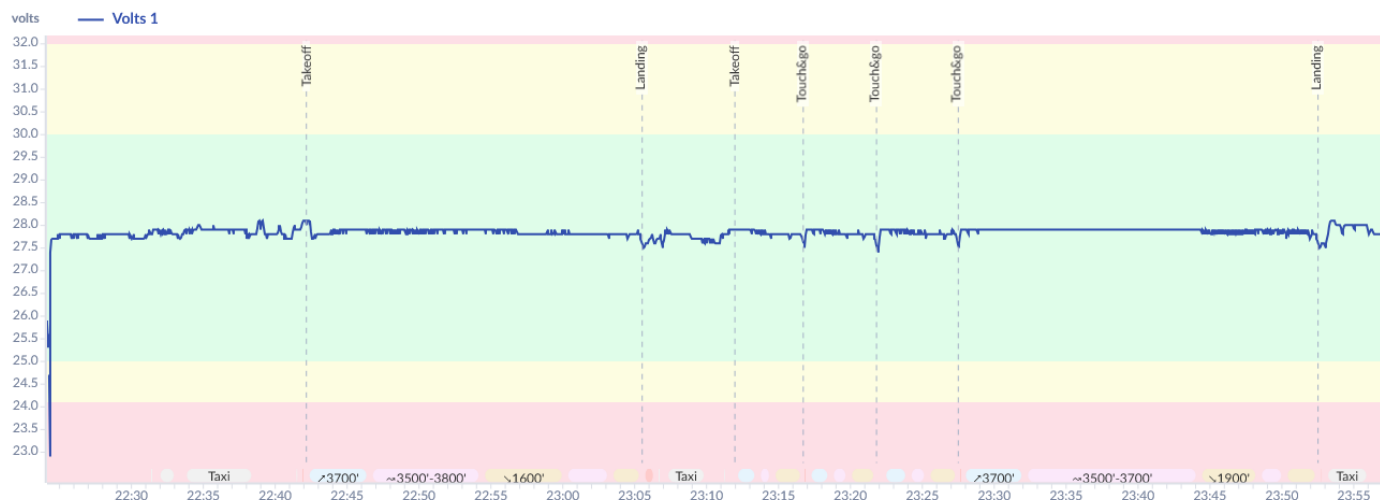
Comparing N238PS to another DA40NG (N541SA) shows something was never right — even from the delivery flight:

N541SA's G1000 reads rock-steady voltage at ~27.8V with barely any fluctuation. N238PS has **never** been this stable:

Even from delivery, N238PS was reading **0.25V low** and had **4–5x more voltage noise** than N541SA. This suggests a marginal ground connection has existed since the factory — the Feb 2024 shop visit then made it significantly worse.

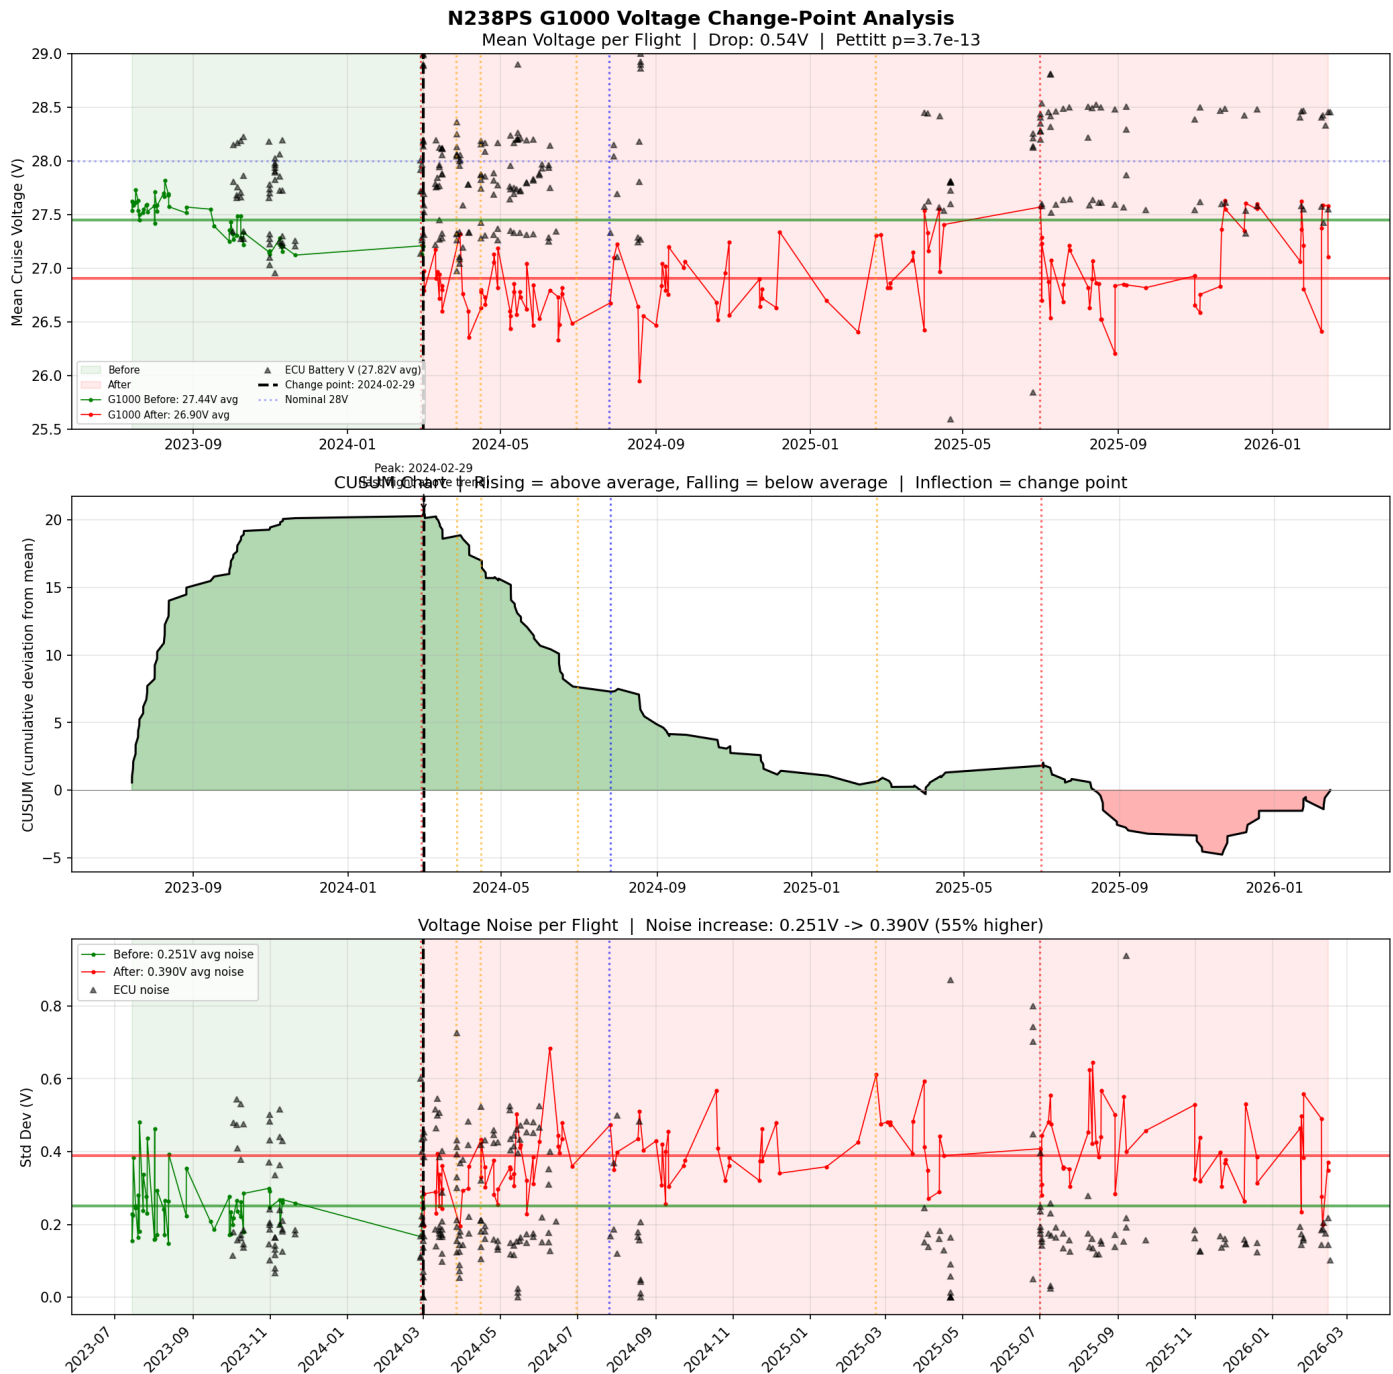
Statistical analysis of **184 flight logs** (Jul 2023 – Feb 2026) pinpoints exactly when the readings shifted. A statistically significant change-point was detected on **February 29, 2024**:

The ECU voltage did NOT change — it reads a steady 27.82V throughout the entire period. The problem is G1000-specific. The Feb 2024 shop visit made a pre-existing marginal connection worse, pushing it into LOW VOLTS territory.

- **Top panel** — Each dot is one flight's average voltage. Green = before Feb 2024, red = after. The ECU dots along the top stay flat at ~27.8V the entire time — the actual bus voltage never changed. Only the G1000 dropped.
- **Middle panel** — A trend line showing the problem is getting progressively worse over time, with a clear inflection at Feb 2024.
- **Bottom panel** — Voltage noise (how much the reading jumps around during each flight). After Feb 2024, noise increased 55% — consistent with a loose or corroded connection that vibration makes worse.

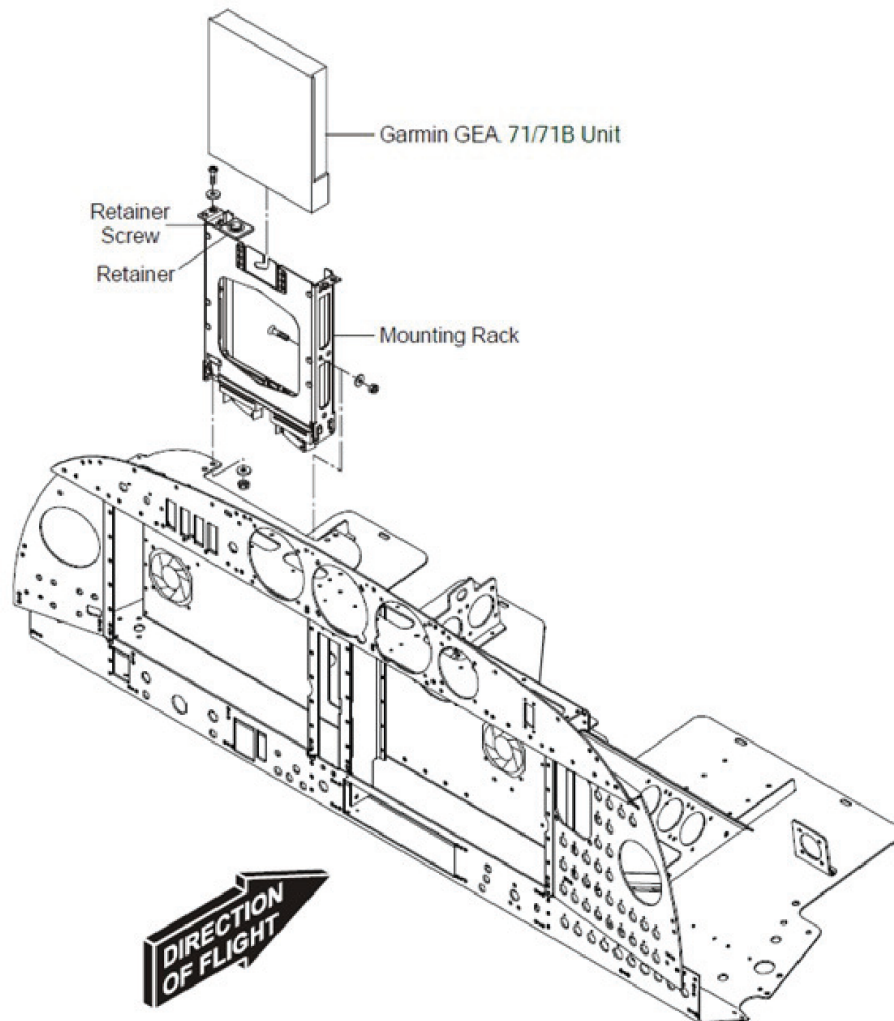
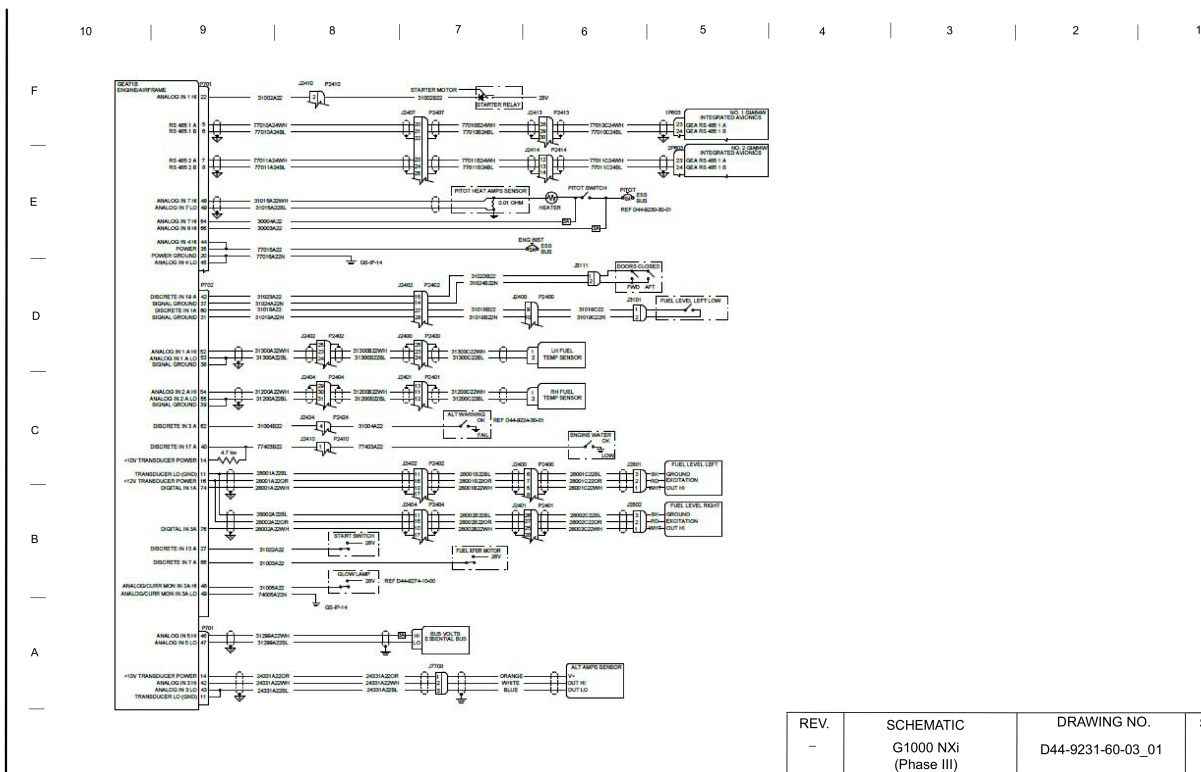
Figure 6 : GEA 71 / 71B Processor Installation

The G1000 bus voltage ("volt1") is measured by the **GEA 71S** (Engine/Airframe unit), which is mounted on the **instrument panel shelf** (AMM 31-40-00, p.985, Figure 6):

- The GEA 71S **measures its own power supply voltage internally** — there is no separate external sense wire
- **Power input:** Pin 35 (AIRCRAFT POWER) via wire **77015A22** from the Essential Bus through the **5A ENG INST** breaker
- **Ground reference:** Pin 20 (POWER GROUND) via wire **77016A22N** to ground stud **GS-IP-14**
- The displayed voltage = what arrives at Pin 35 minus what's at Pin 20

Inspect: - **GEA 71S connector P701** — is it fully seated with lock engaged? This is the voltage sensor unit. Check Pin 20 (power ground) and Pin 35 (aircraft power) specifically. - **Ground stud GS-IP-14** — this is where the GEA 71S power ground wire (77016A22N) terminates. Check for loose nut, corrosion, or paint under the ring terminal. - All GS-IP ground studs on the IP bus bar (see table below) - Look for anything that appears disturbed, loose, or not fully reconnected
