N238PS — G1000 LOW VOLTS Troubleshooting Guide

Aircraft: N238PS (Diamond DA40NG, MAM40-858) **Problem:** G1000 NXi displays lower voltage than actual bus voltage, causing intermittent LOW VOLTS annunciations **Date:** February 2026 **Prepared by:** Aircraft Owner (Ingram Leedy)

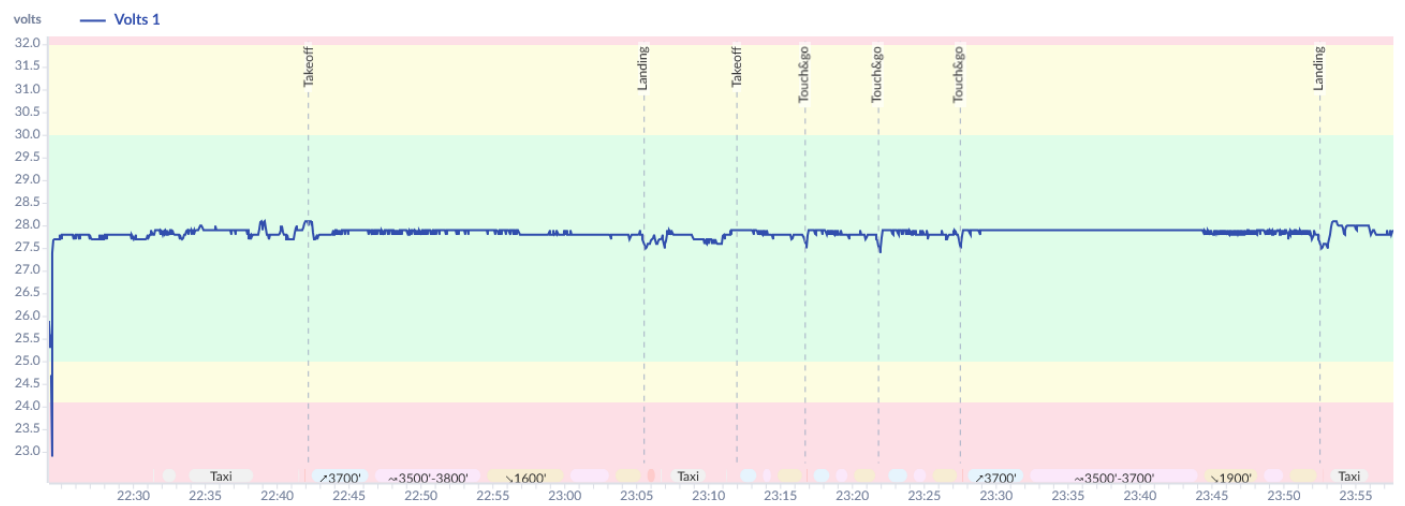
Comparing N238PS to another DA40NG (N541SA) shows something was never right — even from the delivery flight:

N541SA's G1000 reads rock-steady voltage at ~27.8V with barely any fluctuation. N238PS has **never** been this stable:

Even from delivery, N238PS was reading **0.25V low** and had **4–5x more voltage noise** than N541SA. This suggests a marginal ground connection has existed since the factory — the Feb 2024 shop visit then made it significantly worse.

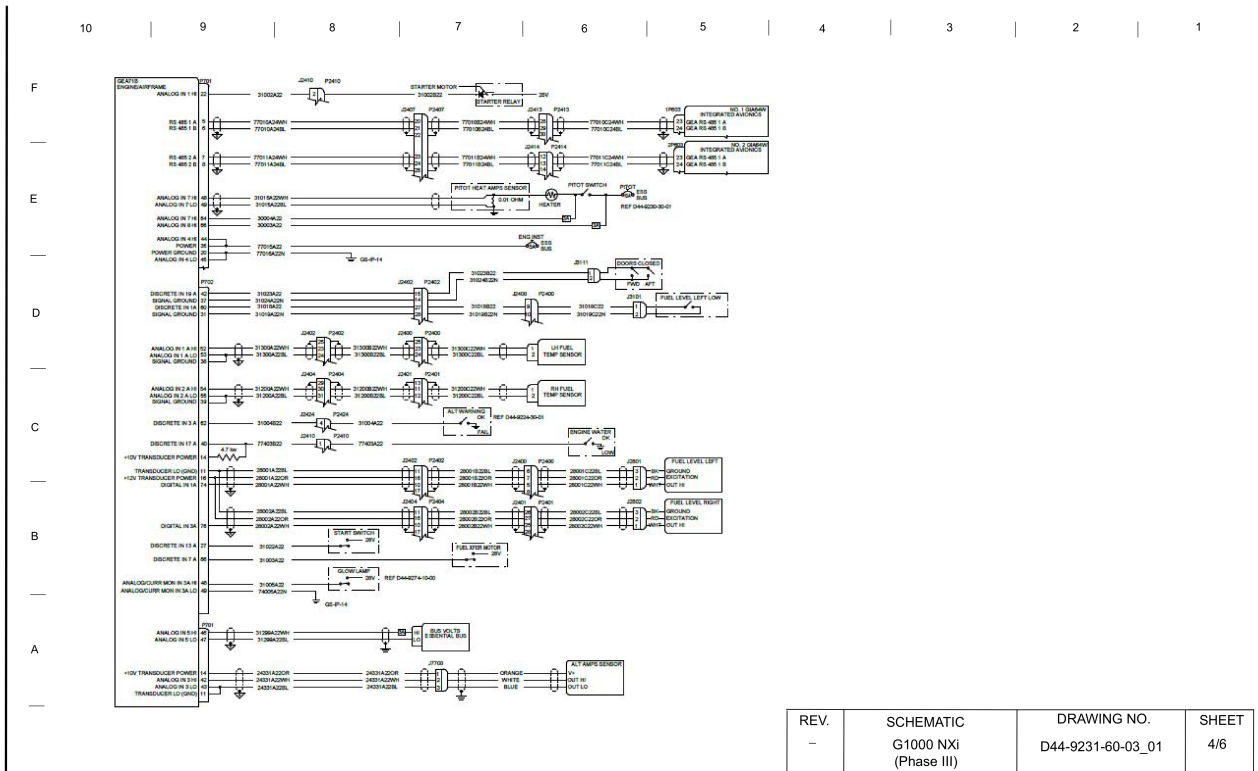
Figure 6 : GEA 71 / 71B Processor Installation

The G1000 bus voltage ("volt1") is measured by the **GEA 71S** (Engine/Airframe unit), which is mounted on the **instrument panel shelf** (AMM 31-40-00, p.985, Figure 6):

- The GEA 71S **measures its own power supply voltage internally** — there is no separate external sense wire
- **Power input:** Pin 35 (AIRCRAFT POWER) via wire **77015A22** from the Essential Bus through the **5A ENG INST** breaker
- **Ground reference:** Pin 20 (POWER GROUND) via wire **77016A22N** to ground stud **GS-IP-14**
- The displayed voltage = what arrives at Pin 35 minus what's at Pin 20

Inspect: - **GEA 71S connector P701** — is it fully seated with lock engaged? This is the voltage sensor unit. Check Pin 20 (power ground) and Pin 35 (aircraft power) specifically. - **Ground stud GS-IP-14** — this is where the GEA 71S power ground wire (77016A22N) terminates. Check for loose nut, corrosion, or paint under the ring terminal. - All GS-IP ground studs on the IP bus bar (see table below) - Look for anything that appears disturbed, loose, or not fully reconnected
