# N238PS — G1000 LOW VOLTS Troubleshooting Guide Aircraft: N238PS

(Diamond DA40NG, MAM40-858) Problem: G1000 NXi displays lower voltage than actual bus voltage, causing intermittent LOW VOLTS annunciations Date: February 2026 Prepared by: Aircraft Owner (Ingram Leedy)

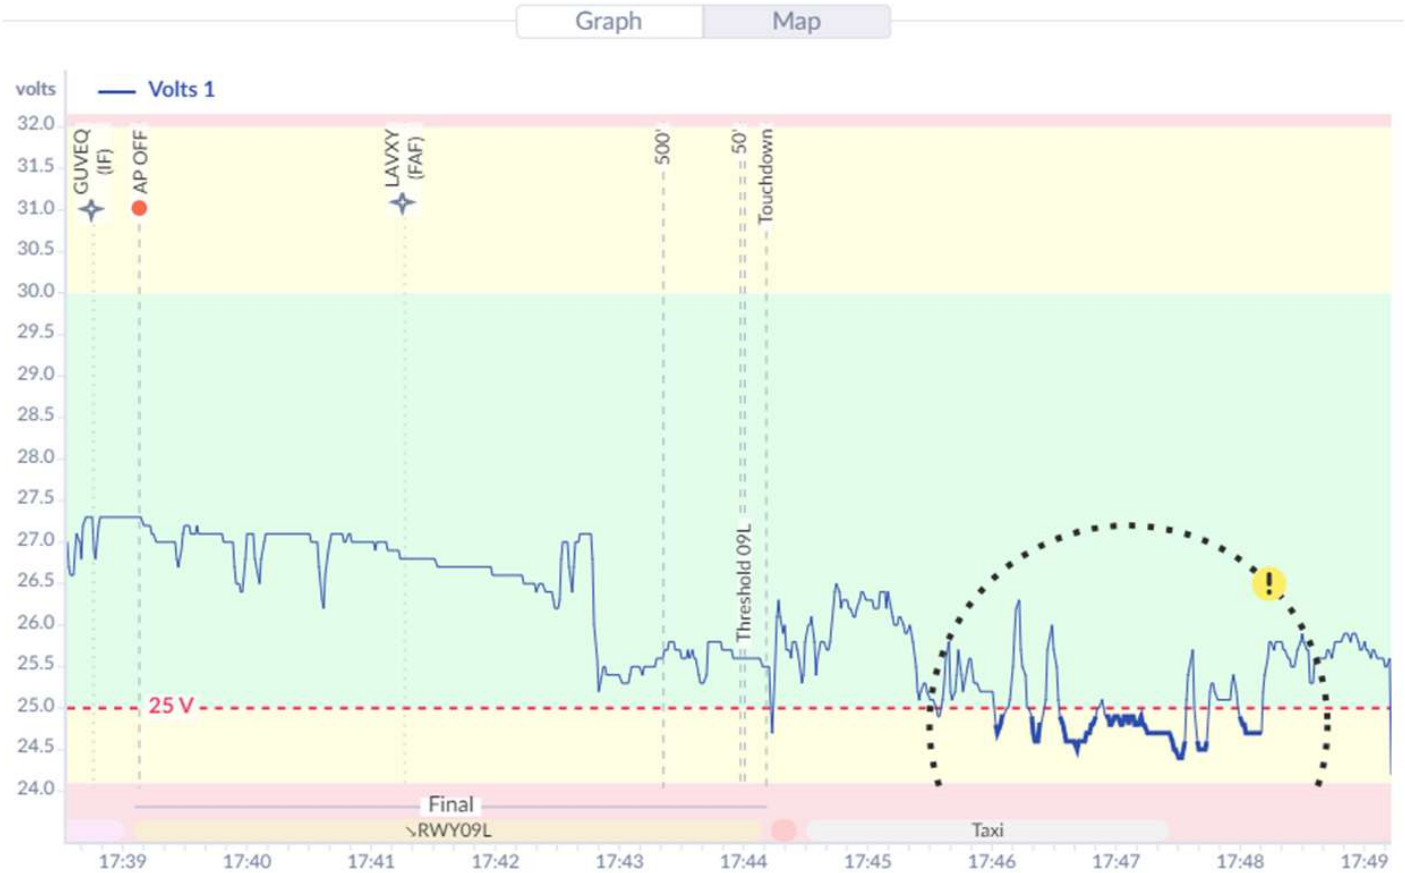
Volts < 25 V for 85 sec in total

**The Problem** The G1000 consistently reads 1–2 volts lower than actual bus voltage, with transient dips up to 5.6 volts low during high-current events. This causes false LOW VOLTS annunciations in flight even though the electrical system is charging normally. [FlySto LOW VOLTS Events \(In-Flight\)](#) These FlySto screenshots show actual LOW VOLTS events captured from G1000 flight logs. The voltage drops below the 25V threshold repeatedly during normal flight operations: 85 seconds below 25V — approach and taxi at KBOW, voltage swinging wildly between 24–27V:

dips are not real — the independent VDL48 logger shows the bus voltage is steady at ~28V during these same periods. The G1000 is the only instrument seeing these drops. **How We Know It's Real** Three independent

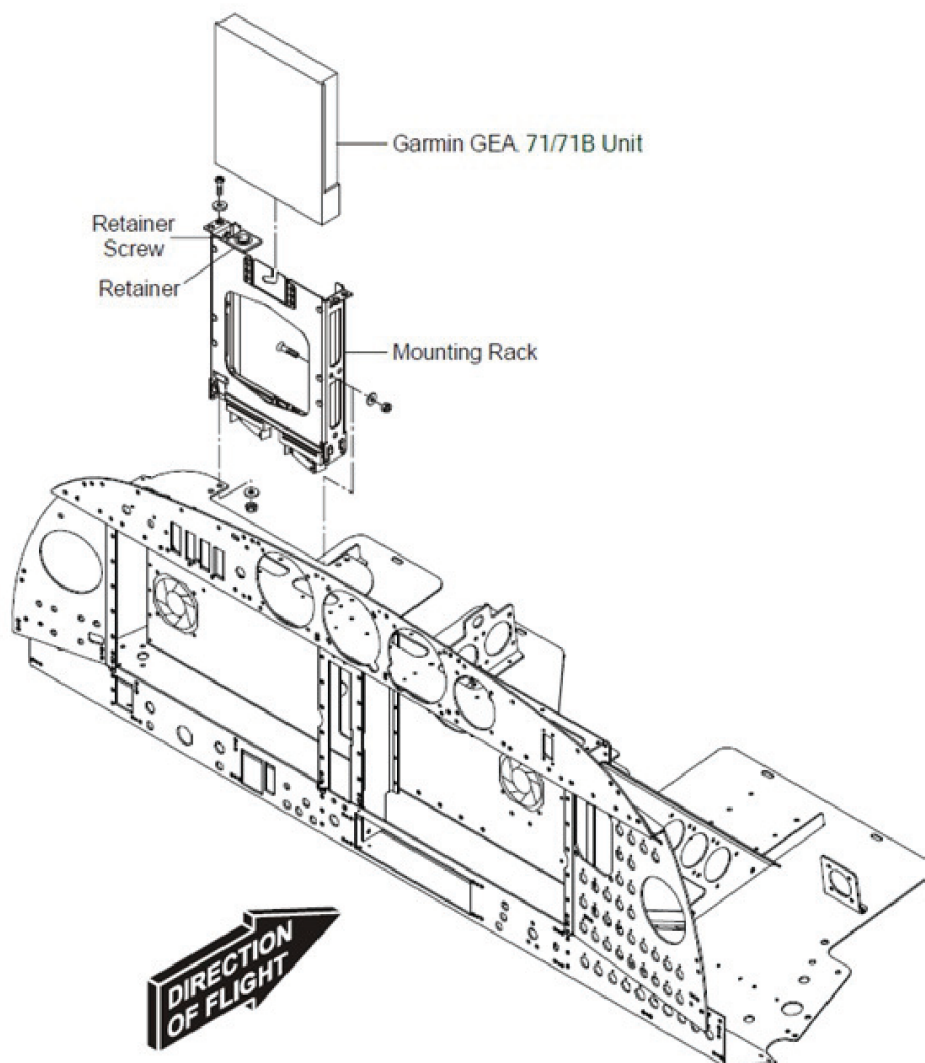
**Figure 6 : GEA 71 / 71B Processor Installation**

None of these addressed the ground path. The alternator and regulators were never the problem — the ECU confirms the charging system works correctly. The Feb 2026 pin cleaning targeted the GDL 69A (SiriusXM datalink transceiver, CH.23). The voltage measurement comes from the GEA 71S (Engine/Airframe unit, connector P701) — its power ground pin (Pin 20, wire 77016A22N to GS-IP-14) was not inspected. Note: This aircraft has a history of connector/pin problems. In May 2023, the G1000 experienced repeated COM/NAV/GPS/AHRS cycling and autopilot disconnects during an IFR flight — that issue was resolved by cleaning pins and reseating the P2413 HSDB harness connector (Jul 2024). Connector issues are a known problem on this airframe. The voltage problem is the same type of issue — a bad connection — just at a different connector/stud that hasn't been addressed yet. **What's Causing It** A high-resistance ground connection somewhere in the GEA 71S's ground return path. **Where the Voltage Is Actually Measured** The G1000 bus voltage ("volt1") is measured by the GEA 71S (Engine/Airframe unit), which is mounted on the instrument panel shelf (AMM 31-40-00, p.985, Figure 6): GEA 71S Installation Location (AMM 31-40-00, Figure 6):

GEA 71S measures its own power supply voltage internally — there is no separate external sense wire Power input: Pin 35 (AIRCRAFT POWER) via wire 77015A22 from the Essential Bus through the 5A ENG INST breaker Ground reference: Pin 20 (POWER GROUND) via wire 77016A22N to ground stud GS-IP-14 The displayed voltage = what arrives at Pin 35 minus what's at Pin 20

**Where to Look Instrument Panel** The GEA 71S — the unit that actually measures the voltage — is on the instrument panel shelf (AMM 31-40-00, p.985). Its connector P701 and ground stud GS-IP-14 are both in this area. Inspect: - GEA 71S connector P701 — is it fully seated with lock engaged? This is the voltage sensor unit. Check Pin 20 (power ground) and Pin 35 (aircraft power) specifically. - Ground stud GS-IP-14 — this is where the GEA 71S power ground wire (77016A22N) terminates. Check for loose nut, corrosion, or paint under the ring terminal. - All GS-IP ground studs on the IP bus bar (see table below) - Look for anything that appears disturbed, loose, or not fully reconnected **Ground Stud Locations (GS-IP Series)** All G1000 components ground to the GS-IP (Ground Stud — Instrument Panel) group. These are the specific studs and what's connected to each:
