# N238PS — G1000 LOW VOLTS Troubleshooting Guide

**Aircraft:** N238PS (Diamond DA40NG, MAM40-858) **Problem:** G1000 NXi displays lower voltage than actual bus voltage, causing intermittent LOW VOLTS annunciations **Date:** February 2026 **Prepared by:** Aircraft Owner (Ingram Leedy)

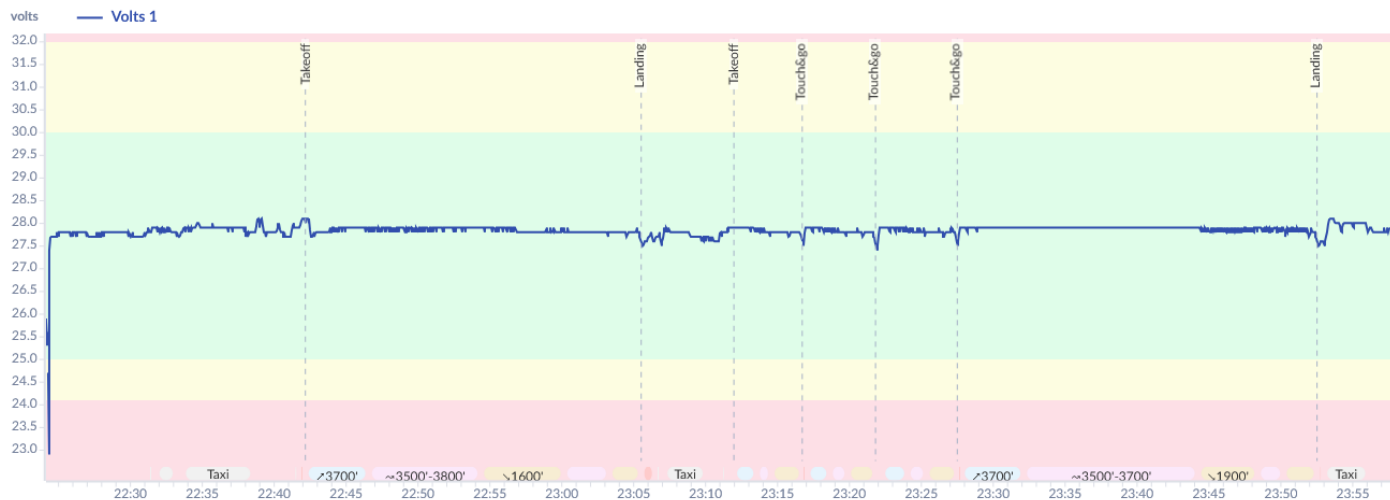
Comparing N238PS to another DA40NG (N541SA) shows something was never right — even from the delivery flight:

N541SA's G1000 reads rock-steady voltage at ~27.8V with barely any fluctuation. N238PS has **never** been this stable:

Even from delivery, N238PS was reading **0.25V low** and had **4–5x more voltage noise** than N541SA. This suggests a marginal ground connection has existed since the factory — the Feb 2024 shop visit then made it significantly worse.
