N238PS — G1000 LOW VOLTS Troubleshooting Guide Aircraft: N238PS

(Diamond DA40NG, MAM40-858) Problem: G1000 NXi displays lower voltage than actual bus voltage, causing intermittent LOW VOLTS annunciations Date: February 2026 Prepared by: Aircraft Owner (Ingram Leedy)

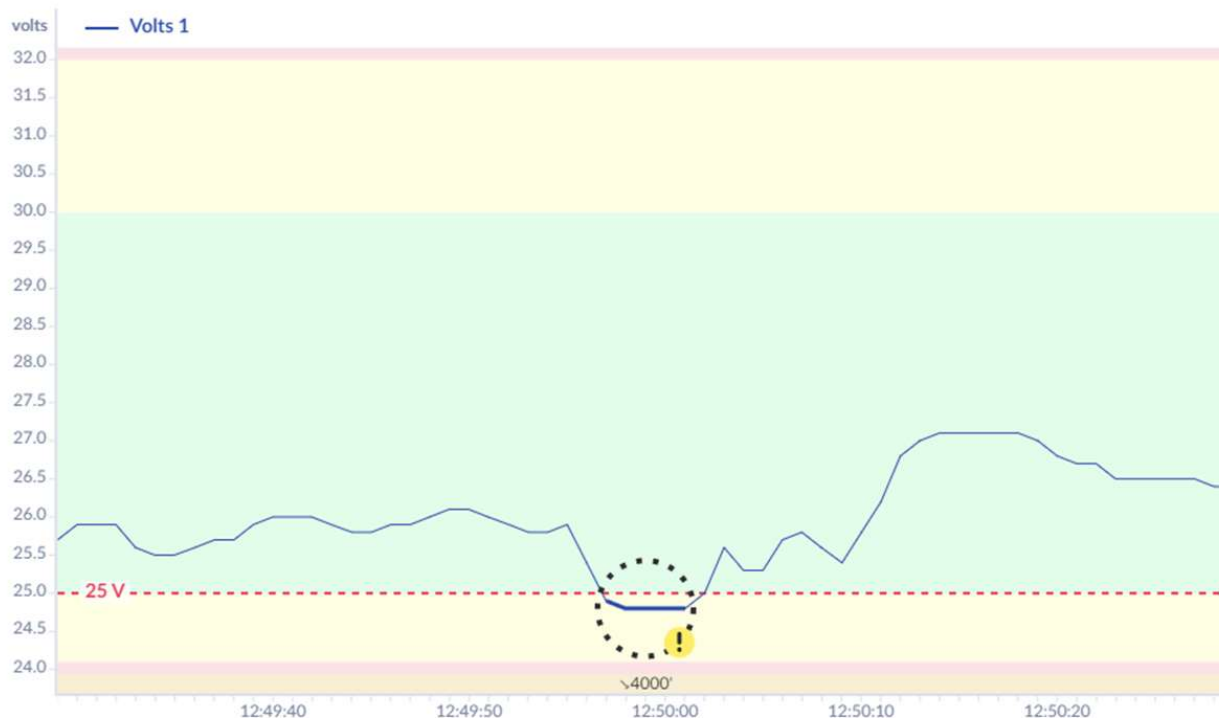
Volts < 25 V for 5 sec

These

dips are not real — the independent VDL48 logger shows the bus voltage is steady at ~28V during these same periods. The G1000 is the only instrument seeing these drops. **How We Know It's Real** Three independent
