N238PS — G1000 LOW VOLTS Troubleshooting Guide Aircraft: N238PS

(Diamond DA40NG, MAM40-858) Problem: G1000 NXi displays lower voltage than actual bus voltage, causing intermittent LOW VOLTS annunciations Date: February 2026 Prepared by: Aircraft Owner (Ingram Leedy)

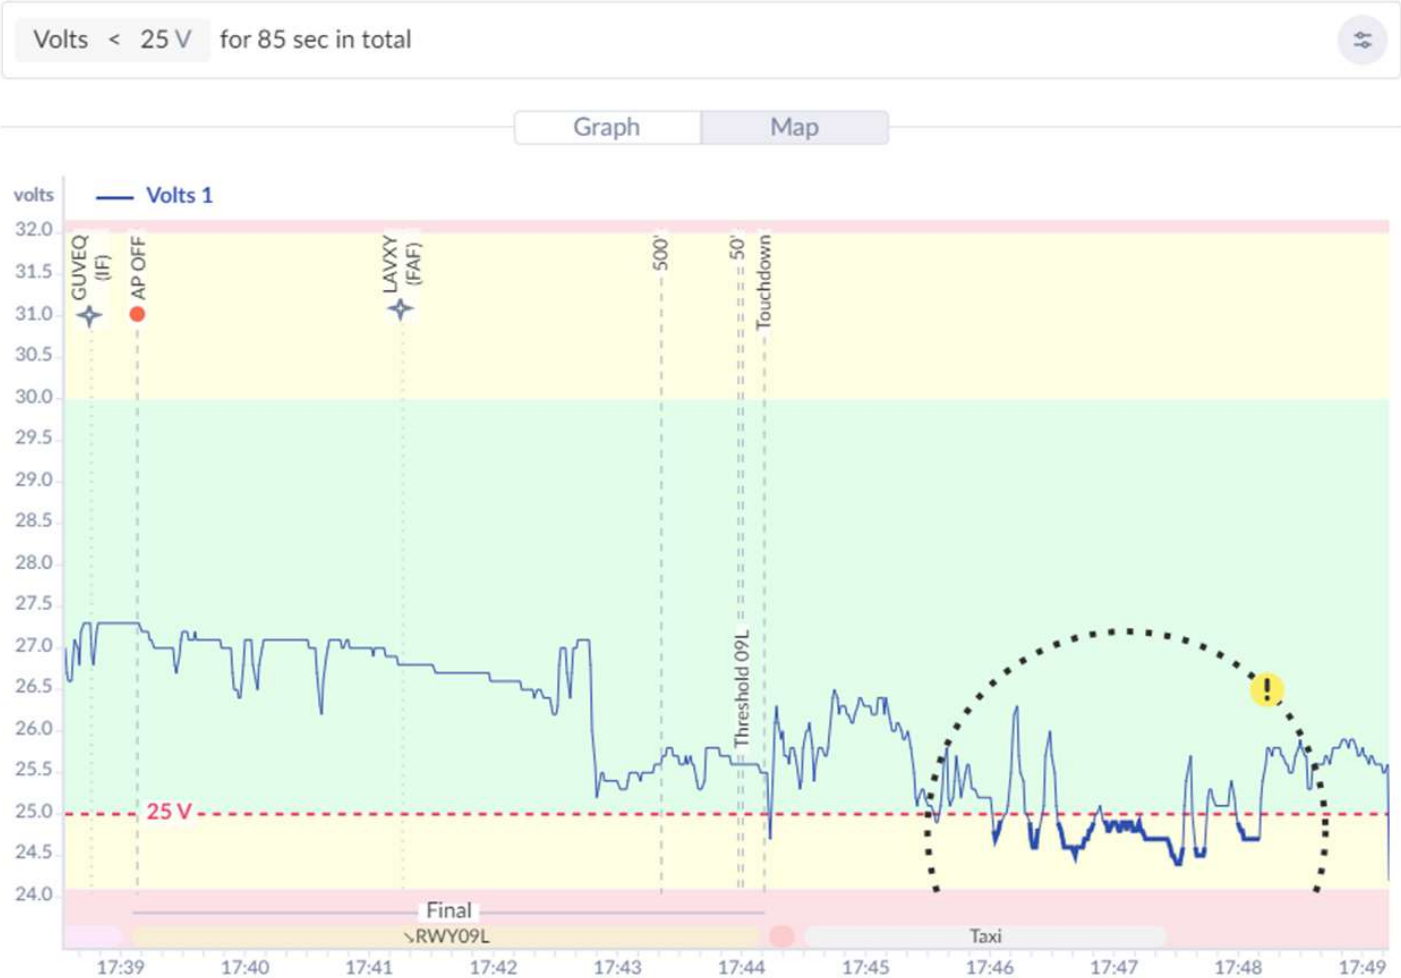
Volts < 25 V

The Problem The G1000 consistently reads 1–2 volts lower than actual bus voltage, with transient dips up to 5.6 volts low during high-current events. This causes false LOW VOLTS annunciations in flight even though the electrical system is charging normally. [FlySto LOW VOLTS Events \(In-Flight\)](#) These FlySto screenshots show actual LOW VOLTS events captured from G1000 flight logs. The voltage drops below the 25V threshold repeatedly during normal flight operations: 85 seconds below 25V — approach and taxi at KBOW, voltage swinging wildly between 24–27V:

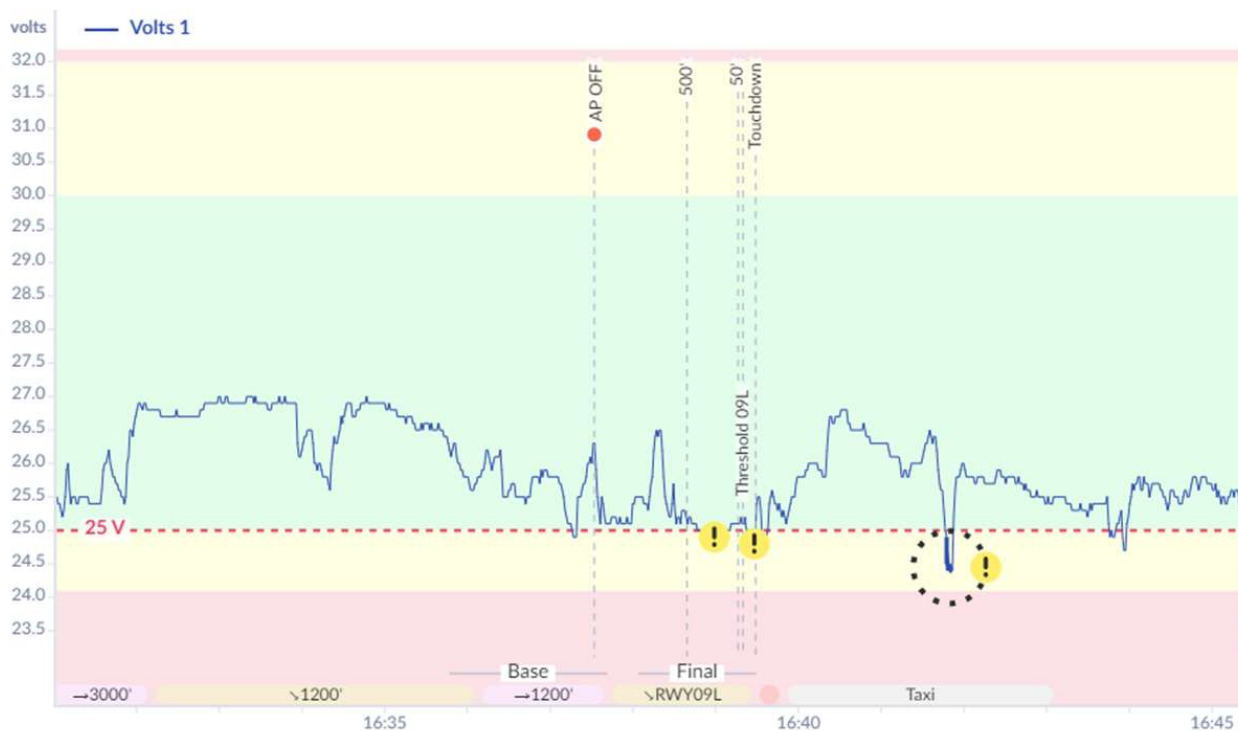
Volts < 25 V for 18 sec in total

18 seconds below 25V — during landing, and 5 seconds below 25V — at altitude during cruise:

These

dips are not real — the independent VDL48 logger shows the bus voltage is steady at ~28V during these same periods. The G1000 is the only instrument seeing these drops. **How We Know It's Real** Three independent

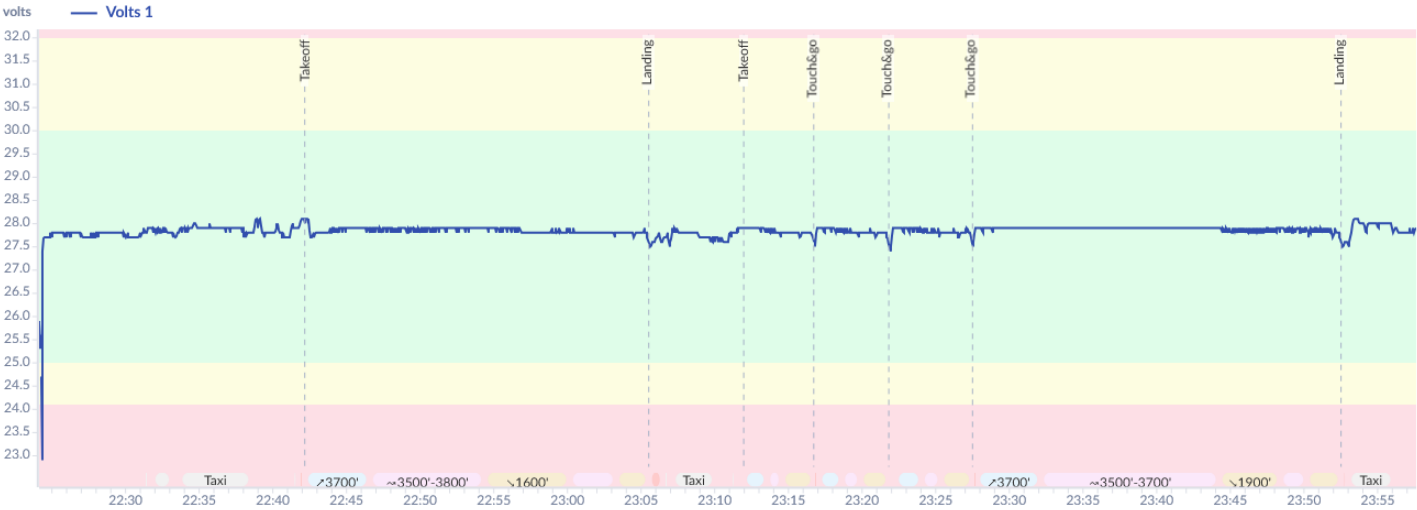
The offset exists on the ground with battery only. This rules out the alternator, voltage regulator, and charging system entirely. [Why the Battery Matters \(but isn't the cause\)](#) The ground path drops ~1.4V regardless of battery condition. But the higher the starting bus voltage, the more headroom the G1000 has before hitting the 25V LOW VOLTS threshold. A fully charged battery with alternator running keeps the bus at ~28V, so the G1000 reads ~26.6V — above the threshold most of the time. If the battery is weak or undercharged, the bus sits lower and the G1000 dips below 25V more easily. A BatteryMinder trickle charger and keeps the battery fully maintained between flights. This maximizes voltage headroom and keeps the G1000 reading within operational margins most of the time — but it's a workaround, not a fix. HIGH-current transient loads (radio TX, autopilot servos, flaps) still cause dips that break through even that margin, which is what triggers the LOW VOLTS annunciations seen in the FlySto screenshots above. [When It Started and How It's Getting Worse](#) The Problem Existed From Day One Comparing N238PS to another DA40NG (N541SA) shows something was never right — even from the delivery flight:

G1000 reads rock-steady voltage at ~27.8V with barely any fluctuation. N238PS has never been this stable:

Even from delivery, N238PS was reading 0.25V low and had 4–5x more voltage noise than N541SA. This suggests a marginal ground connection has existed since the factory — the Feb 2024 shop visit then made it significantly worse.

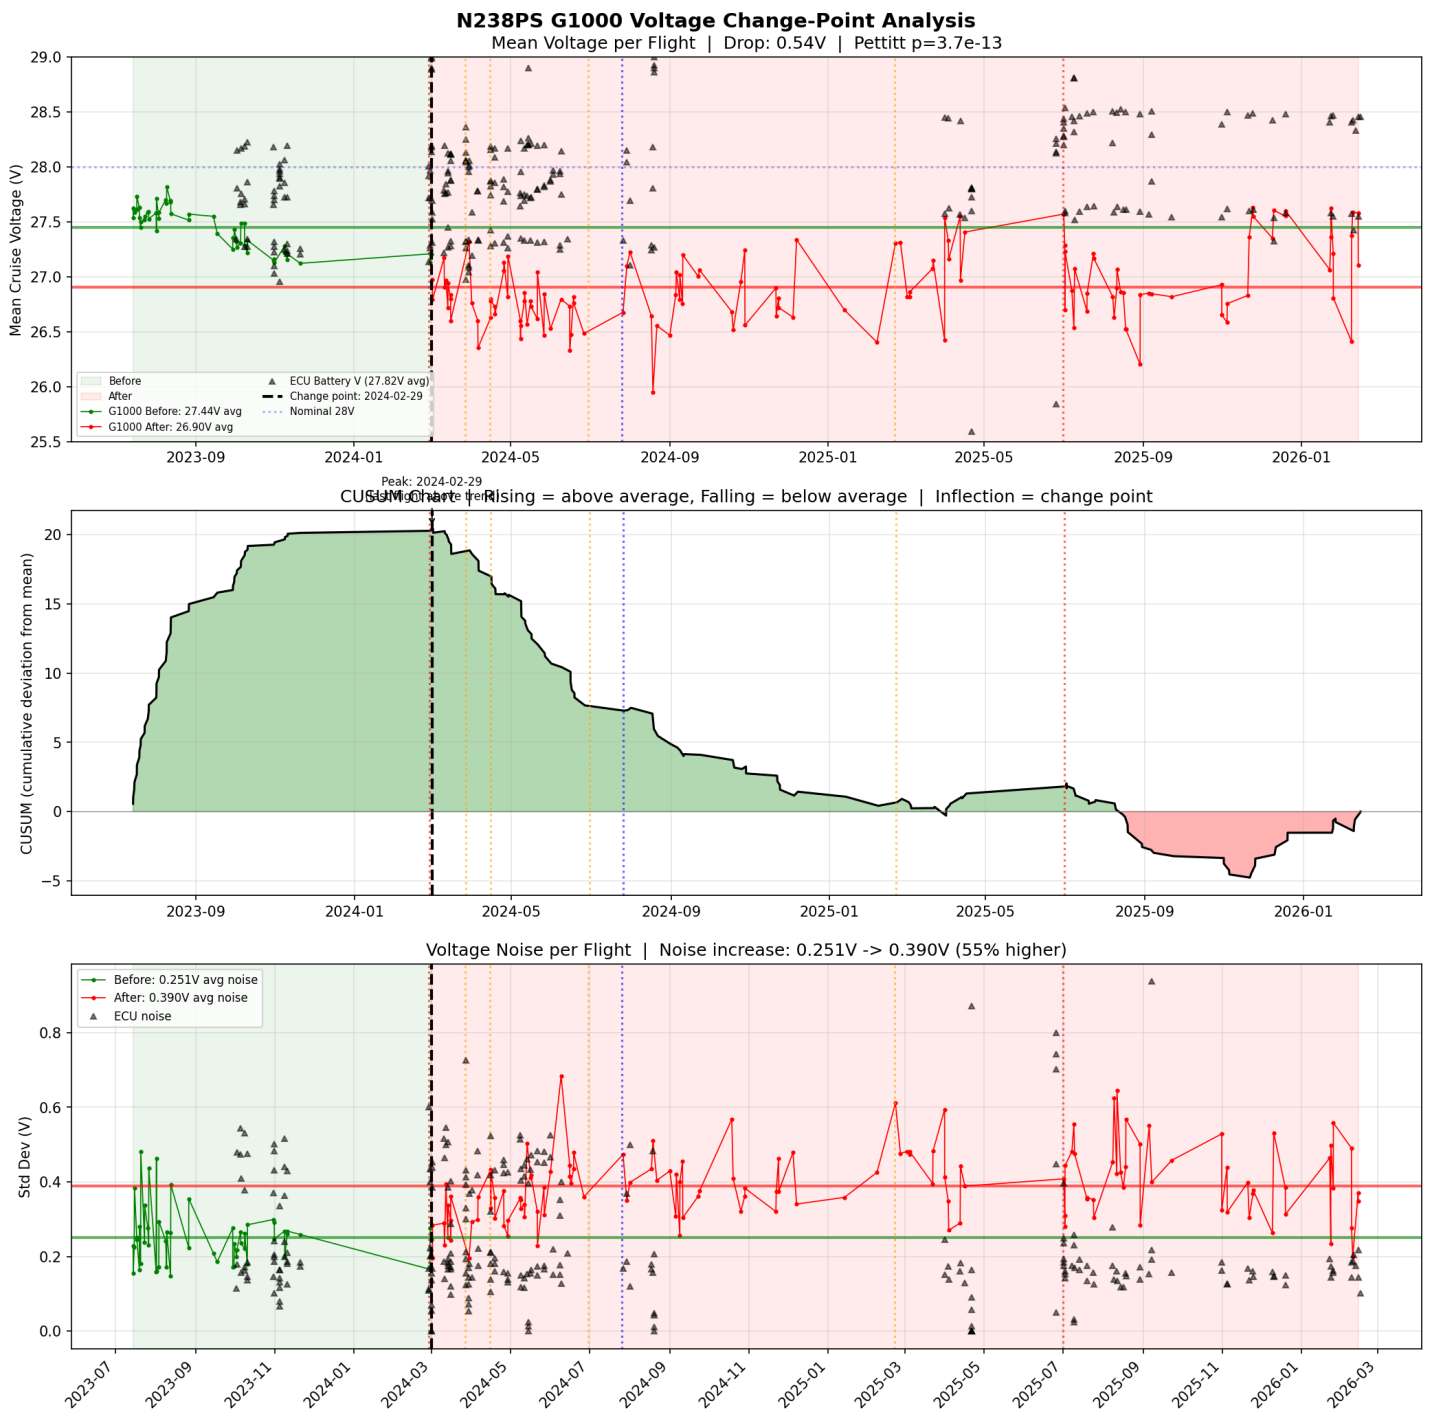
The Change-Point: February 2024 Statistical analysis of 184 flight logs (Jul 2023 – Feb 2026) pinpoints exactly when the readings shifted. A statistically significant change-point was detected on February 29, 2024:

The ECU voltage did NOT change — it reads a steady 27.82V throughout the entire period. The problem is G1000-specific. The Feb 2024 shop visit made a pre-existing marginal connection worse, pushing it into LOW VOLTS territory.

to read this chart: Top panel — Each dot is one flight's average voltage. Green = before Feb 2024, red = after. The ECU dots along the top stay flat at ~27.8V the entire time — the actual bus voltage never changed. Only the G1000 dropped. Middle panel — A trend line showing the problem is getting progressively worse over time, with a clear inflection at Feb 2024. Bottom panel — Voltage noise (how much the reading jumps around during each flight). After Feb 2024, noise increased 55% — consistent with a loose or corroded connection that vibration makes worse.

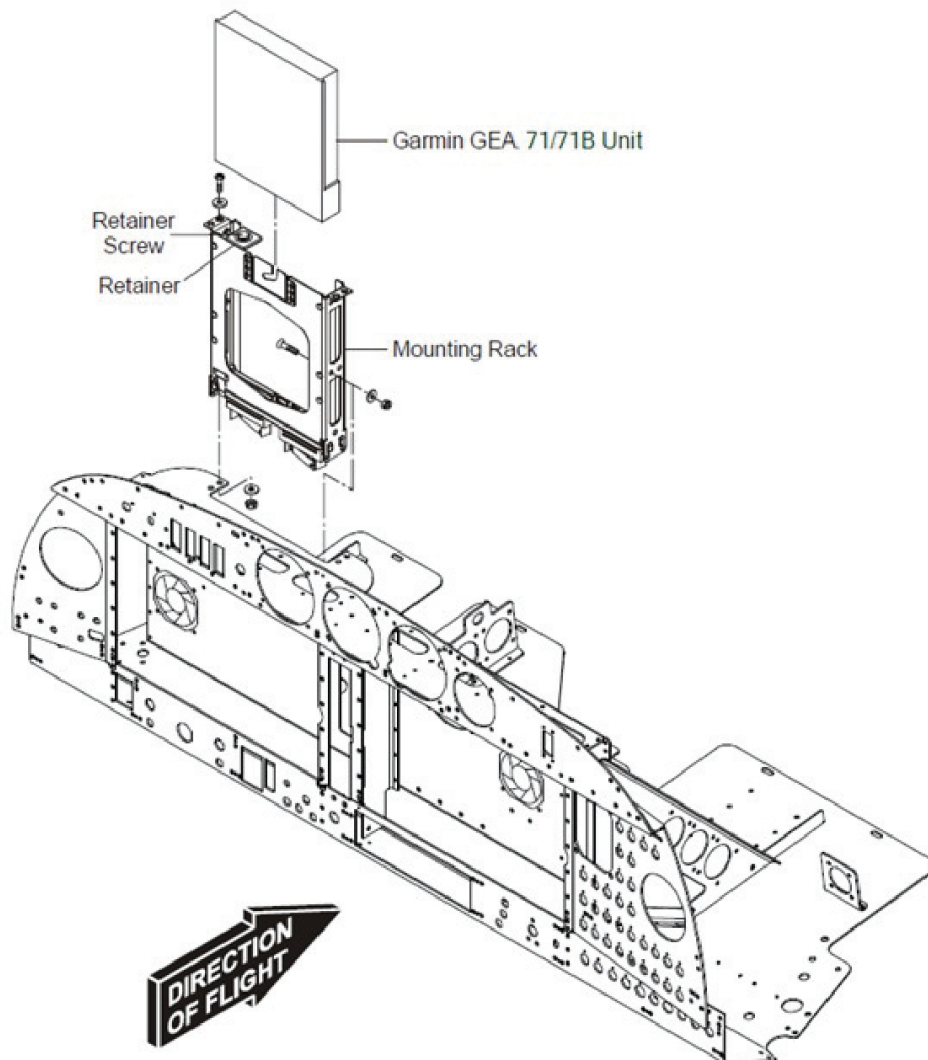
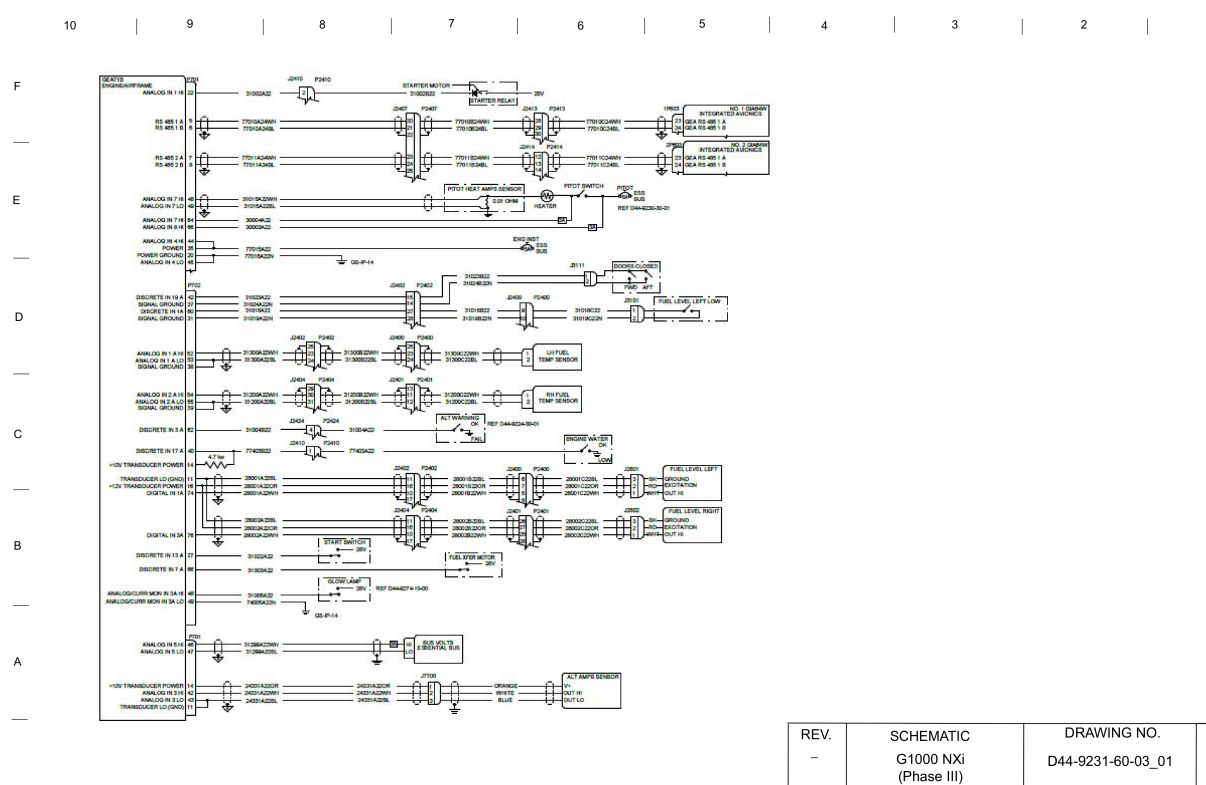
**Figure 6 : GEA 71 / 71B Processor Installation**

None of these addressed the ground path. The alternator and regulators were never the problem — the ECU confirms the charging system works correctly. The Feb 2026 pin cleaning targeted the GDL 69A (SiriusXM datalink transceiver, CH.23). The voltage measurement comes from the GEA 71S (Engine/Airframe unit, connector P701) — its power ground pin (Pin 20, wire 77016A22N to GS-IP-14) was not inspected. Note: This aircraft has a history of connector/pin problems. In May 2023, the G1000 experienced repeated COM/NAV/GPS/AHRS cycling and autopilot disconnects during an IFR flight — that issue was resolved by cleaning pins and reseating the P2413 HSDB harness connector (Jul 2024). Connector issues are a known problem on this airframe. The voltage problem is the same type of issue — a bad connection — just at a different connector/stud that hasn't been addressed yet. **What's Causing It** A high-resistance ground connection somewhere in the GEA 71S's ground return path. **Where the Voltage Is Actually Measured** The G1000 bus voltage ("volt1") is measured by the GEA 71S (Engine/Airframe unit), which is mounted on the instrument panel shelf (AMM 31-40-00, p.985, Figure 6): GEA 71S Installation Location (AMM 31-40-00, Figure 6):

Where to Look Instrument Panel The GEA 71S — the unit that actually measures the voltage — is on the instrument panel shelf (AMM 31-40-00, p.985). Its connector P701 and ground stud GS-IP-14 are both in this area.

- GEA 71S connector P701 — is it fully seated with lock engaged? This is the voltage sensor unit. Check Pin 20 (power ground) and Pin 35 (aircraft power) specifically.
- Ground stud GS-IP-14 — this is where the GEA 71S power ground wire (77016A22N) terminates. Check for loose nut, corrosion, or paint under the ring terminal.
- All GS-IP ground studs on the IP bus bar (see table below)
- Look for anything that appears disturbed, loose, or not fully reconnected
