N238PS — G1000 LOW VOLTS Troubleshooting Guide

Aircraft: N238PS (Diamond DA40NG, MAM40-858) **Problem:** G1000 NXi displays lower voltage than actual bus voltage, causing intermittent LOW VOLTS annunciations **Date:** February 2026 **Prepared by:** Aircraft Owner (Ingram Leedy)

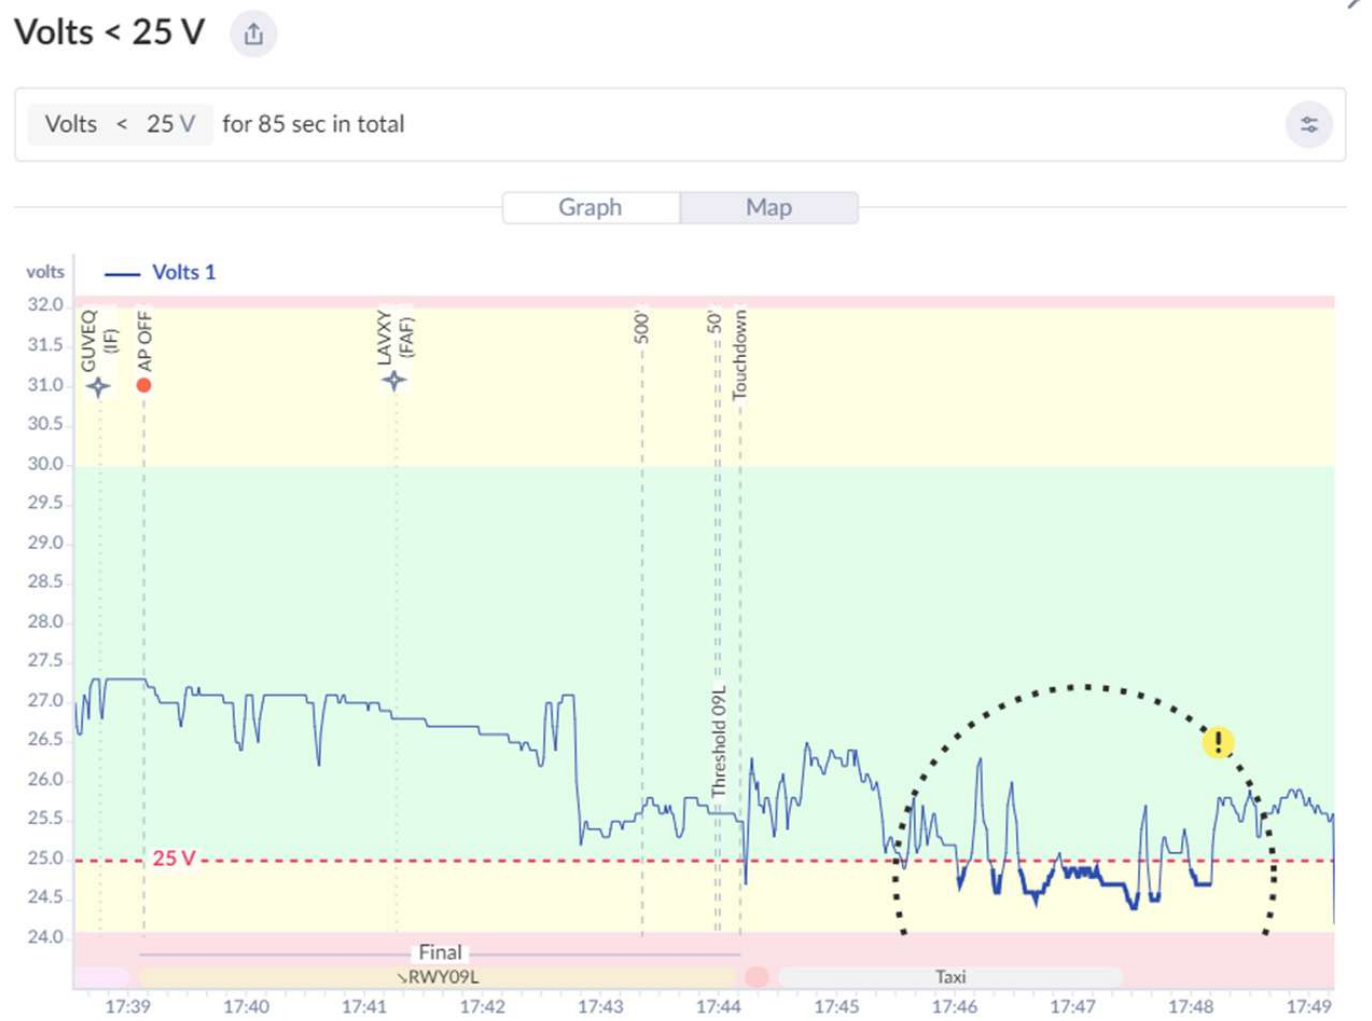
85 seconds below 25V — approach and taxi at KBOW, voltage swinging wildly between 24–27V:

These dips are **not real** — the independent VDL48 logger shows the bus voltage is steady at ~28V during these same periods. The G1000 is the only instrument seeing these drops.

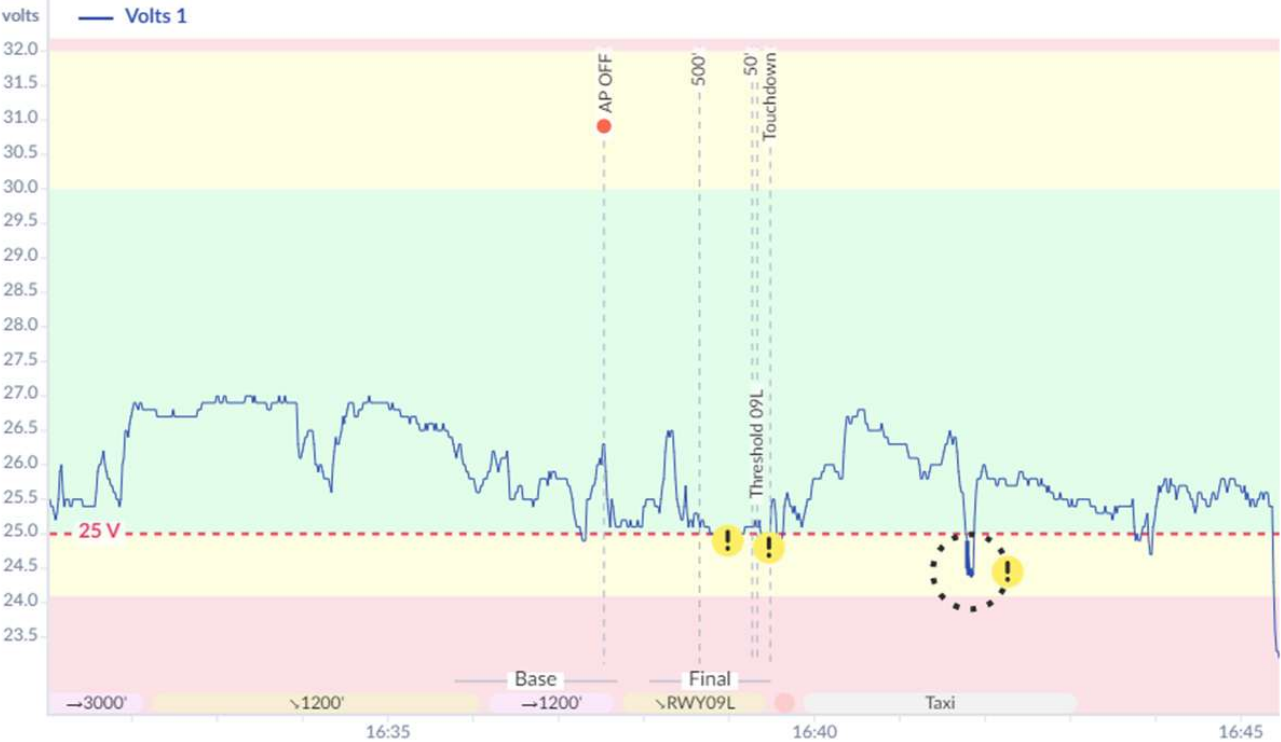
18 seconds below 25V — during landing, and **5 seconds below 25V** — at altitude during cruise:

Volts < 25 V for 18 sec in total

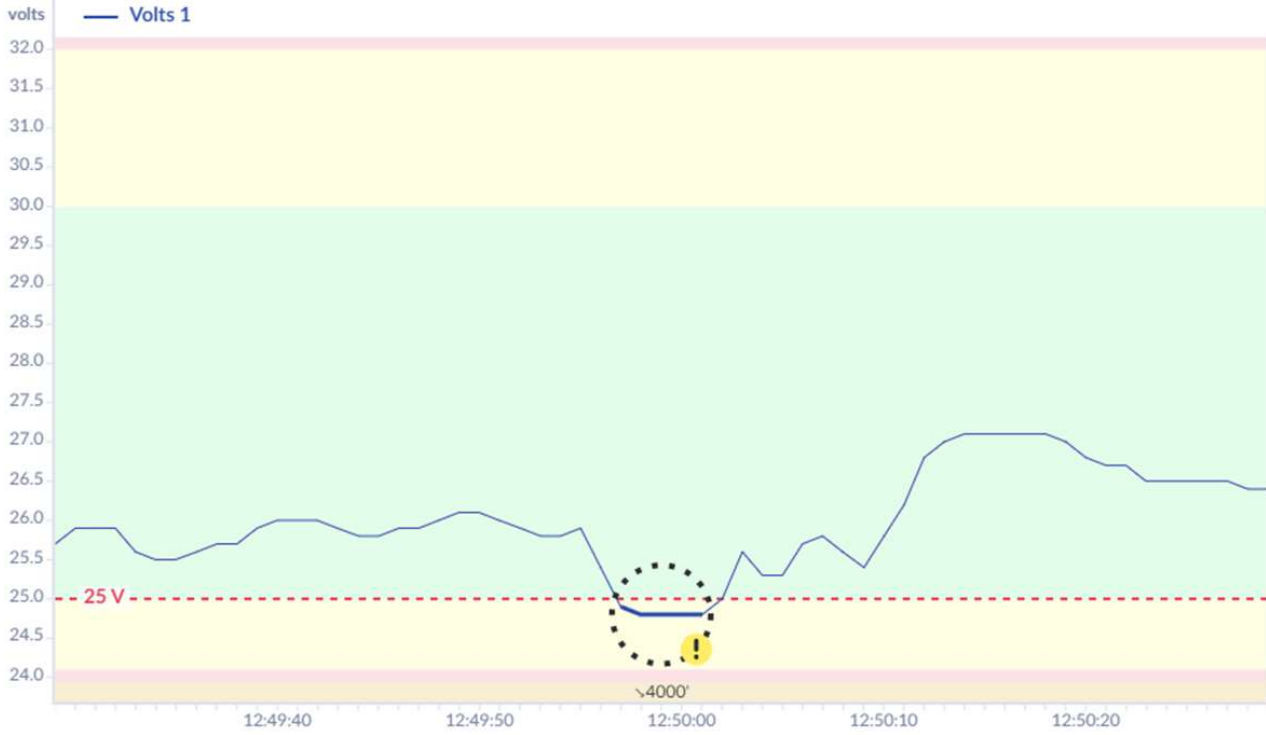
Volts < 25 V for 5 sec

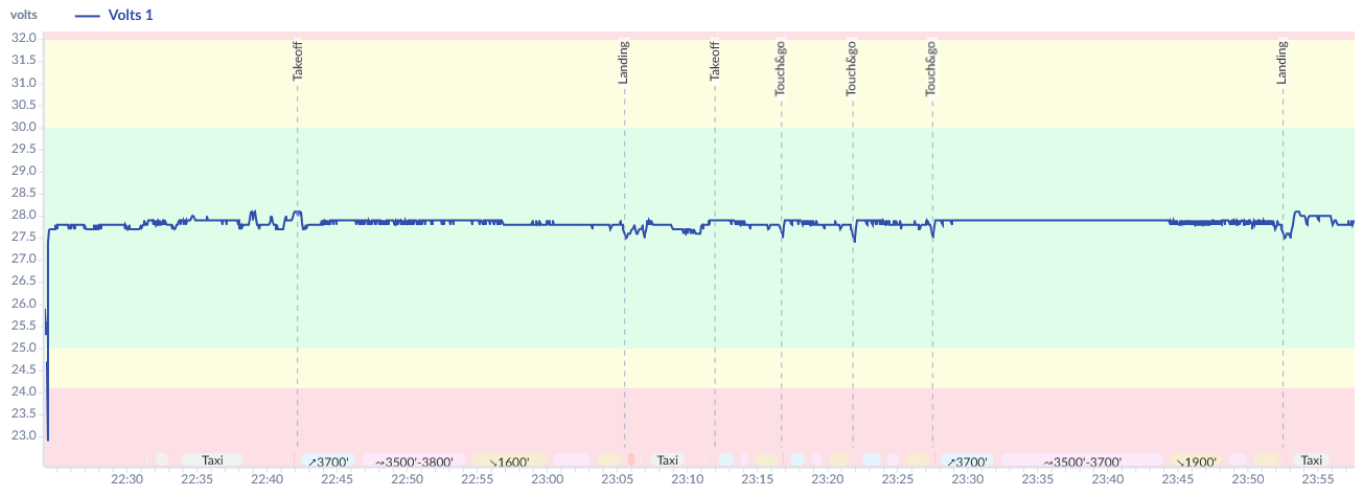
A FlySto voltage graph from another DA40NG (N541SA) shows rock-steady voltage at ~27.8V with barely any fluctuation. The G1000 is capable of reading stable, accurate voltage — the problem is specific to N238PS.

N238PS has **never** been this stable — not even on the delivery flight. Comparing voltage stability across the entire history:

Even from delivery, N238PS was reading **0.25V low** and had **4–5x more voltage noise** than N541SA. This suggests a marginal ground connection has existed since the factory — the Feb 2024 shop visit then made it significantly worse.
