N238PS — G1000 LOW VOLTS Troubleshooting Guide

Aircraft: N238PS (Diamond DA40NG, MAM40-858) **Problem:** G1000 NXi displays lower voltage than actual bus voltage, causing intermittent LOW VOLTS annunciations **Date:** February 2026 **Prepared by:** Aircraft Owner (Ingram Leedy)

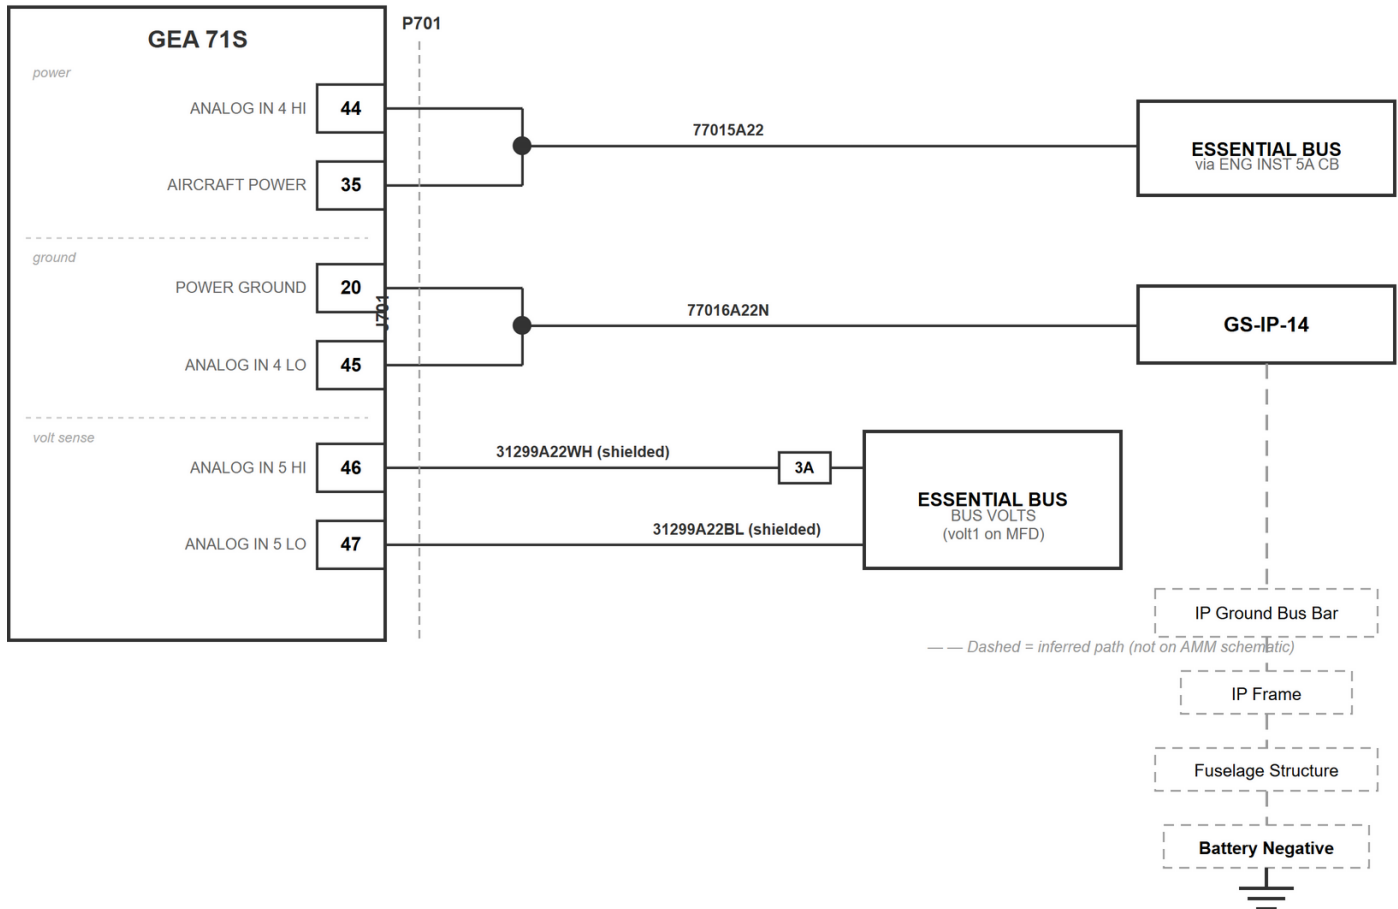
GEA 71S — Voltage Measurement Path — N238PS (DA40 NG)

Both voltage channels share the same ground reference (Pin 20 (POWER GROUND) / Pin 45 (ANALOG IN 4 LO) → wire 77016A22N → **GS-IP-14**). A high-resistance ground shifts **both** readings down equally.

The GEA 71S grounds through **GS-IP-14** (power ground Pin 20 (POWER GROUND) and Pin 45 (ANALOG IN 4 LO), wire 77016A22N), which must return to the battery negative terminal through the instrument panel ground bus bar, IP frame structure, and fuselage. The exact routing from the GS-IP bus bar to battery negative is not shown on the AMM CH.92 wiring schematics (see [Documentation Status](#) below) — but current must complete this circuit, and every joint in the chain adds potential resistance.
