N238PS — G1000 LOW VOLTS Troubleshooting Guide

Aircraft: N238PS (Diamond DA40NG, MAM40-858) **Problem:** G1000 NXi displays lower voltage than actual bus voltage, causing intermittent LOW VOLTS annunciations **Date:** February 2026 **Prepared by:** Aircraft Owner (Ingram Leedy)

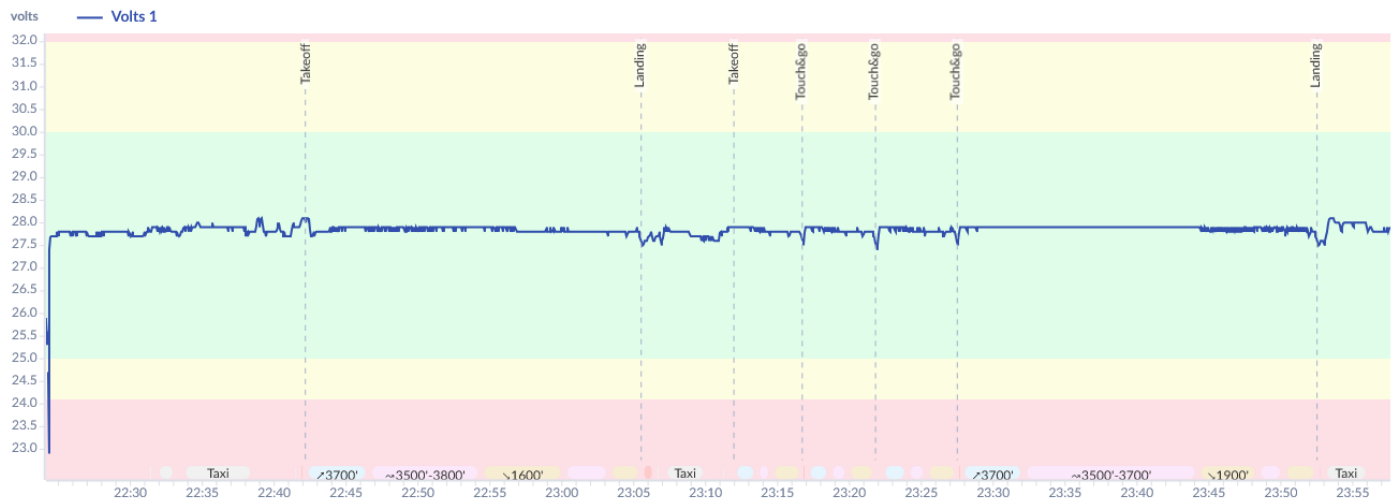
Comparing N238PS to another DA40NG (N541SA) shows something was never right — even from the delivery flight:

N541SA's G1000 reads rock-steady voltage at ~27.8V with barely any fluctuation. N238PS has **never** been this stable:

Even from delivery, N238PS was reading **0.25V low** and had **4–5x more voltage noise** than N541SA. This suggests a marginal ground connection has existed since the factory — the Feb 2024 shop visit then made it significantly worse.

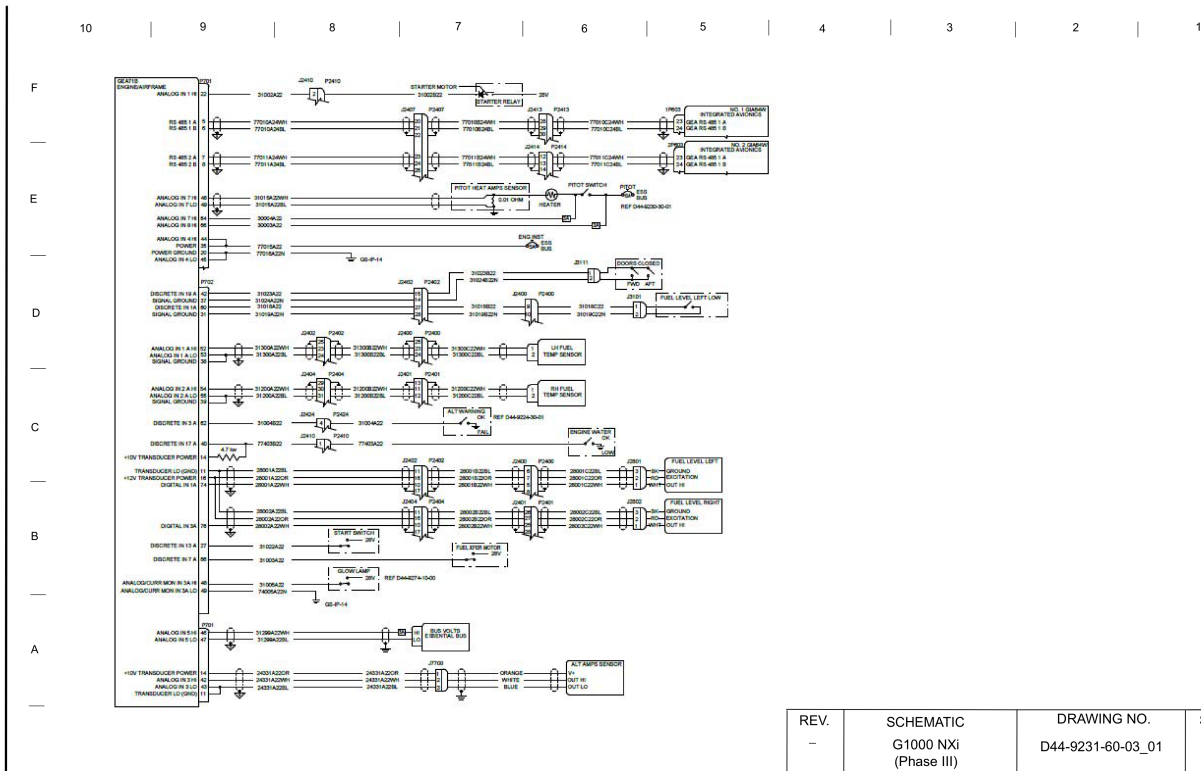
Figure 6 : GEA 71 / 71B Processor Installation

The G1000 bus voltage ("volt1") is measured by the **GEA 71S** (Engine/Airframe unit), which is mounted on the **instrument panel shelf** (AMM 31-40-00, p.985, Figure 6):

- The GEA 71S **measures its own power supply voltage internally** — there is no separate external sense wire
- **Power input:** Pin 35 (AIRCRAFT POWER) via wire **77015A22** from the Essential Bus through the **5A ENG INST** breaker
- **Ground reference:** Pin 20 (POWER GROUND) via wire **77016A22N** to ground stud **GS-IP-14**
- The displayed voltage = what arrives at Pin 35 minus what's at Pin 20

Inspect: - GEA 71S connector P701 — is it fully seated with lock engaged? This is the voltage sensor unit. Check Pin 20 (power ground) and Pin 35 (aircraft power) specifically. - **Ground stud GS-IP-14** — this is where the GEA 71S power ground wire (77016A22N) terminates. Check for loose nut, corrosion, or paint under the ring terminal. - All GS-IP ground studs on the IP bus bar (see table below) - Look for anything that appears disturbed, loose, or not fully reconnected
