N238PS — G1000 LOW VOLTS Troubleshooting Guide

Aircraft: N238PS (Diamond DA40NG, MAM40-858) **Problem:** G1000 NXi displays lower voltage than actual bus voltage, causing intermittent LOW VOLTS annunciations **Date:** February 2026 **Prepared by:** Aircraft Owner (Ingram Leedy)

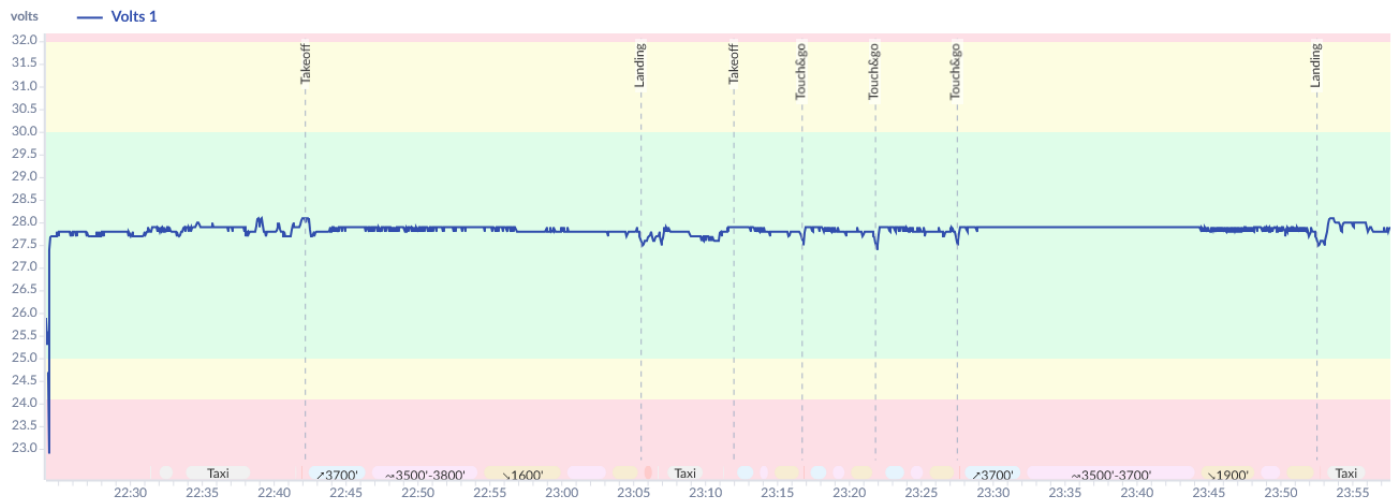
N541SA's G1000 reads rock-steady voltage at ~27.8V with barely any fluctuation. N238PS has **never** been this stable:

Even from delivery, N238PS was reading **0.25V low** and had **4–5x more voltage noise** than N541SA. This suggests a marginal ground connection has existed since the factory — the Feb 2024 shop visit then made it significantly worse.

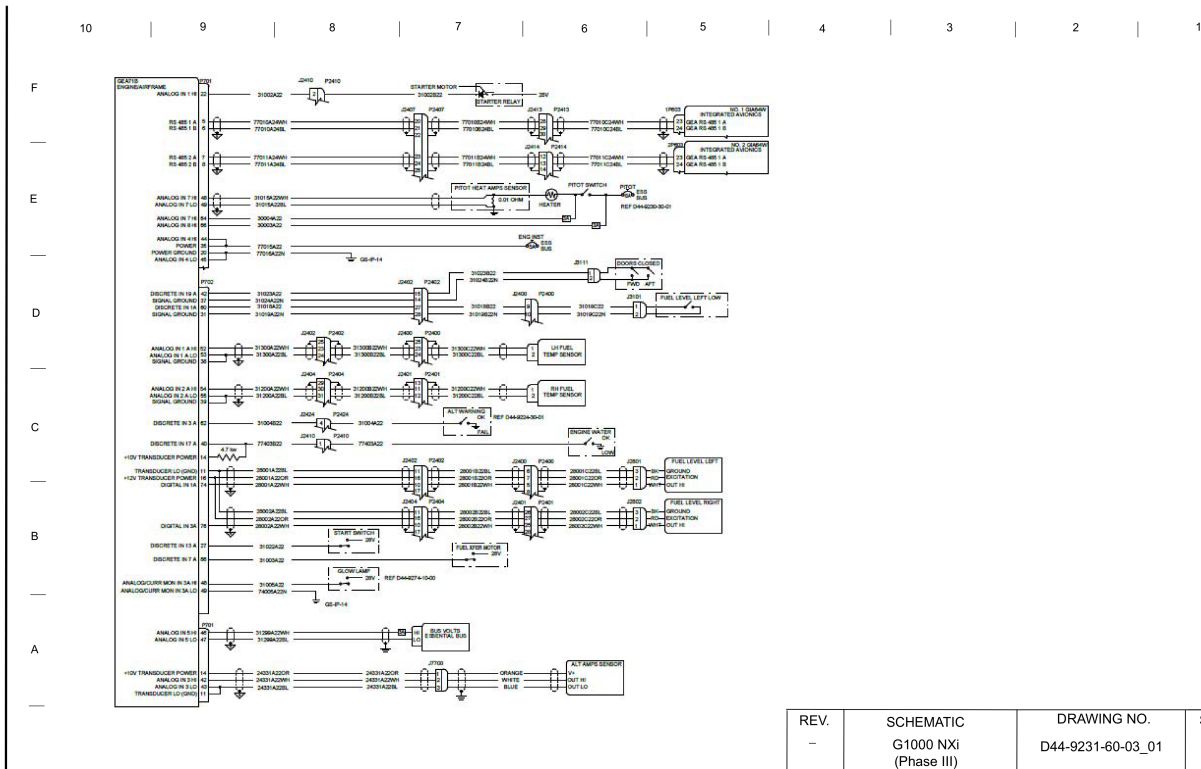
Figure 6 : GEA 71 / 71B Processor Installation

The G1000 bus voltage ("volt1") is measured by the **GEA 71S** (Engine/Airframe unit), which is mounted on the **instrument panel shelf** (AMM 31-40-00, p.985, Figure 6):

The **GEA 71S** — the unit that actually measures the voltage — is on the **instrument panel shelf** (AMM 31-40-00, p.985). Its connector P701 and ground stud GS-IP-14 are both in this area.

Inspect: - **GEA 71S connector P701** — is it fully seated with lock engaged? This is the voltage sensor unit. Check Pin 20 (power ground) and Pin 35 (aircraft power) specifically. - **Ground stud GS-IP-14** — this is where the GEA 71S power ground wire (77016A22N) terminates. Check for loose nut, corrosion, or paint under the ring terminal. - All GS-IP ground studs on the IP bus bar (see table below) - Look for anything that appears disturbed, loose, or not fully reconnected
